Mill Brook Stream Bank Stabilization and Habitat Enhancement Project September 2007

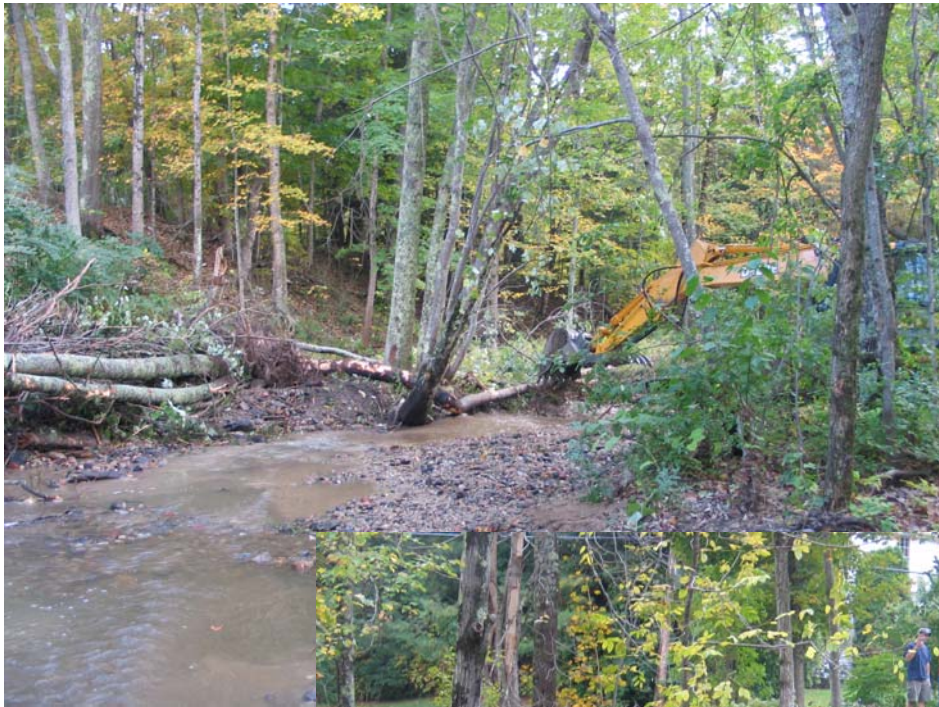
Left - Root wad and native tree stacking.

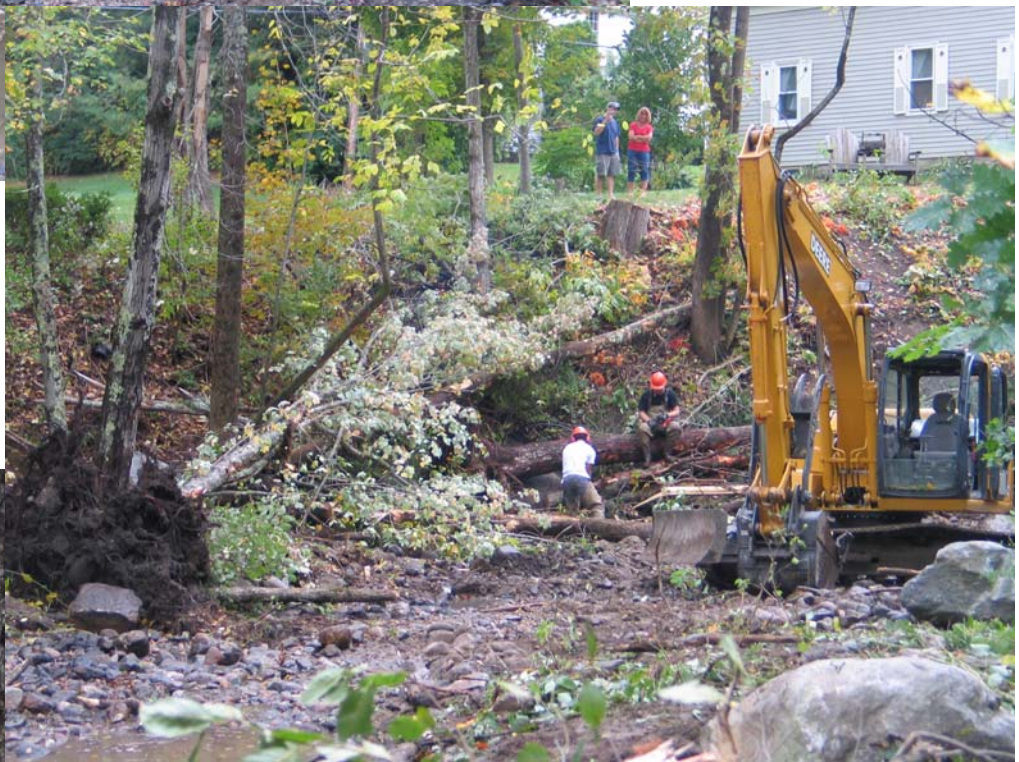
Below - Anchoring of root wads to boulders and or live native trees

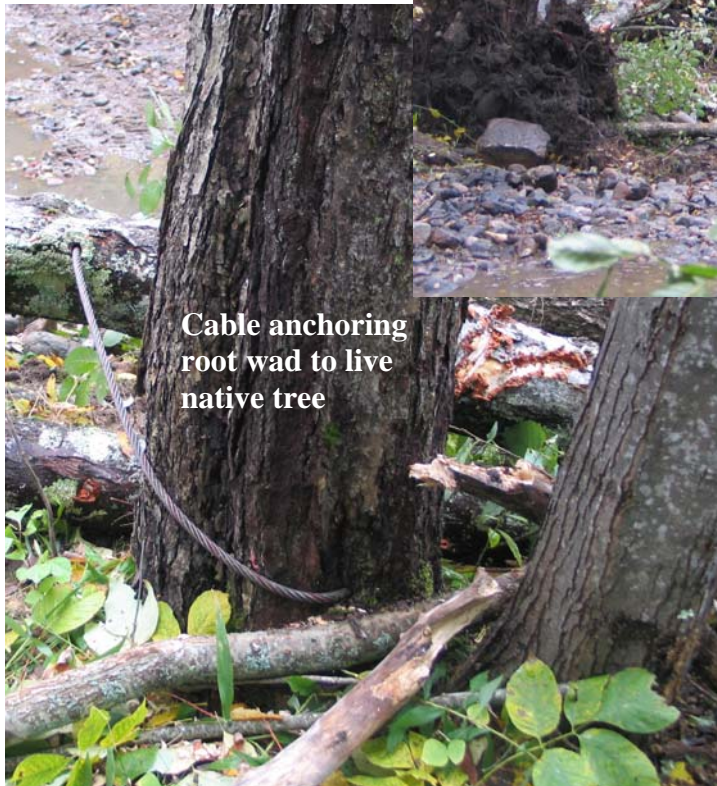
Cable anchoring root wad to live native tree

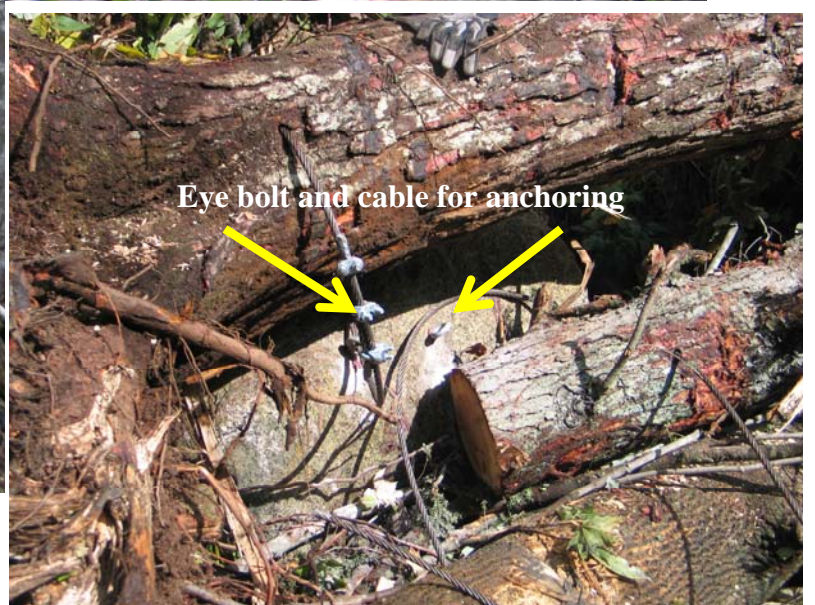
Eye bolt and cable for anchoring

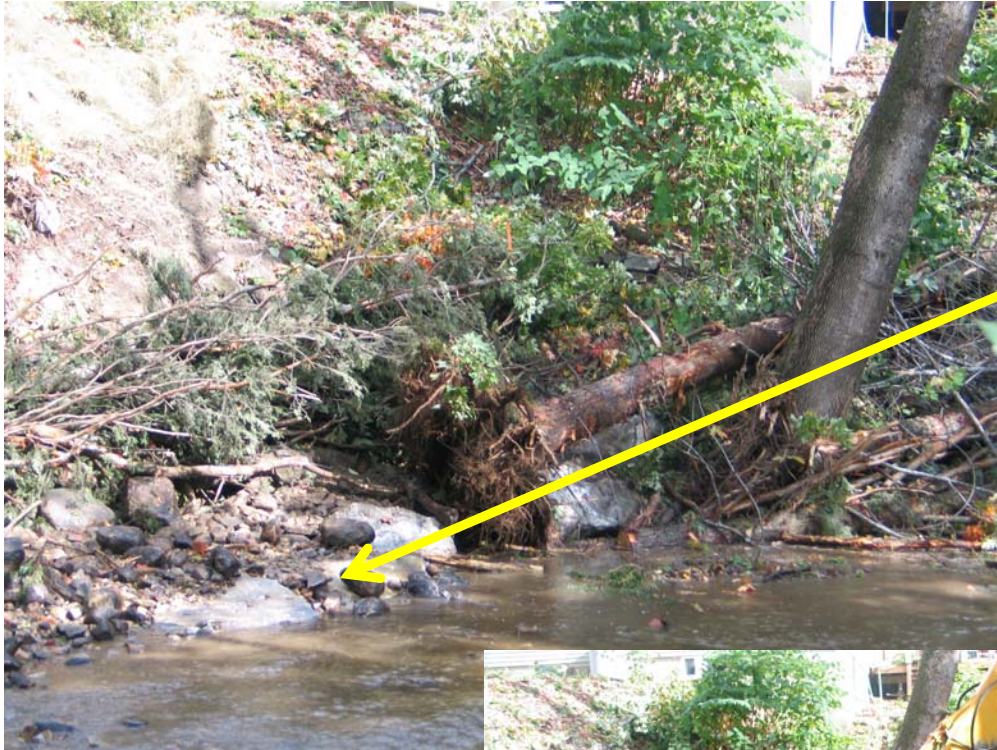
Rock vein with root wads packed around and behind.

Boulder placement to encourage pool formation and slow velocity.

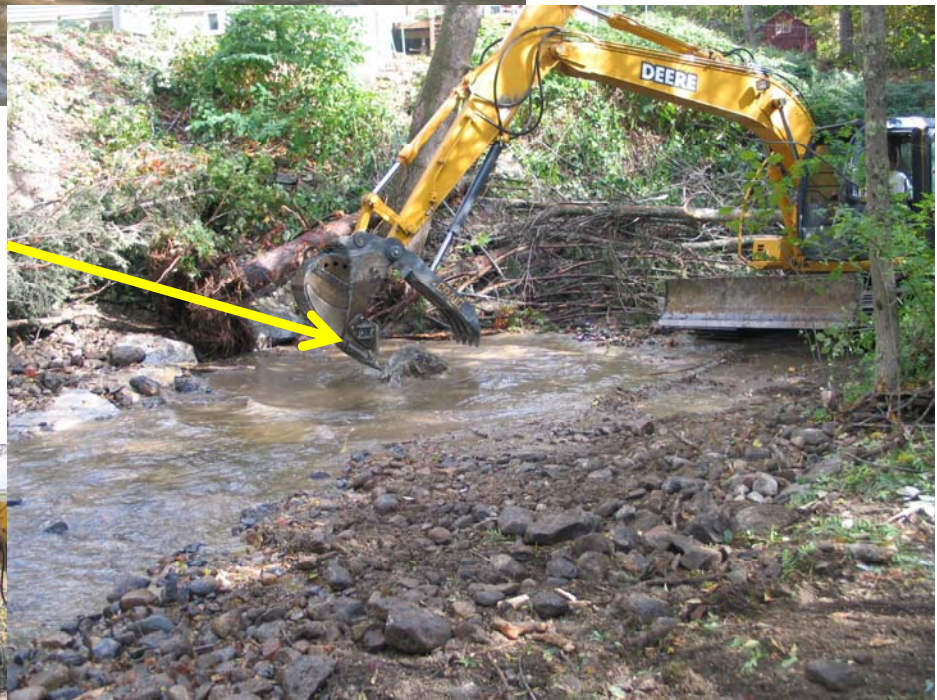
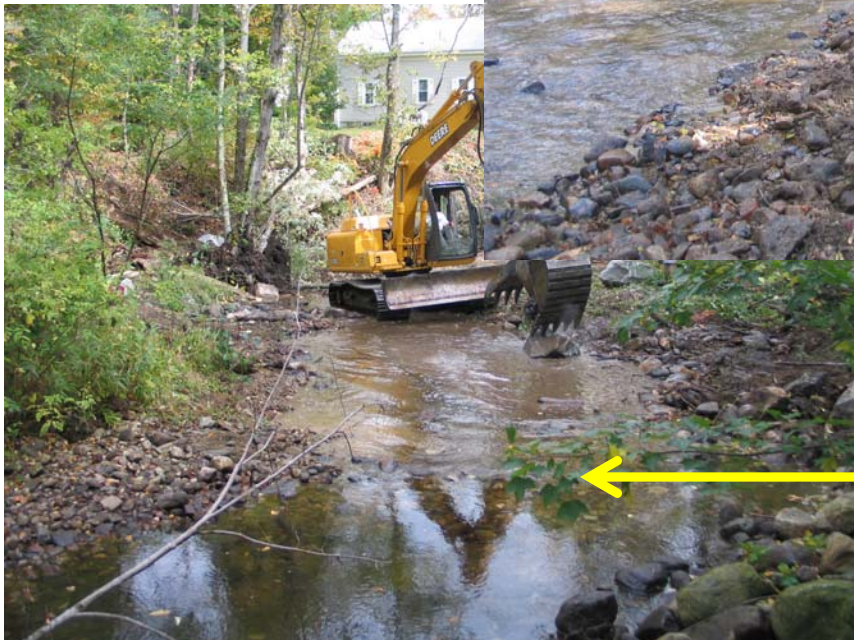
Temporary dam removed and feathering of stream bed

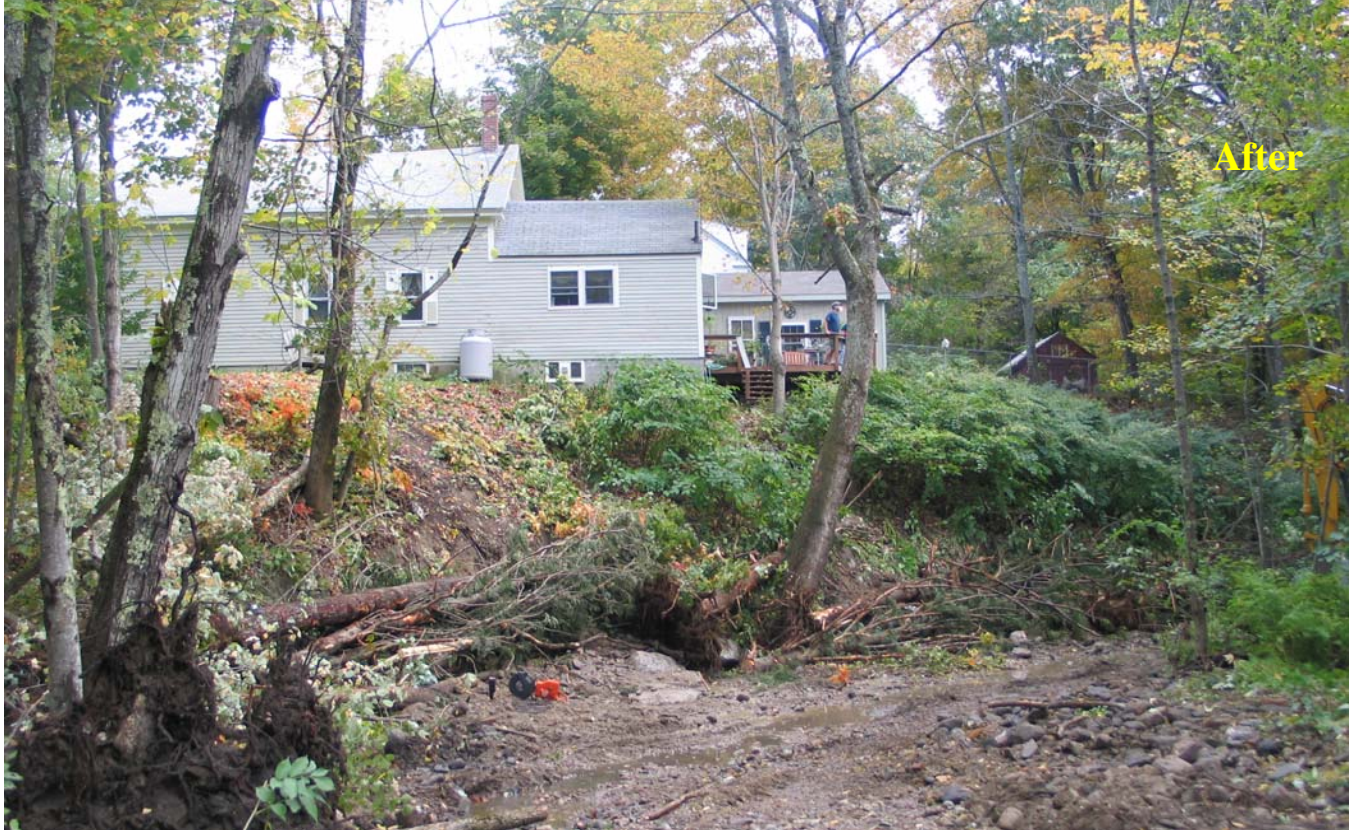
After

Feathering stream bottom

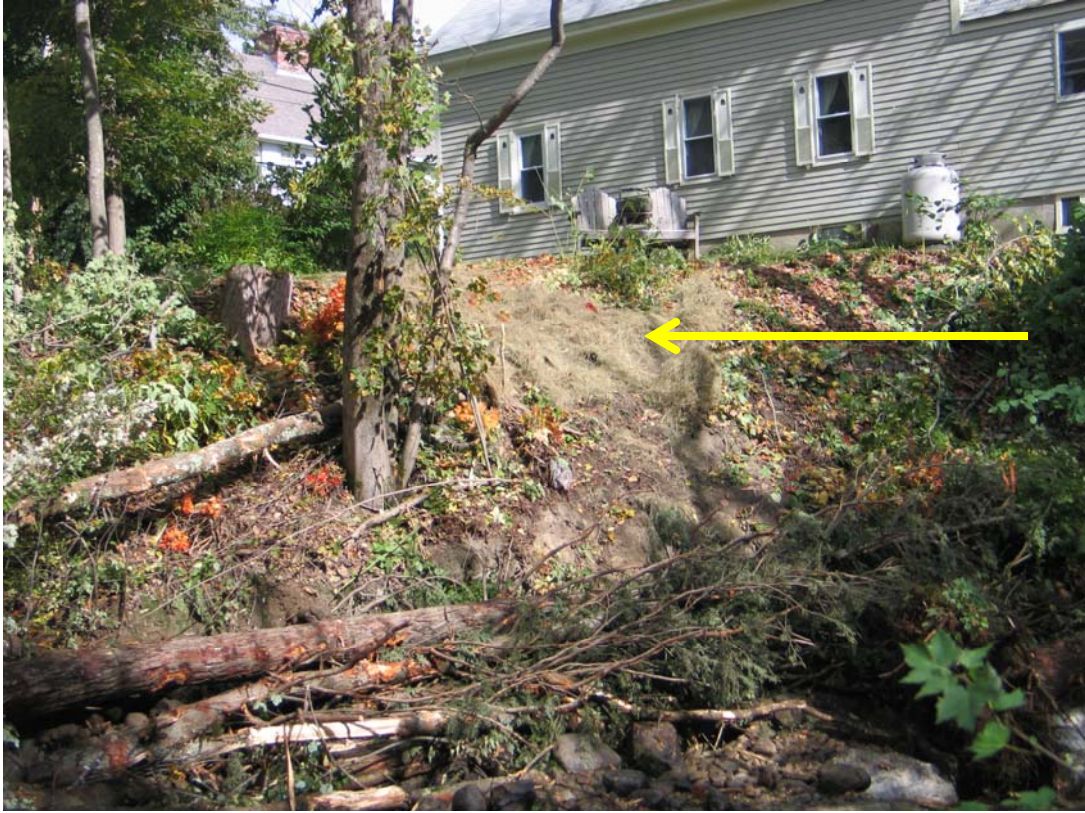
Seeding and Hay bare areas with winter rye

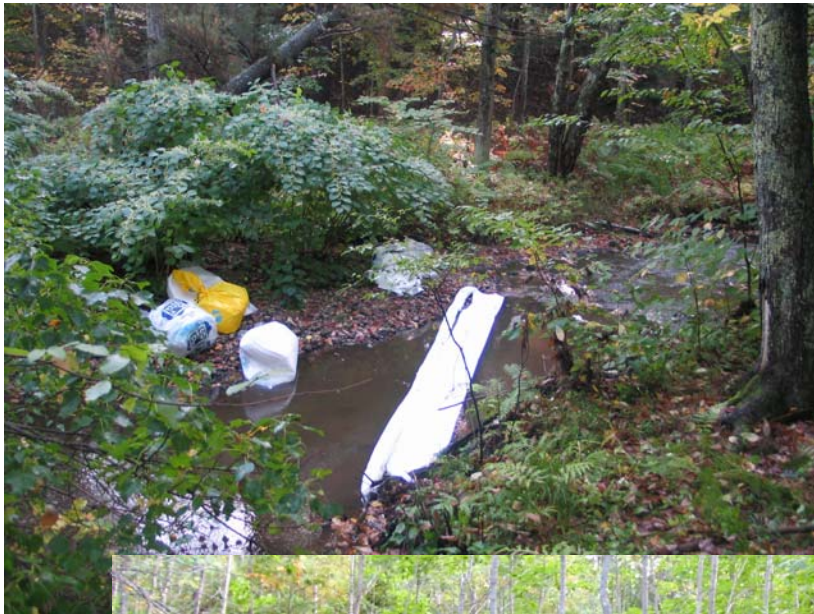
Boom for protection against possible oil/fuel leaks from equipment

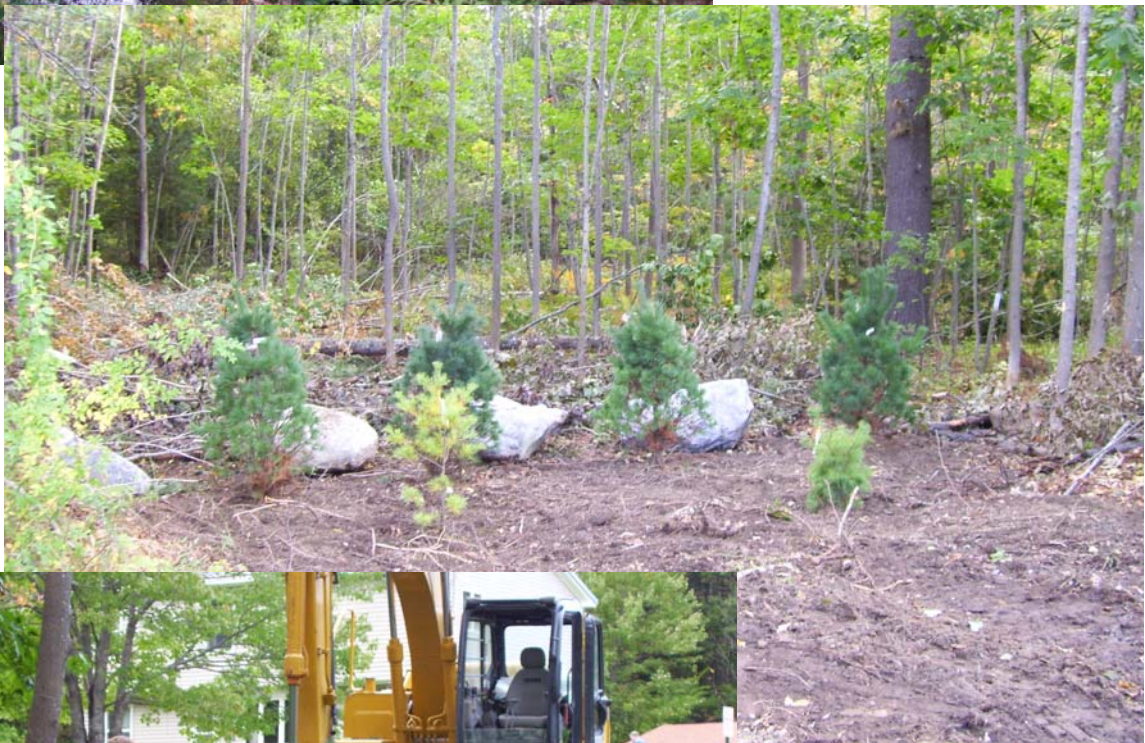
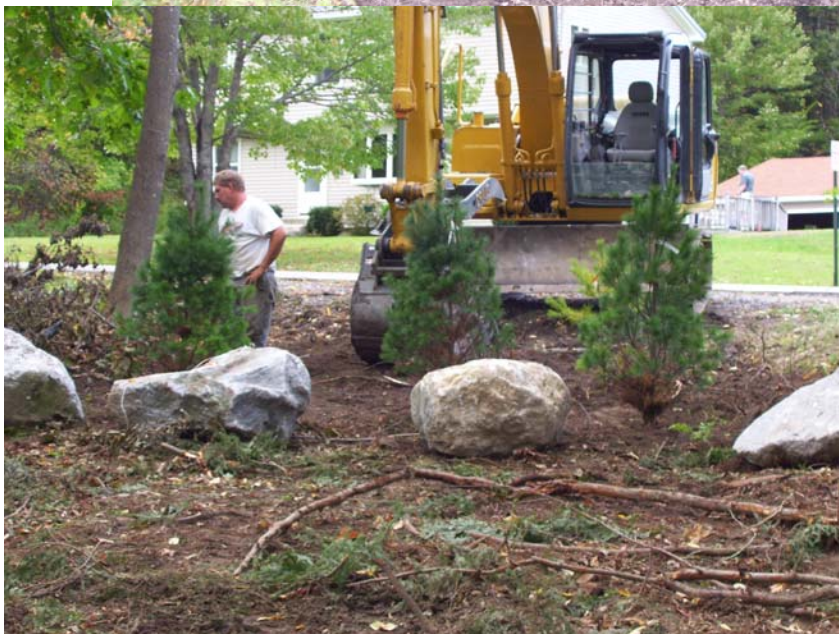
Access/entrance area blocked by boulders and six white pines.

Access road also stabilized with brush, winter rye and hay.
