Mill Brook

Stream Habitat Walk

Cumberland County, Maine
May 31, 2003

Report Date: September 18, 2003
Prepared by the Maine Stream Team Program

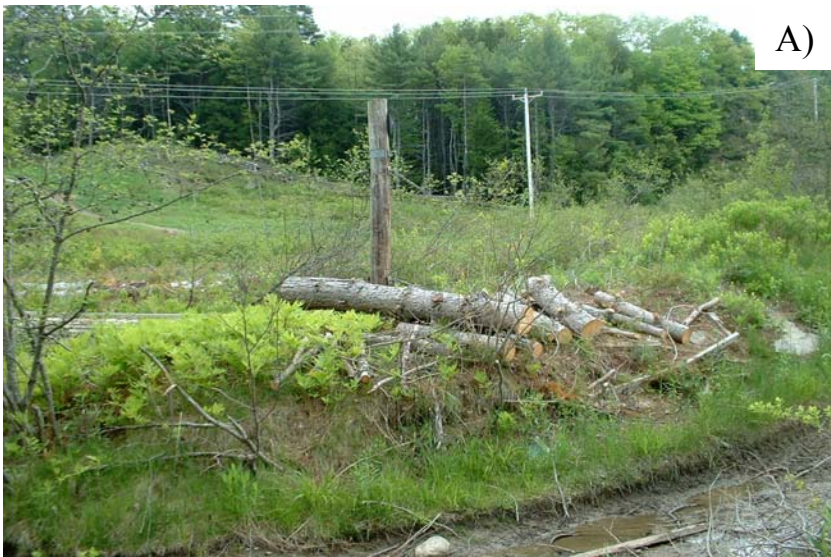
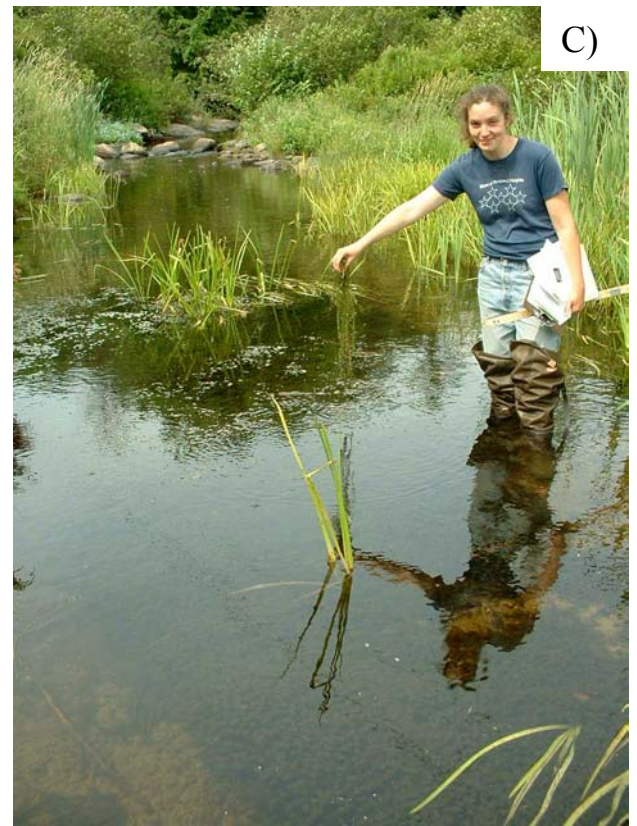
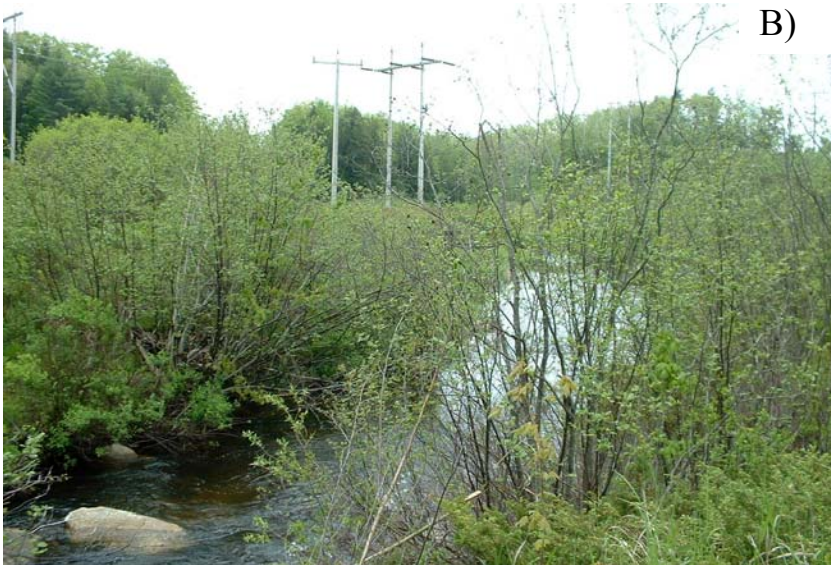
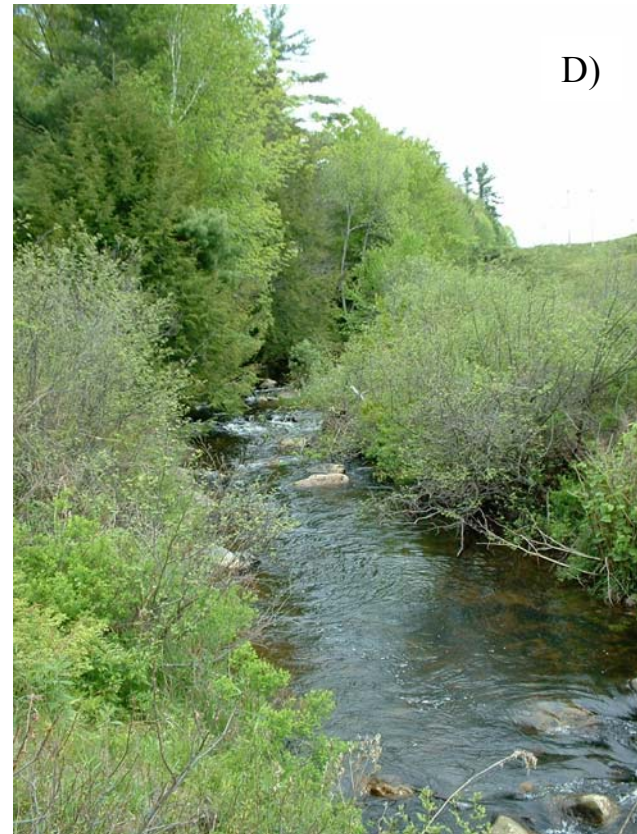
Site 4 photographs: A) recent riparian cutting along brook in powerline area; B) typical vegetation included bushes less than 10' in height such as young alders; C) *Elodea* sp. (American waterweed) found on July 14th (*Elodea* is an aquatic plant that is native to Maine, unlike Eurasian and variable water milfoil, both of which are exotic/invasive plants); D) Mill Brook in the powerline area, where shade is sparse; and E) looking downhill at the powerline area (the arrows point to where the brook is located; the stream is flowing right to left) (this photo was taken on 7/25/03).

Site 4) This area has been heavily disturbed by powerline-area clearing and associated ATV trail use. There is a high potential for erosion and sedimentation, as well as stream shading/temperature, problems here.

- > Further investigation regarding the riparian zone is recommended - especially at the powerline areas (near sites 4 and 4-B) and the lower brook sites (near sites 5 and 6). It would be worth knowing whether these areas, especially at the lower, apparently minimally-disturbed sites, would the vegetation type naturally be just a mix of shrubs, grasses, and smaller riparian trees (e.g., alder) as a result of what might be locally moist, hydric soils, or should there also be larger conifer and deciduous trees in the area? There may have historically been a large-scale tree harvest, perhaps about the time the sewer line was put in place. Another question might be: “Could anything be done to enhance the riparian vegetation conditions?”. In other words, are the conditions right for doing riparian vegetation restoration projects at the lower brook sites or powerline areas (assuming the landowners would permit it)?

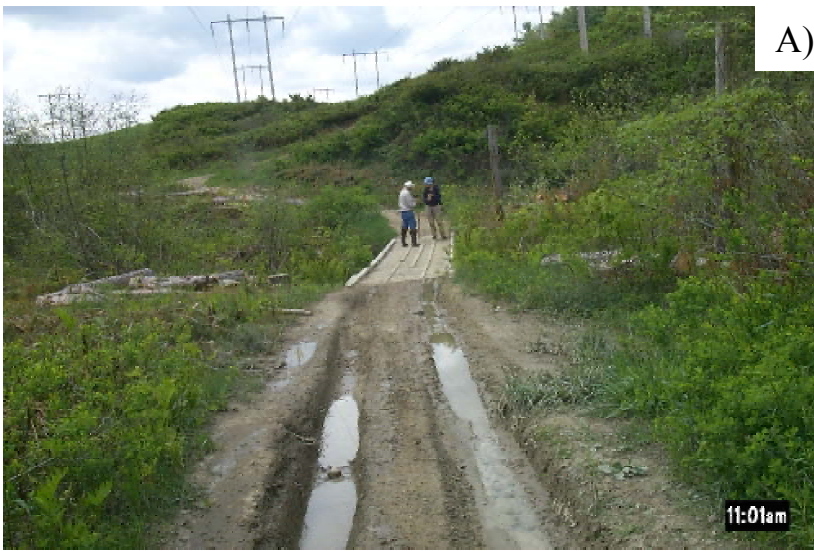
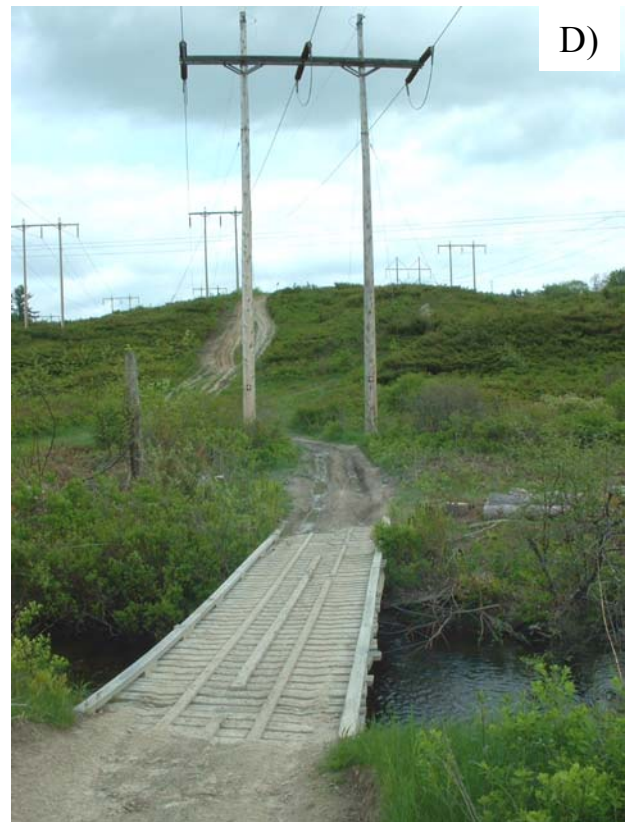
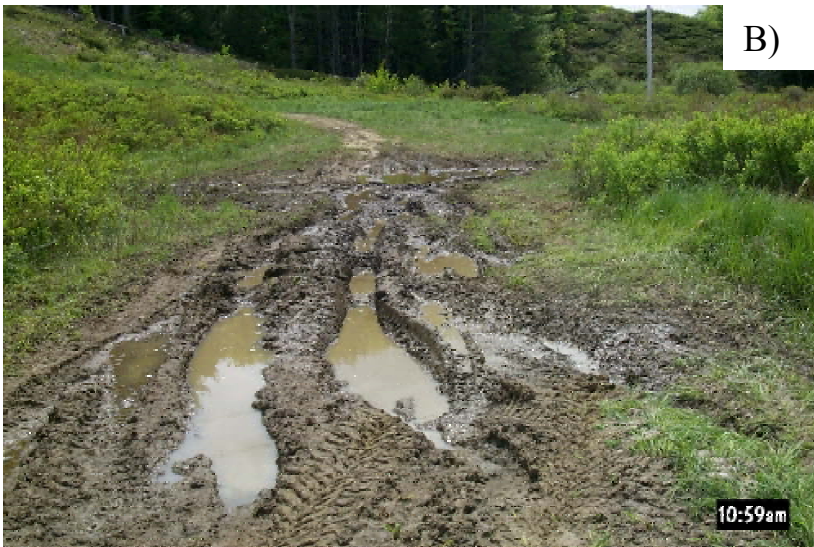
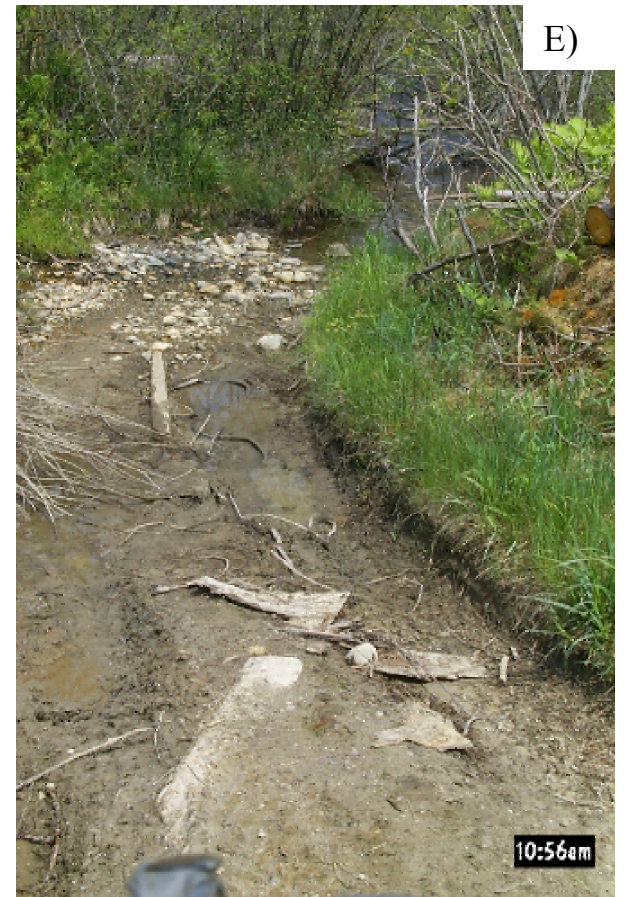
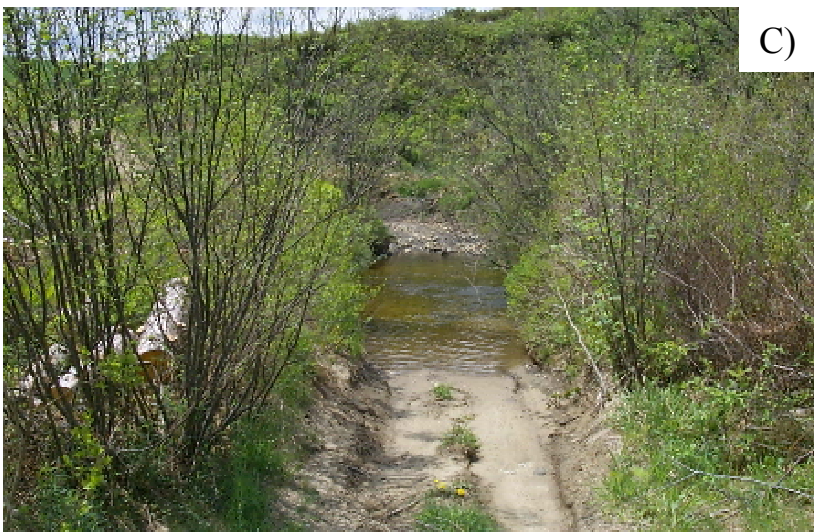
Site 4 photographs of ATV impacts: A & D) ATV bridge over Mill Brook; B) tire ruts alongside the brook; C) ATV crossing through the stream adjacent to the bridge; and E) trail leading to stream.

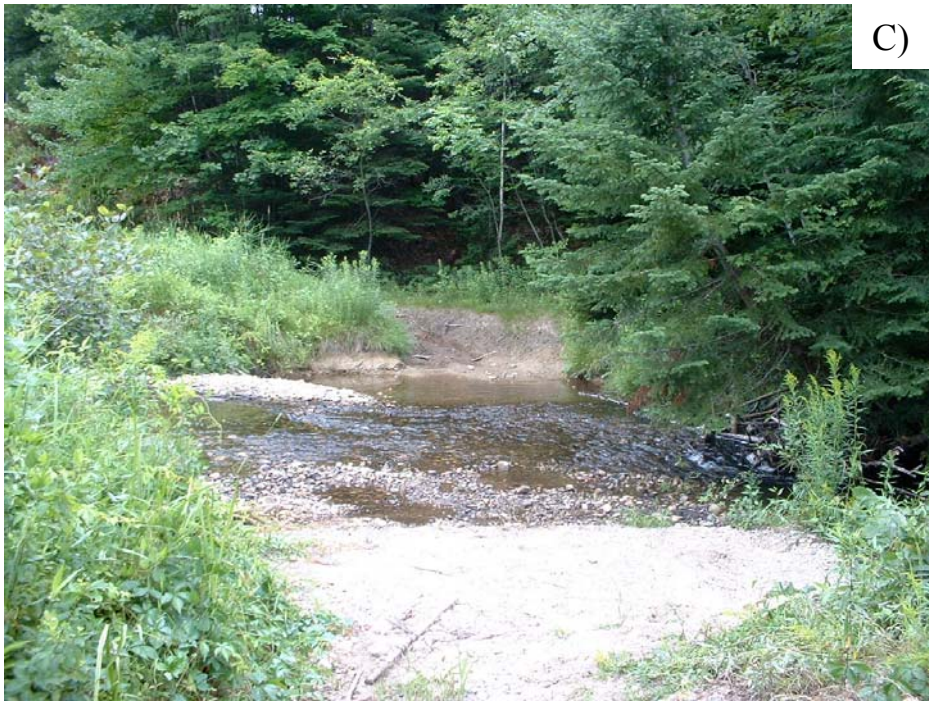
Site 4-B* photographs: A-B) signs of aggradation (that is, sediment accumulation or bar formation) in the middle of Mill Brook's channel and C-D) local ATV trail impacts. *These photos were taken on July 25, 2003, on a reconnaissance walk of this area.

Site 4-B) This site only was only subjected to a reconnaissance walk. However, this rapid survey discovered that sedimentation appears to be a problem, which is likely due to ATV trail use, upstream sources of erosion, as well as possibly a nearby gravel pit (although sediment settling basins are present here).

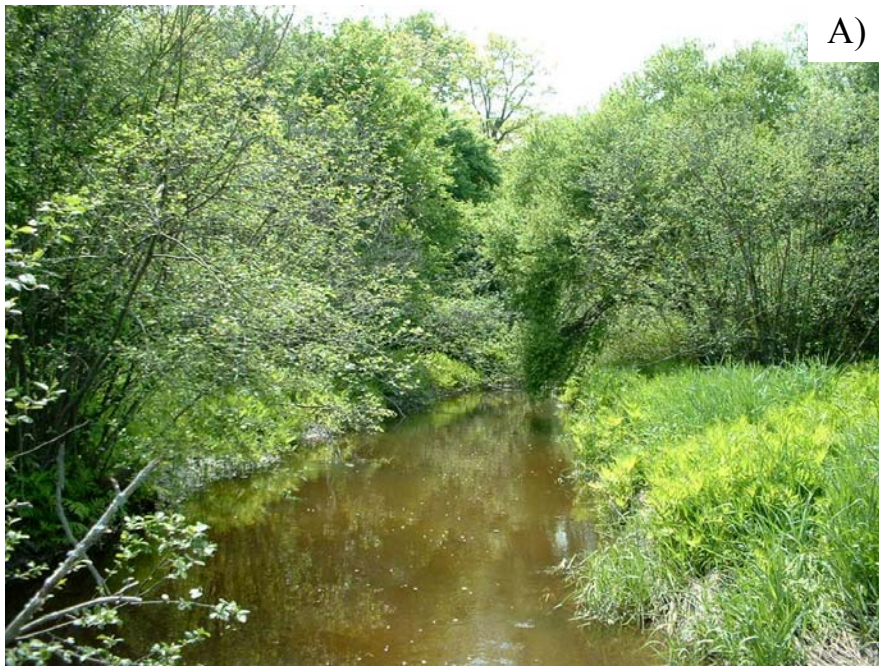
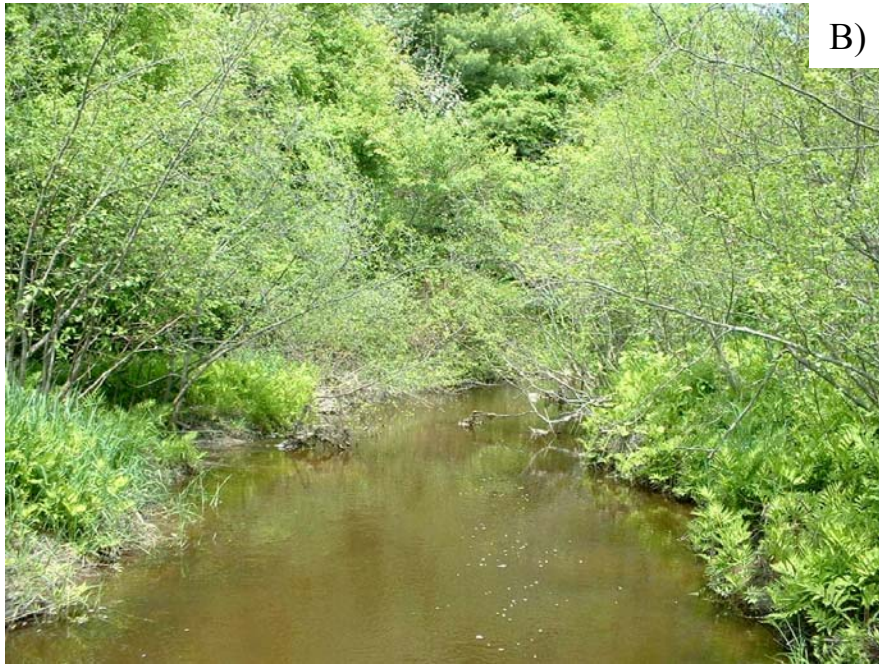
Site 5 photographs: A-B) Looking upstream and downstream from the ATV bridge shown in photo C; C) ATV bridge; and D) a small debris dam perhaps created by beaver.

Sites 5 & 6) Major concerns: Sediment pollution from badly eroding ATV trails, thermal stress from a general lack of many mature, tall trees in the riparian zone, and potential sewer line leaks.

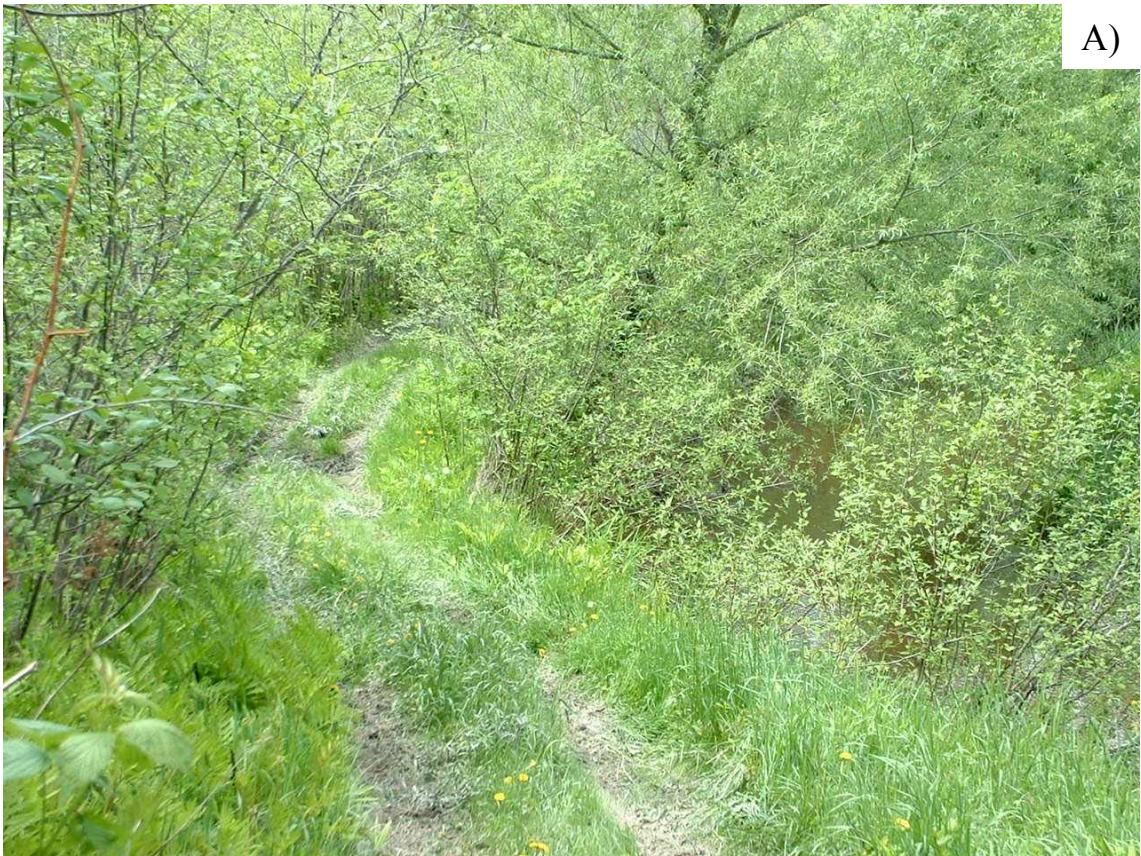
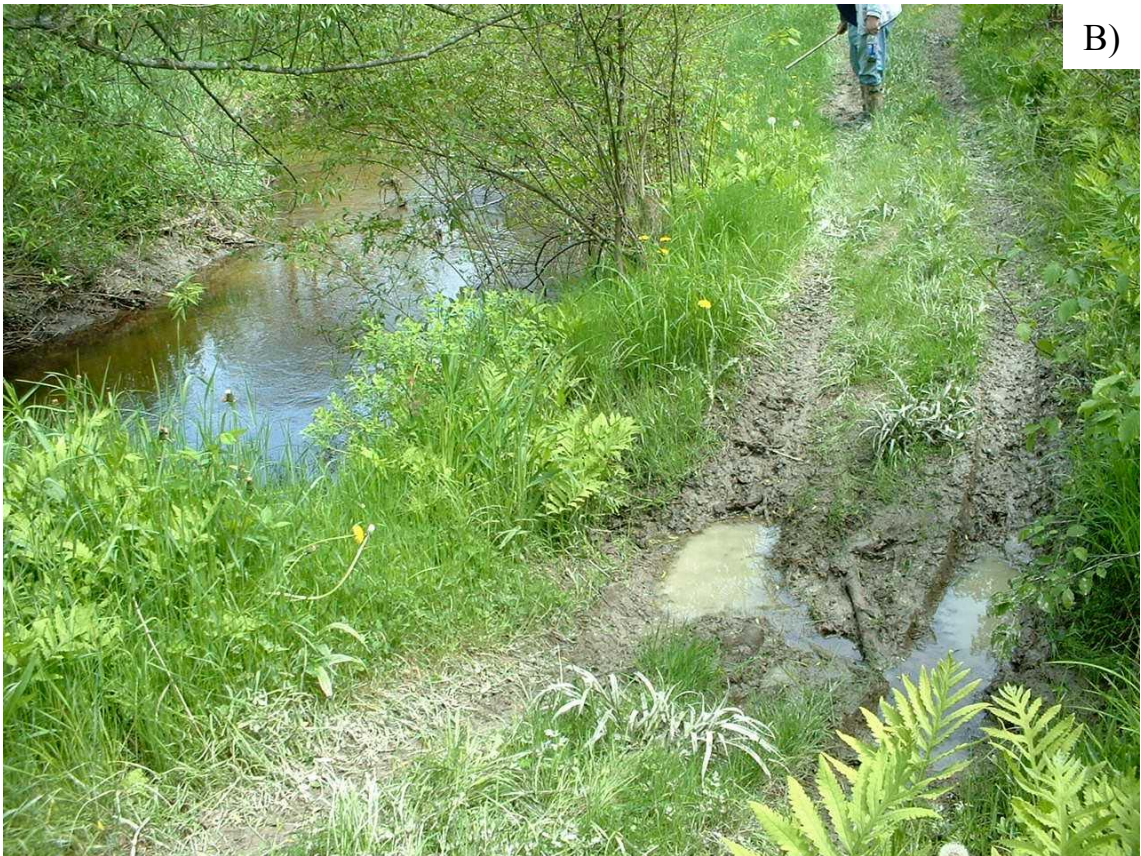
Photographs collected near and between Sites 5 & 6: A-B) muddy ATV trails located a few feet away from Mill Brook. Note that the brook is fairly hidden behind some trees and shrubs on the right side of photo A.

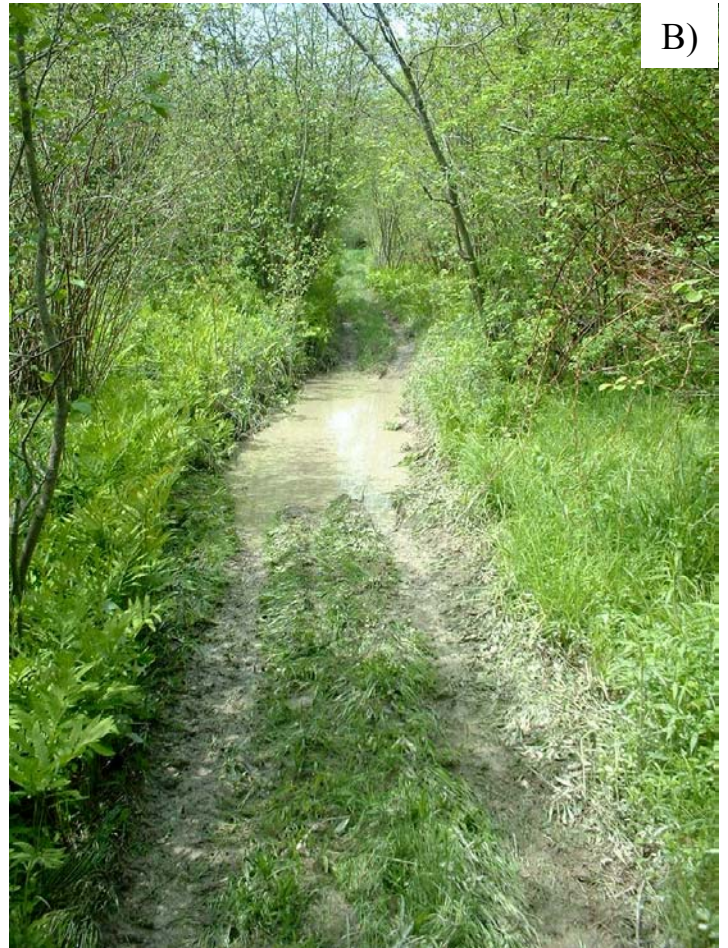
Photographs collected near and between Sites 5 & 6: A-C) muddy ATV trails located a few feet away from Mill Brook. The brook is fairly hidden behind some trees and shrubs in the upper-central location of photo A. Also note the drainage off of the ATV trail into the brook in this photo.

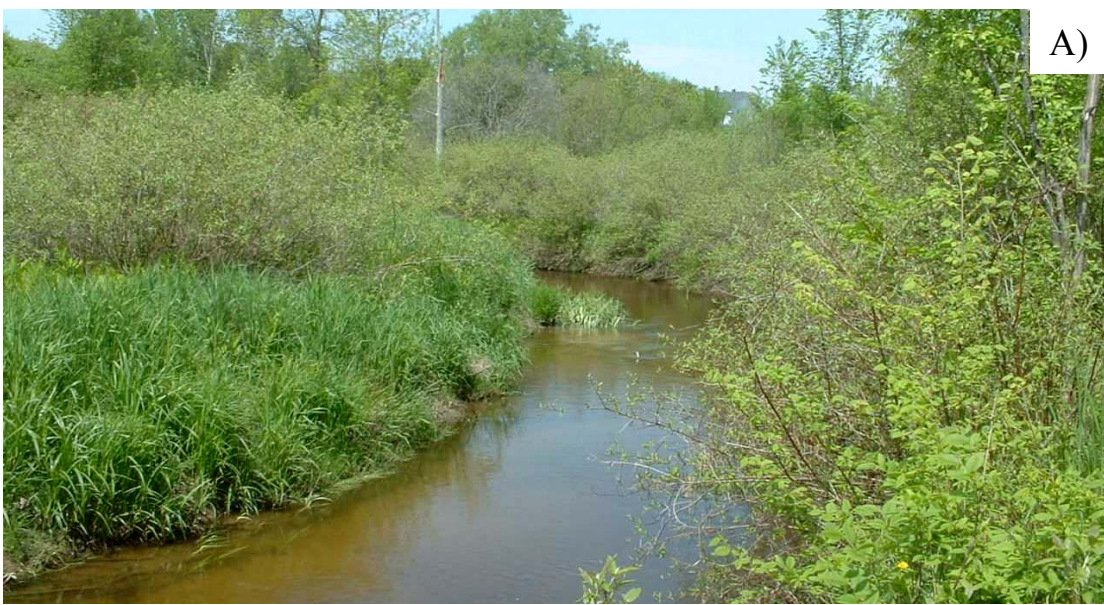
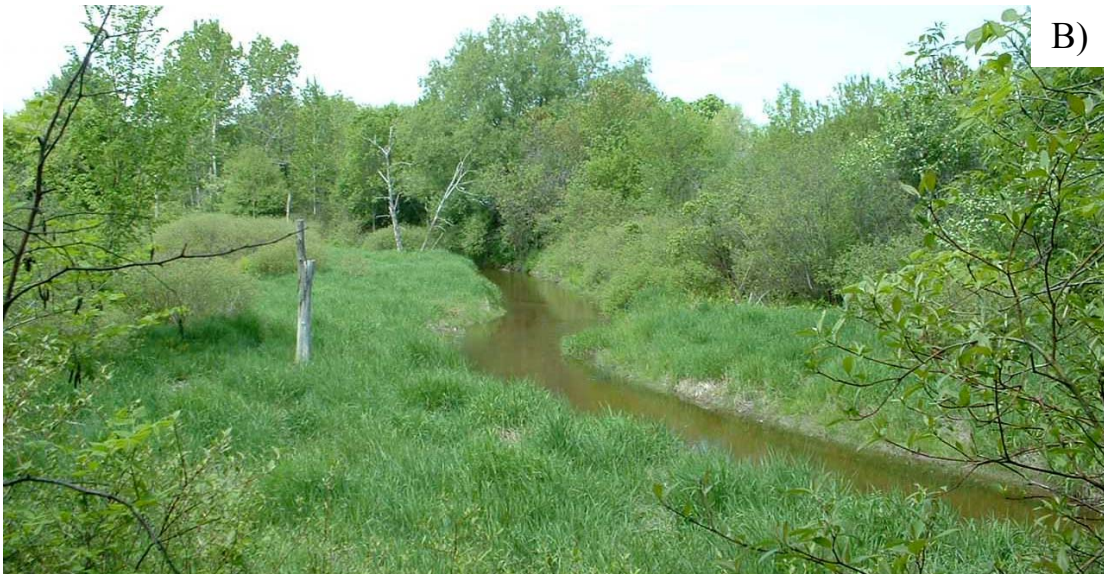
Site 6 photographs: A-C) meandering, low gradient, silty-sandy-bottomed stream; and D) a manhole above a sewer line and an ATV trail near Mill Brook. Photo C was taken on 5/20/03 and it is situated just upstream of Bridge Street.

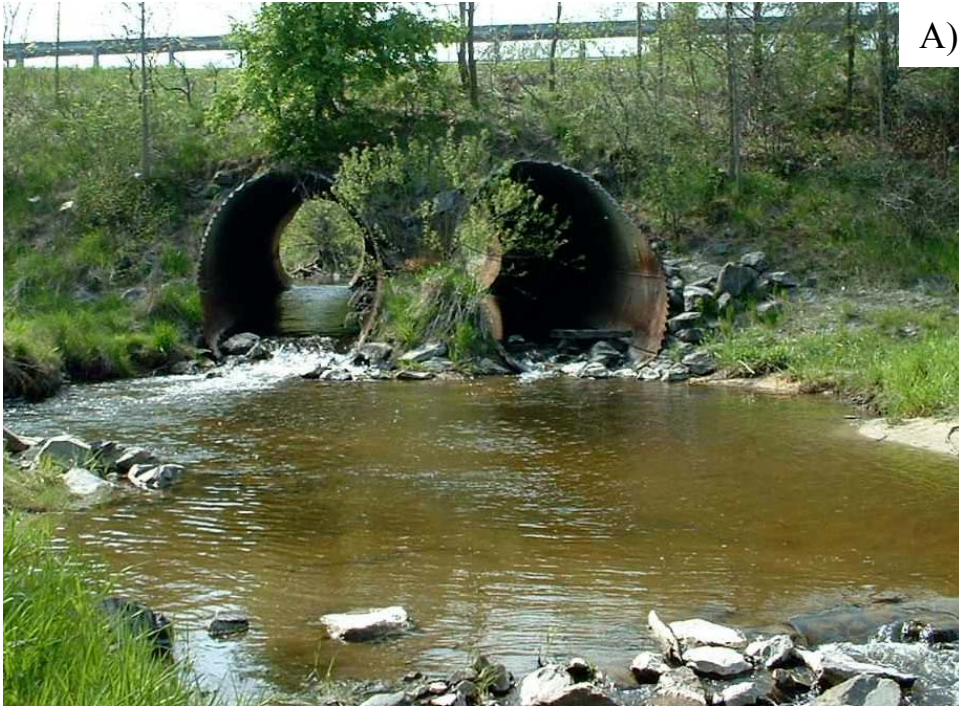
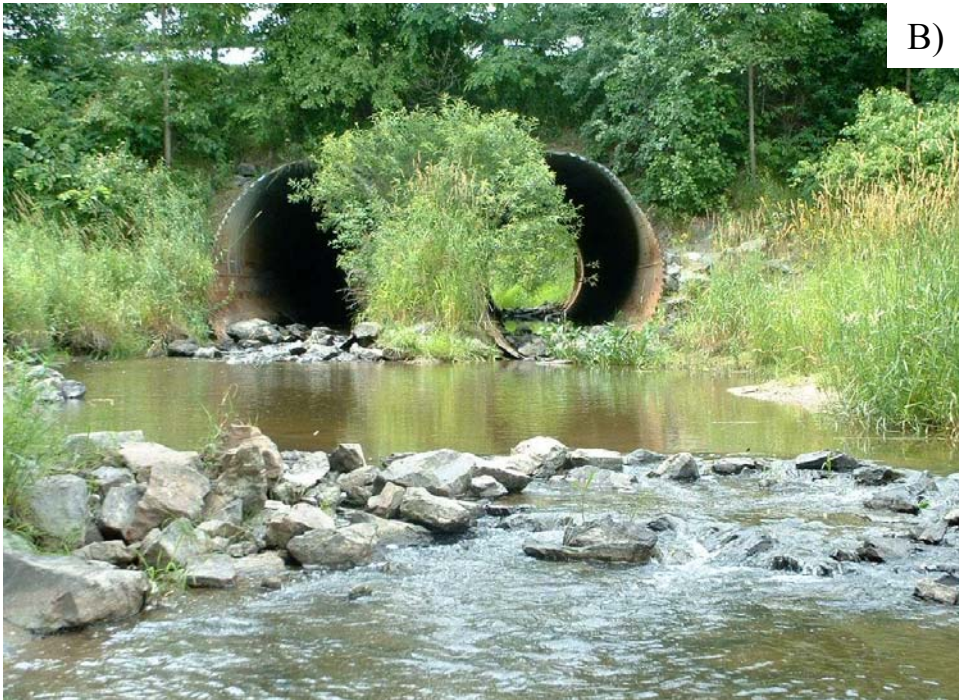
Photographs of the culverts underneath Bridge Street: A) taken on May 20, 2003; and B-C) taken on July 14, 2003.

- > Investigate potential fish passage issues at all the culverts on the stream.
- > Conduct more stream walks on sites not included in this survey, including small tributaries to Mill Brook which might provide cold water to certain areas of the brook that can provide cold-water refugia to fish such as salmonids during warm periods of the year.

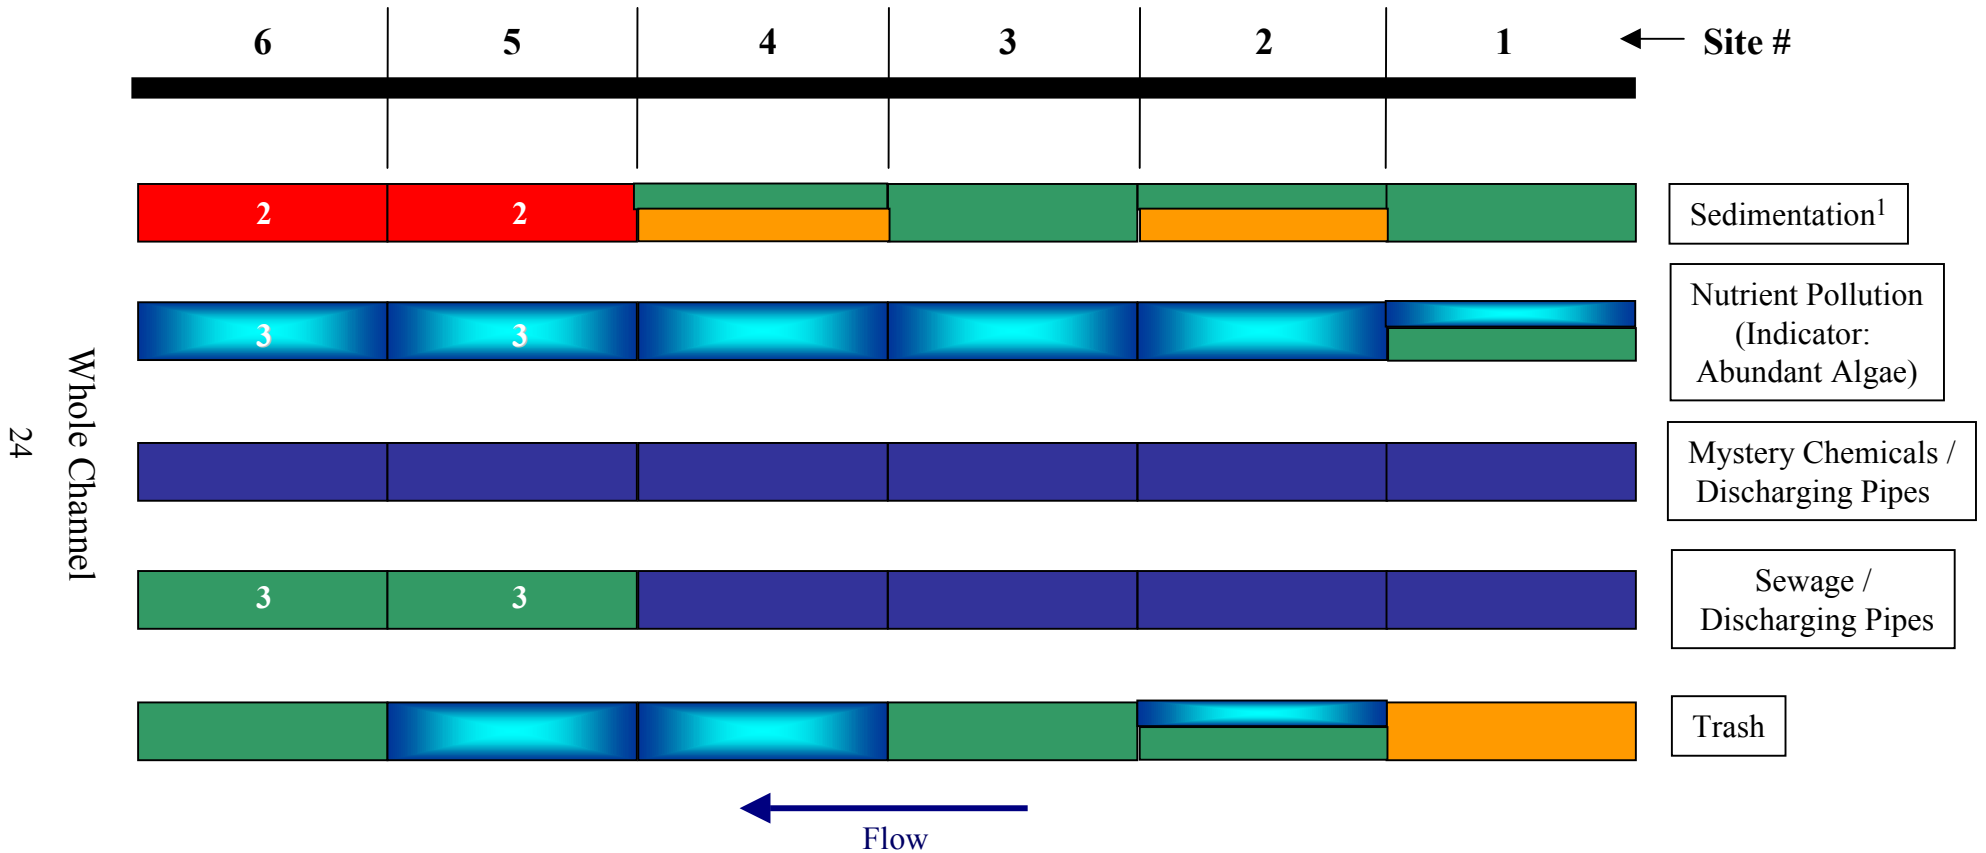
Figure 3. Evidence of Pollution or Other Impacts.

¹ Embeddedness is high in many places, although the fact that the local surficial has a lot of sands and clays in it may be a large influence.

² The substrate at these sites was almost entirely sands and silts. This may be due to natural factors such as local surficial geology, gentle slope, beaver activity in addition to erosion from ATV trails and poorly vegetated areas.

³ A sewer line was close to the stream in these areas, which possibly could contribute nutrients, bacteria, and viruses if leaks were to occur.
