Project Report: Mapping and Restoration Inventory
of Fringing Marsh Habitat in the Casco Bay Estuary

3.2008

Peter Hayes

Wells National Estuarine Research Reserve

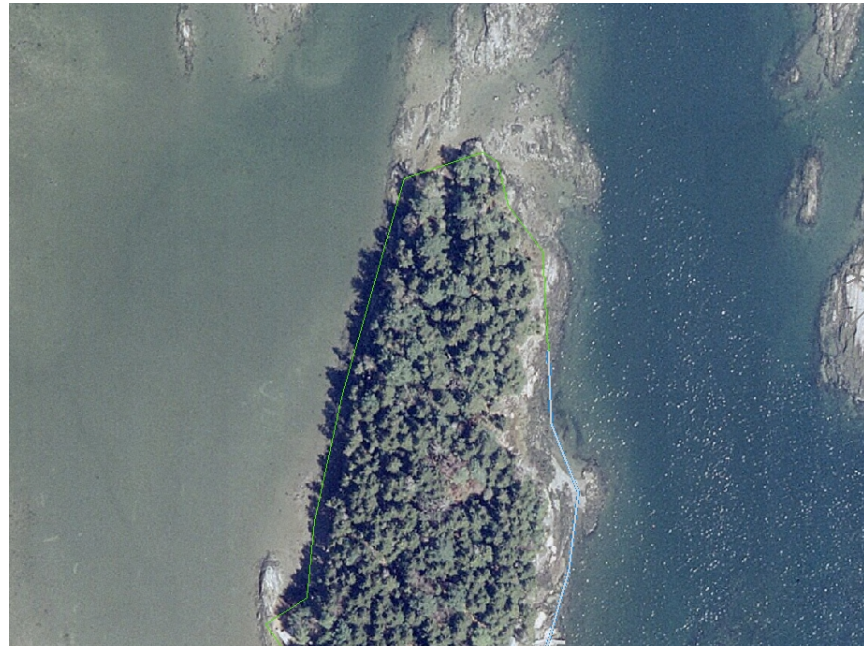
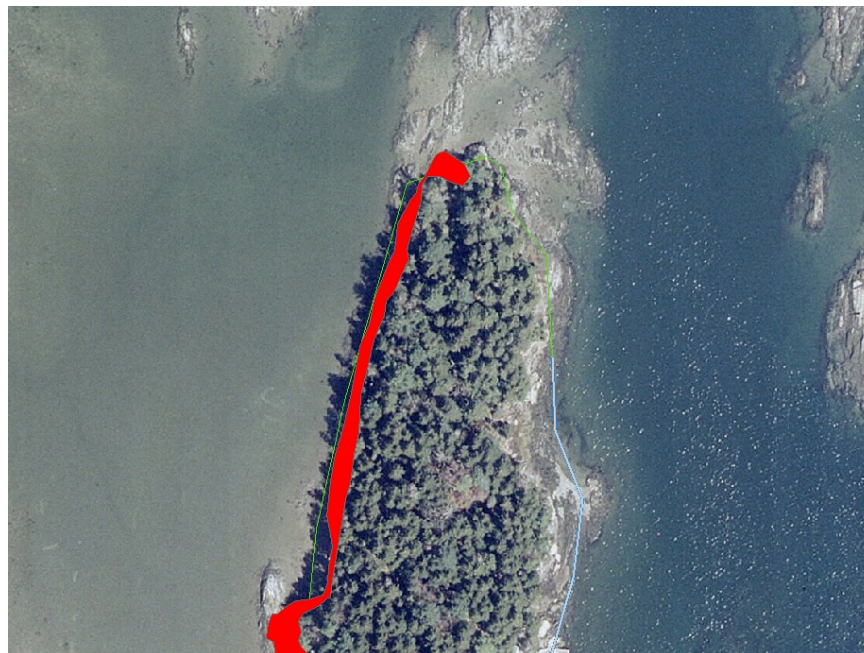
Figure 5: (top) An example of commonly-encountered difficulties - an identification area in which shading by foliage obscured coastal habitat; (bottom) the marsh coverage shown was eventually identified using multiple resources.

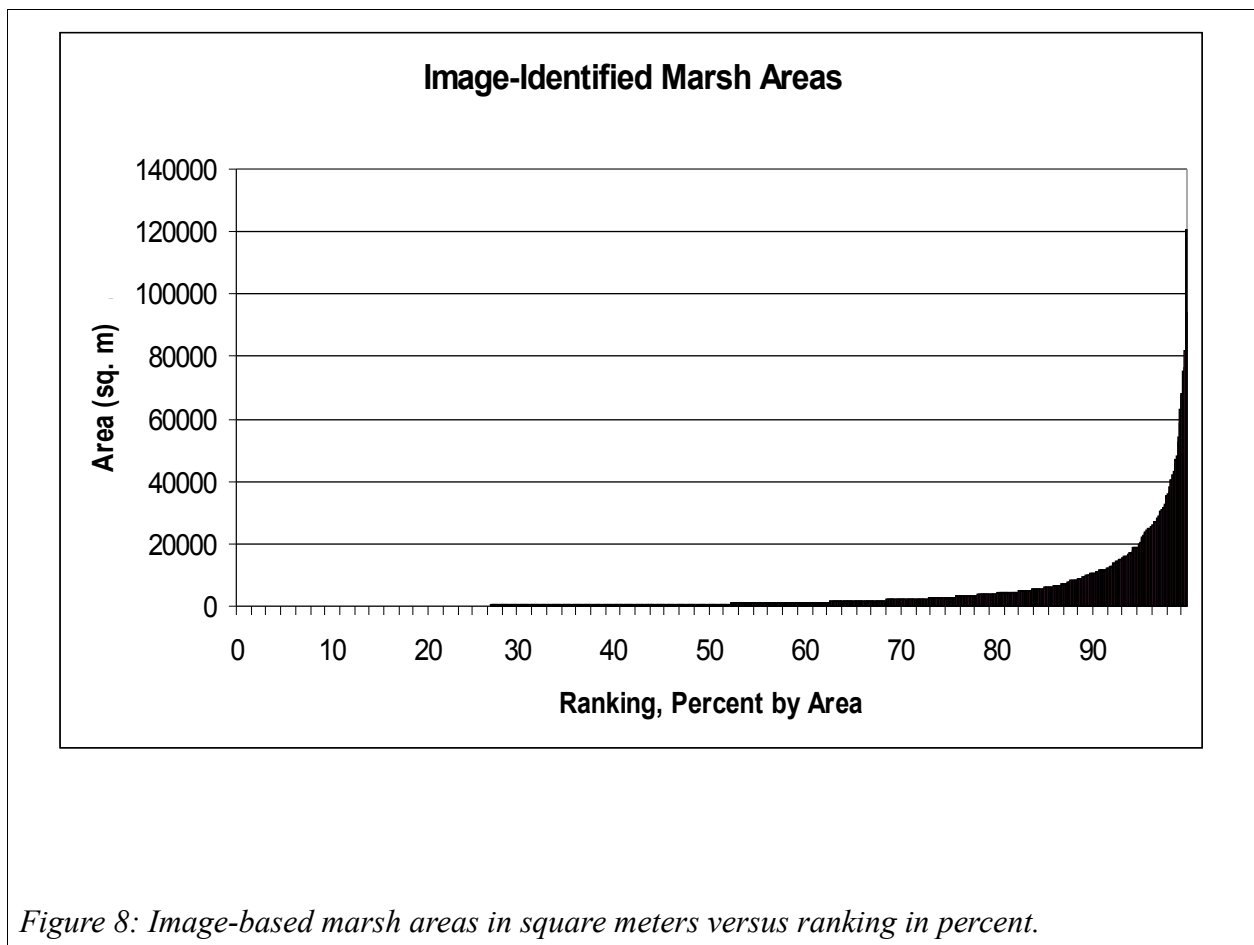
Figure 8: Image-based marsh areas in square meters versus ranking in percent.

began near the mouth of an estuary or channel, continued along the channel, and, at some point, transitioned to finger marsh and were not included in the data. The choice of this point varies, but the upper range of marsh areas is likely to be the result of fringing marsh contiguous with fluvial minor marsh (finger marsh). The majority of the marsh units identified were small: approximately 83% were 5000 m² or less.

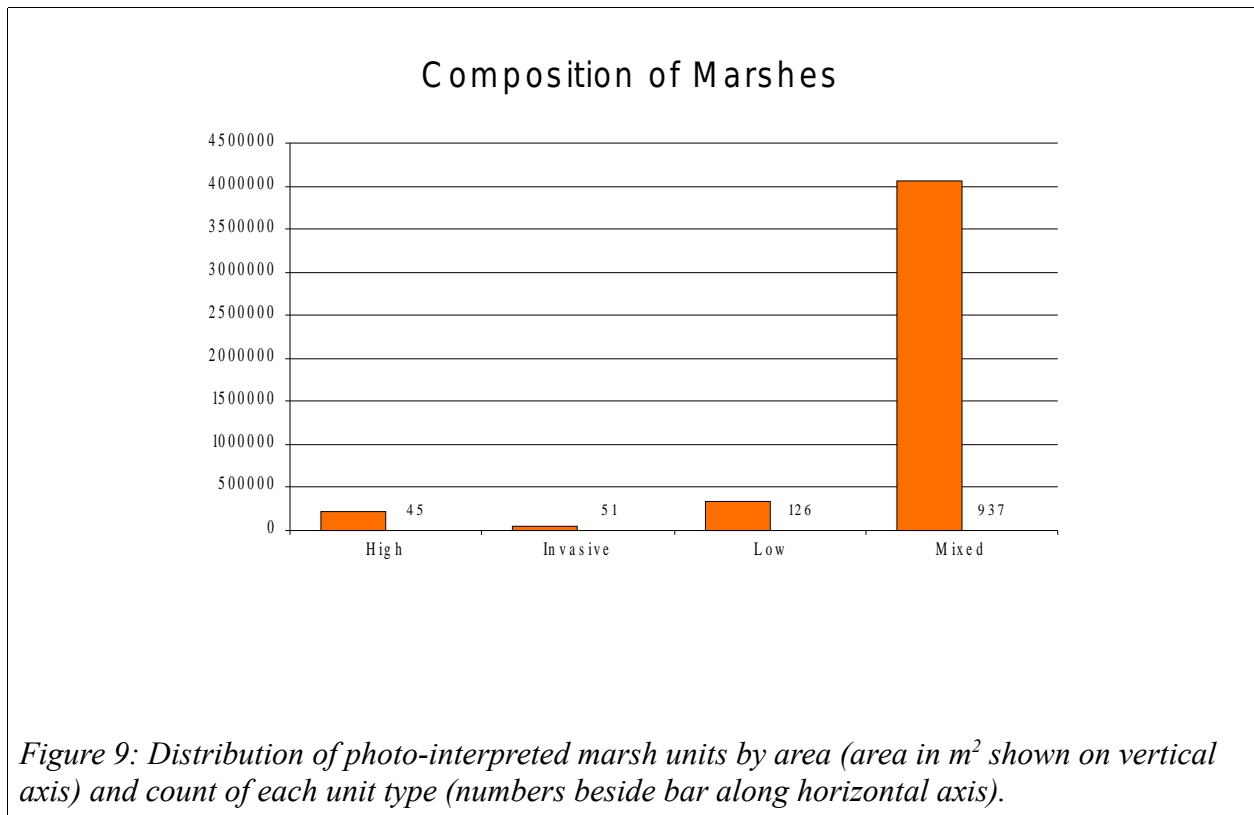
Figure 9: Distribution of photo-interpreted marsh units by area (area in m² shown on vertical axis) and count of each unit type (numbers beside bar along horizontal axis).

A majority of the marshes were identified as the 'Mixed' type (including low and/or high marsh and, potentially, some amount of invasive) because boundaries between high and low marsh were difficult or impossible to discern from the imagery and all but large patches of invasive species might not be identified; but, for some marshes, further identification was possible (**Figure 9**).

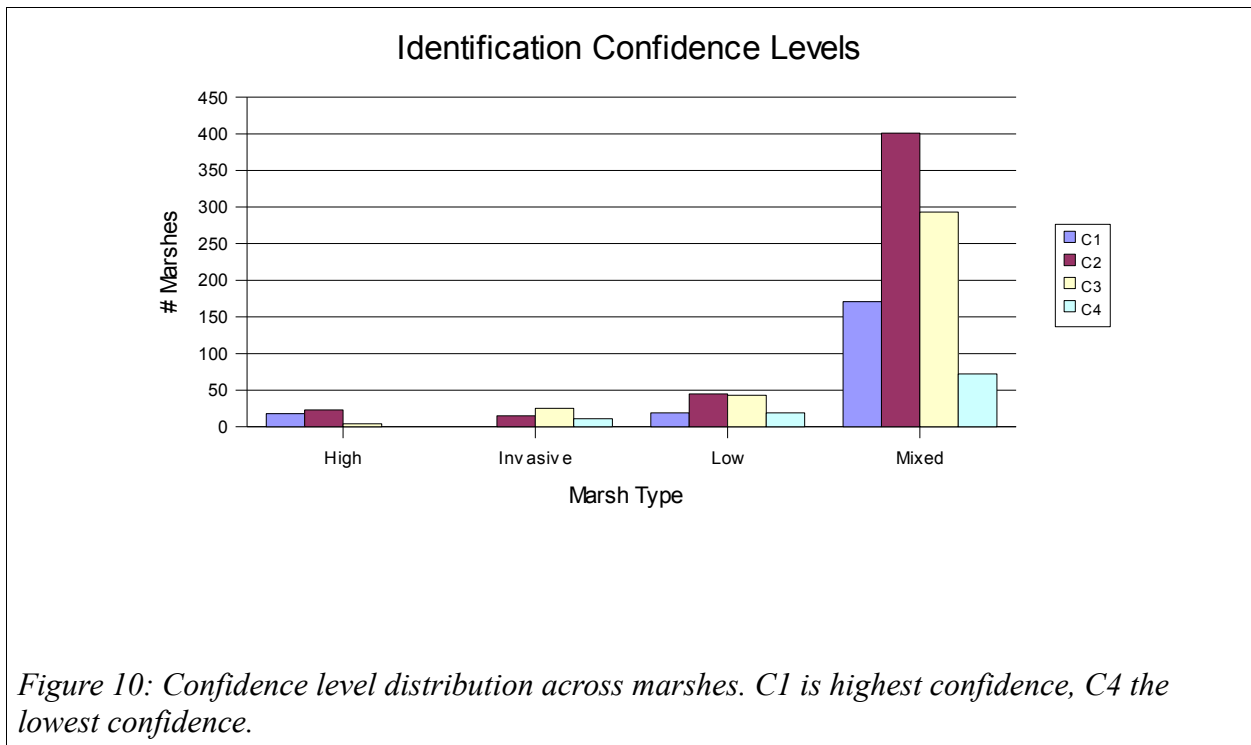
Each marsh unit was assigned the confidence level of the operator when delineating the marsh. Values ranged from 1 to 4, with 1 indicating the highest confidence and 4 the lowest (Figure 10). The distribution of confidence levels across marsh types showed a consistent pattern with most marshes receiving scores of 2 or 3. The diversity of indicators sometimes used to arrive at an estimate of the marsh boundaries and type means there is no means of determining correlations between types and confidence levels. In other words, our method does not allow us to address questions such as “*Is a high marsh identified with only a level 3 confidence sure to be a fringing marsh with confidence 1 or is it also only assured of being a fringing marsh (potentially with mixed high and low marsh types) with confidence 3?*”. Identification as a fringing marsh and identification of type were not rated independently for confidence.

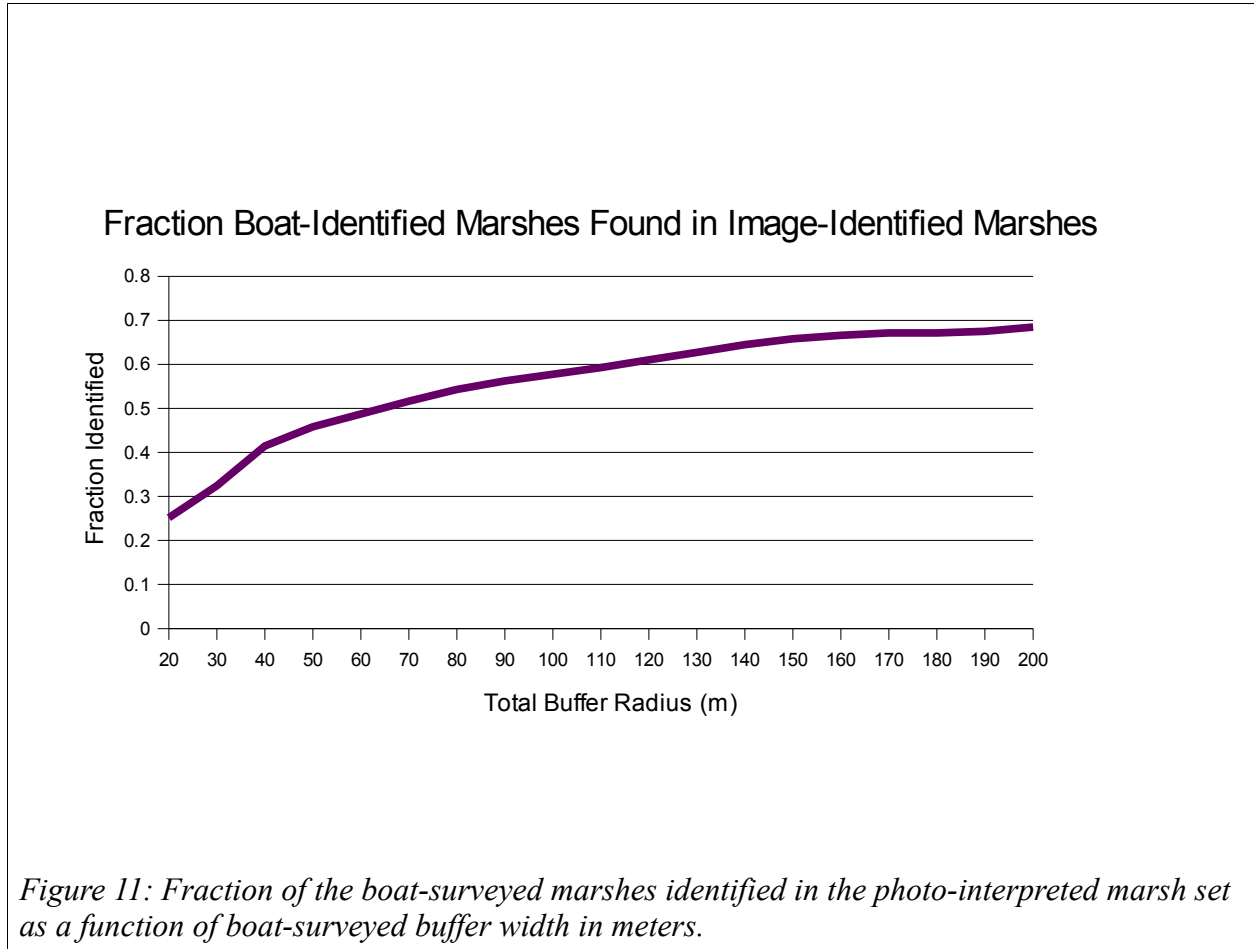
The shape of the curve (which appears to approach 0.7 asymptotically as the radius increases) might be taken to indicate an upper limit of approximately 70% of the existing marshes identified (using a radius of 200 meters) from photo-interpretation. This could, in part, indicate the change in marshes between the two periods (in other words, approximately 30% of the existing marshes were not present – within 200 meters – four years earlier). In terms of accuracy of the image-based identification, the identification successfully found between 40%

and 65% (where the curve seems to level off significantly) of the marshes present, depending on the radius used to draw the ellipse used to create marsh polygons from the marsh length transects measured in the boat survey.

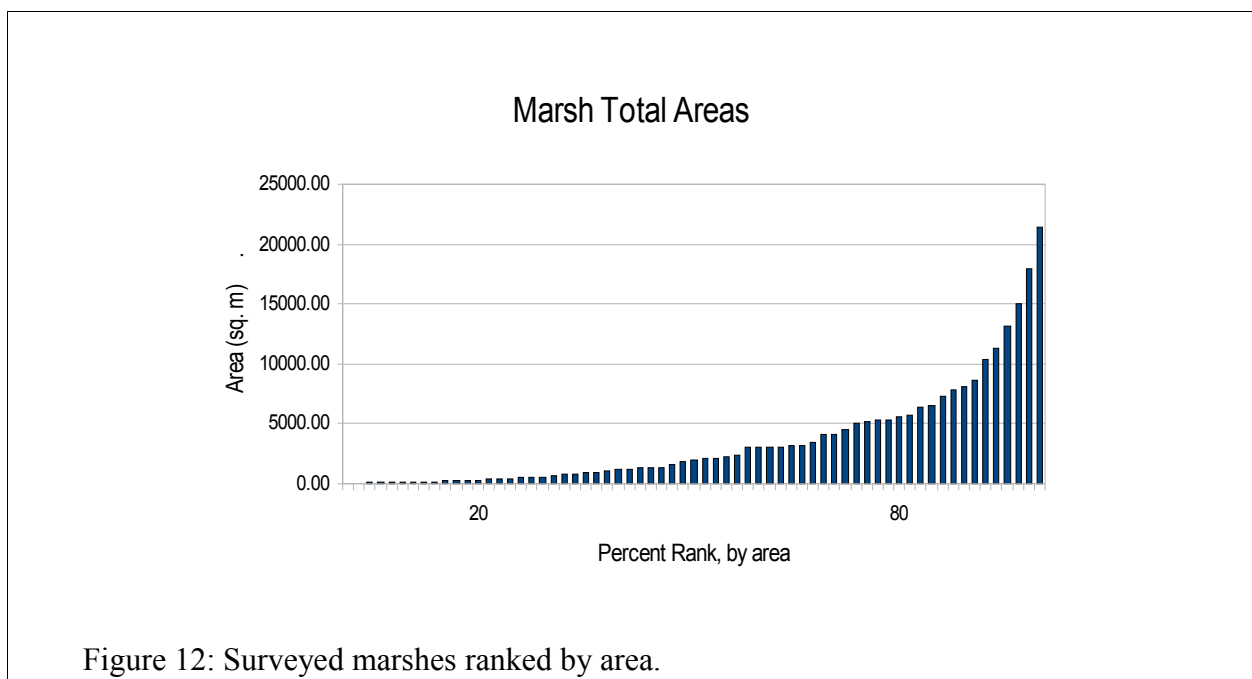
Figure 12: Surveyed marshes ranked by area.

Measurements of marsh areas (**Figure 12**) were limited at the upper end of the range because a maximum of approximately 300 meters of marsh length was surveyed. Measurement of marshes above this length (constituting approximately 8 % of the measured marshes) were truncated at approximately 300 meters of length. Consequently, area estimates for the larger marshes are less than the true marsh areas and descriptive statistics are biased lower than the true values. The average area was 3570 m² (with a standard error of 570 m²); the median marsh area was 2055 m², while 80% of the marshes were of 5500 square meters or less. Approximately 46.5
