Restoration of Riparian Buffer at the Former Smelt Hill Dam Site, Falmouth, Maine

Final Report

June 30, 2006

**Gulf of Maine
Council on the
Marine Environment**

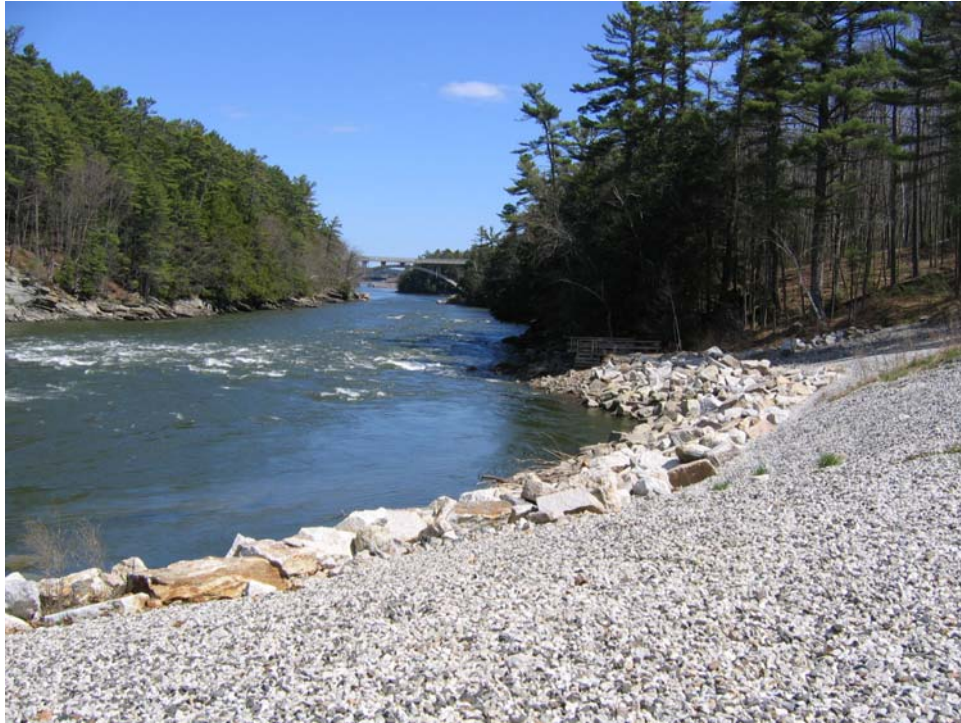
May 2005. Presumpscot River southern shore facing downstream at site of Smelt Hill dam removal.

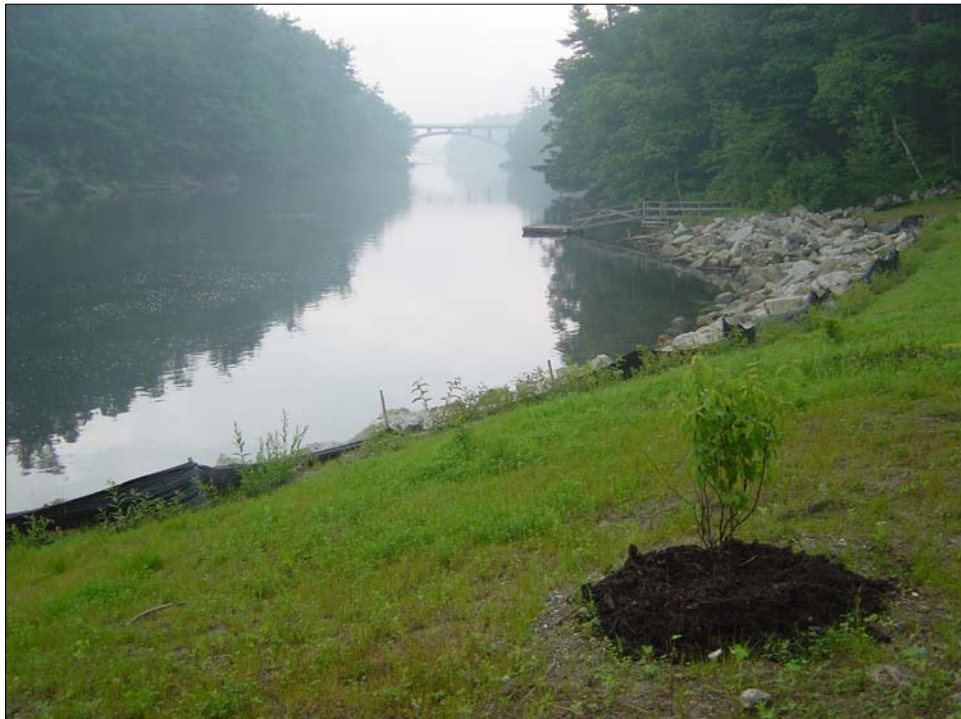
June 2006. Presumpscot River southern shore facing downstream at site of Smelt Hill dam removal. Note willow waddles planted during fall 2005 flourishing in front of silt fence along the length of the site.

- Phase I:
 - 100% of the willow waddles planted in the fall of 2005 show extensive leafing and appear to be establishing a solid vegetated strip along the length of the riverbank.

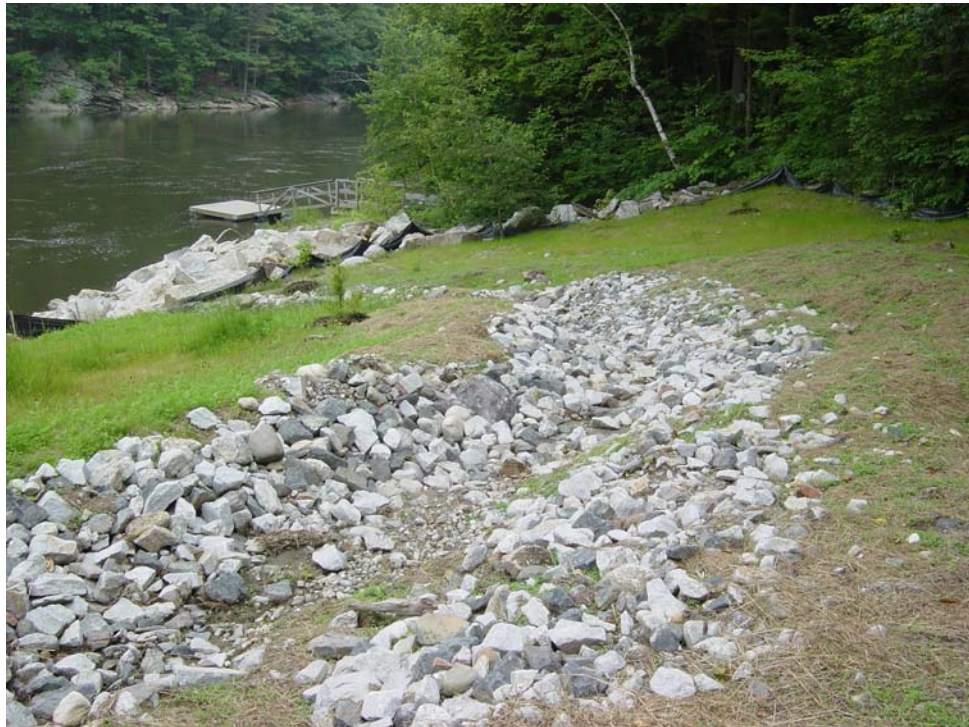
June 29, 2006. Smelt Hill swale, lower run, post Phase II adaptive management implementation.

recommendations. In late April 2006, live stakes were planted adjacent to drainage channels and the entire site was reseeded. Between June 20 and June 27, 6-12 inch rip-rap, 1-2 foot boulders, and erosion control mulch were delivered and used to prevent further erosion, create a series of settling basins and checks dams, strengthen the swale, build up berms adjacent to drainage channels, and stabilize other areas around the site as needed. Additional work is scheduled for the site in July 2006, including additional revegetation work, planting, swale stabilization and erosion repair by the newly formed Presumpscot River Youth Conservation Corps (PRYCC). The PRYCC will also be working with abutting landowners to reduce on-site flow of sediment from erosion occurring above the site on private property by creating additional settling basins and stabilizing eroding channel banks. Once all implementation activities on site have been concluded, the original silt fencing will be removed.

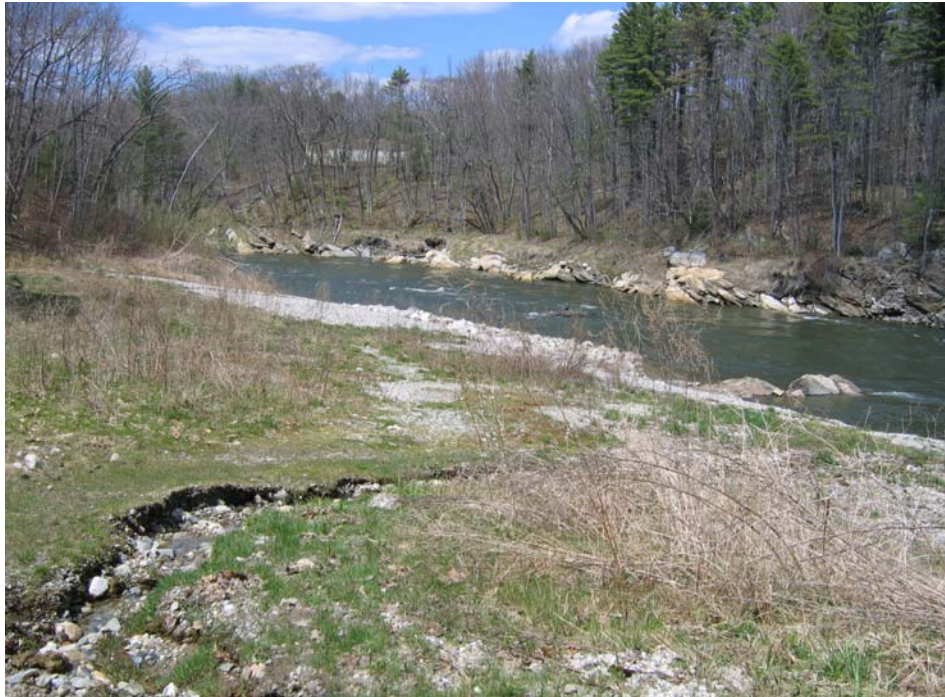
April 2005. Original stormwater runoff channel pre project implementation.

Address stormwater runoff & erosion: There was also a need to improve stormwater runoff at the site. Prior to project implementation, stormwater runoff had created a deepening and widening gully during significant rain events. A significant headcut had formed and was migrating up the slope. Most of the stormwater appeared to be coming from an existing catch basin and culvert outlet, rather than the road itself. A small, crushed rock trail leading down from one house lot may have exacerbated the erosion by channelizing the stormflow and not allowing it to spread out through the woods. The gully downstream of the culvert outlet but upstream of the project site showed signs of recent erosion, with the channel widening and eroding down to boulder or bedrock material and resulting in sediment deposition into the Presumpscot River. The storm flow exited the woods at the access road and then ran in the eroded gully down across the riprap slope. The upper riprap (crushed rock) had slumped in a few areas due to the runoff over the slope.

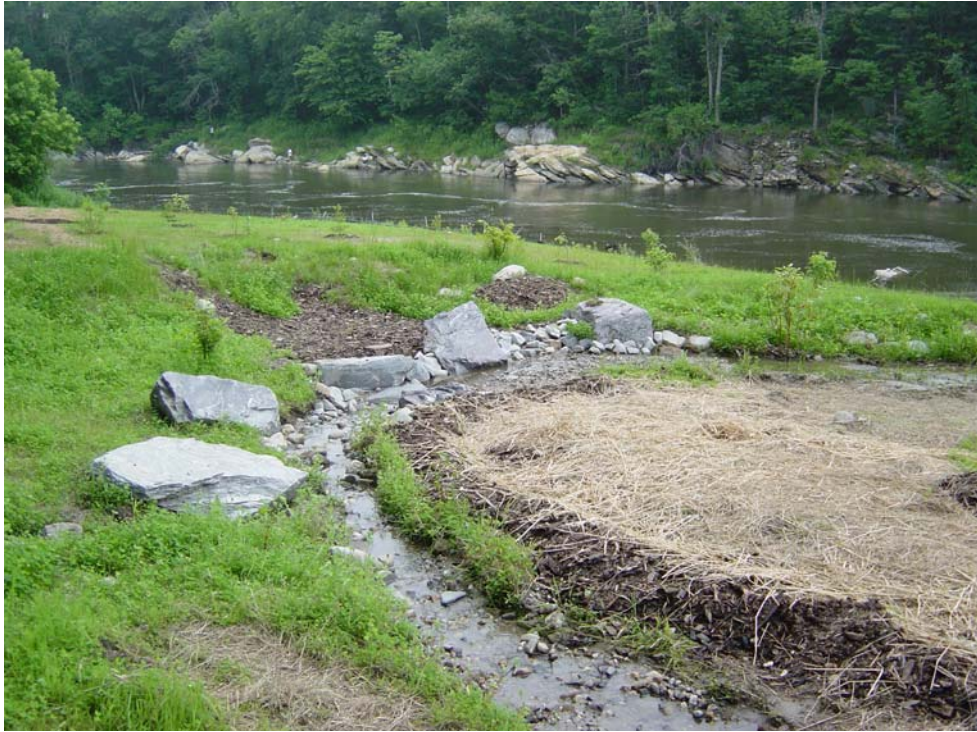
June 2006. Swale after Phase II adaptive management. Hayed area will be reseeded by Presumpscot Youth Conservation Corps the second week of July.

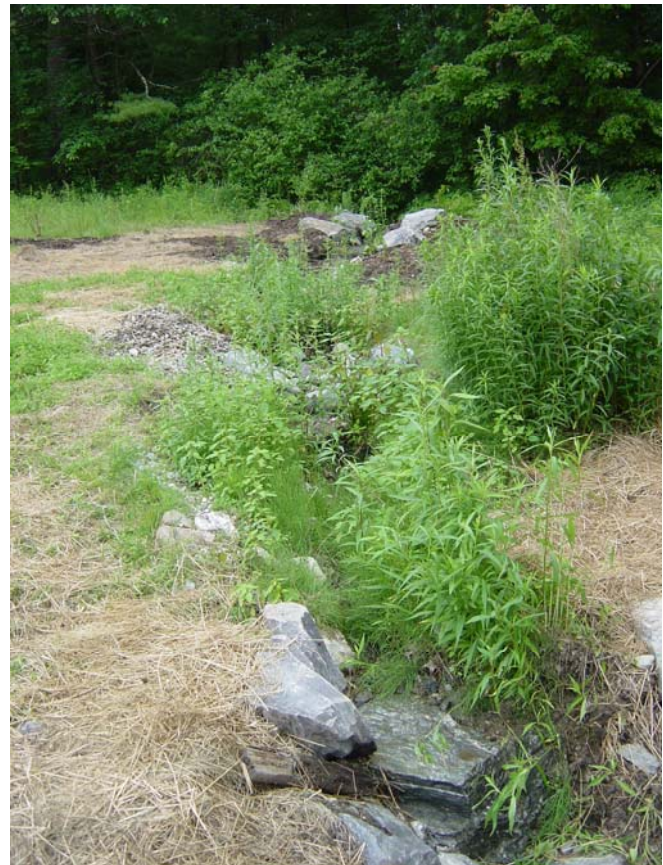
June 29, 2006. This drainage channel emerged during heavy rains in October 2005. Phase II adaptive management installed large boulders and some of the plants seen in the background. The Presumpscot River Youth Conservation Corps will continue this naturalization process at other low flow drainages on the site in July 2006.

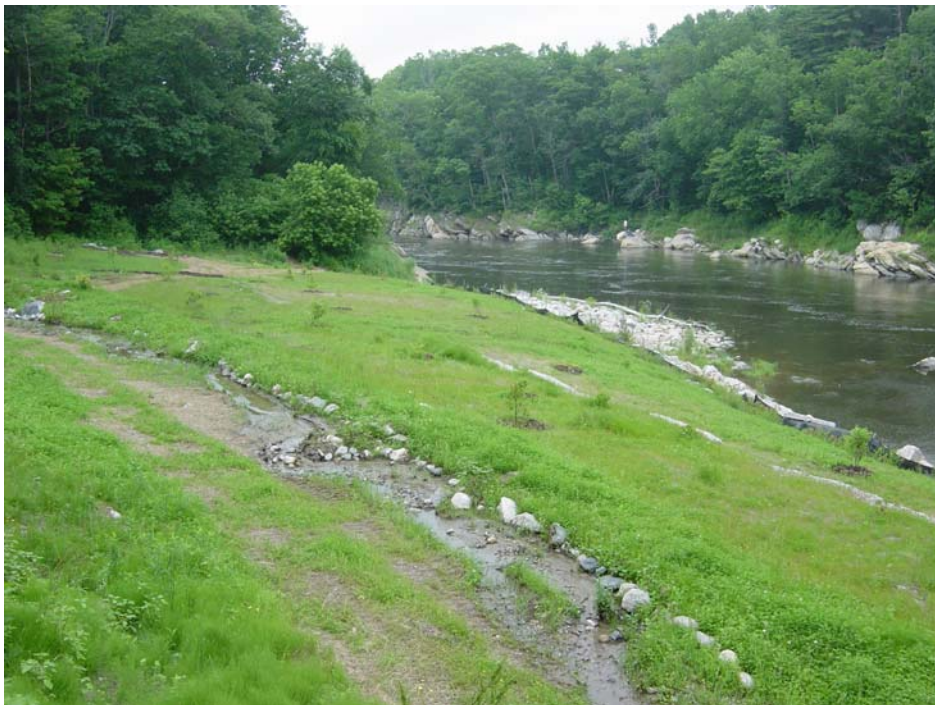
June 29, 2006. Site post- Phase II implementation. Note granite wall to the left, which was unearthed during Phase I regrading activities.
