**EXPANDING AND SUSTAINING THE SHELLFISHERIES  
OF CASCO BAY — PHASES II AND III  
CASCO BAY ESTUARY PROJECT**

**September 2003**

*Prepared for*  
**CASCO BAY ESTURARY PROJECT**  
University of Southern Maine

*Prepared by*  
**NORMANDEAU ASSOCIATES, INC.**  
253 Main Street  
Yarmouth, Maine 04096

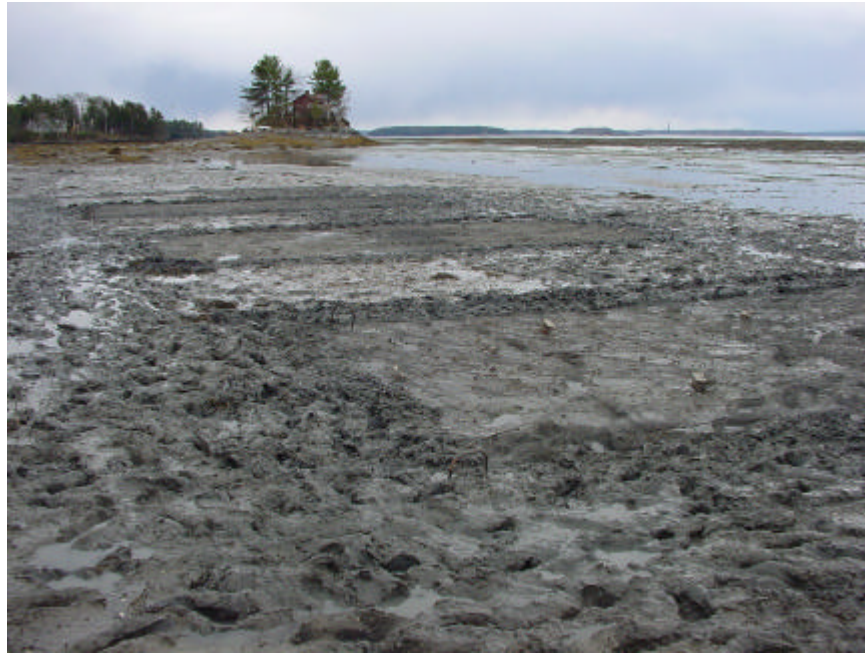
Figure 4.3-8. Photograph Showing Experimental Layout at Lower Raspberry Cove, Freeport Immediately after Reestablishment on 23 April 2002

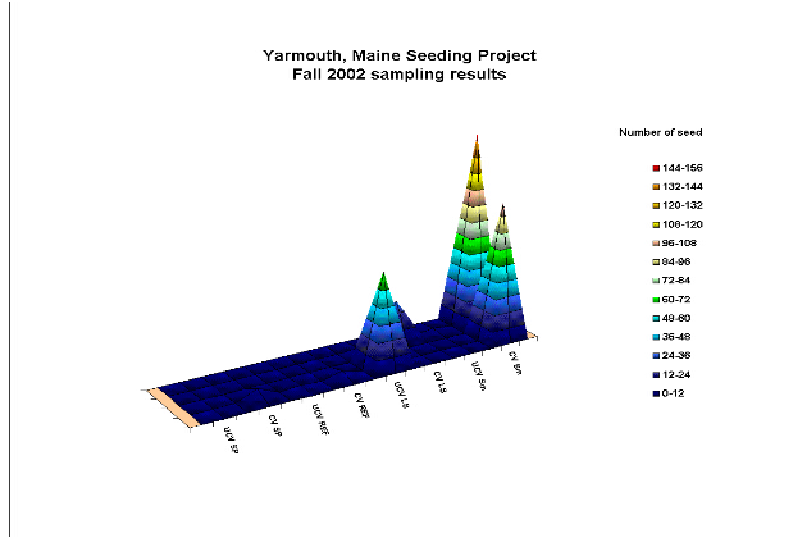
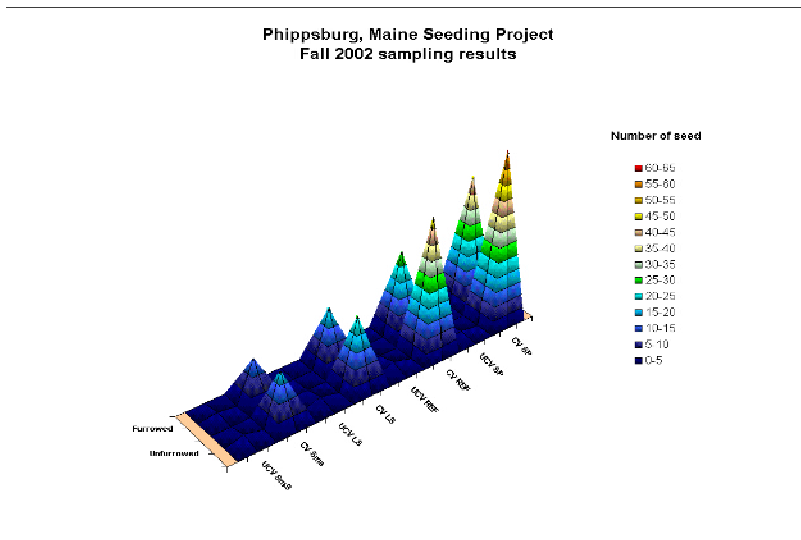
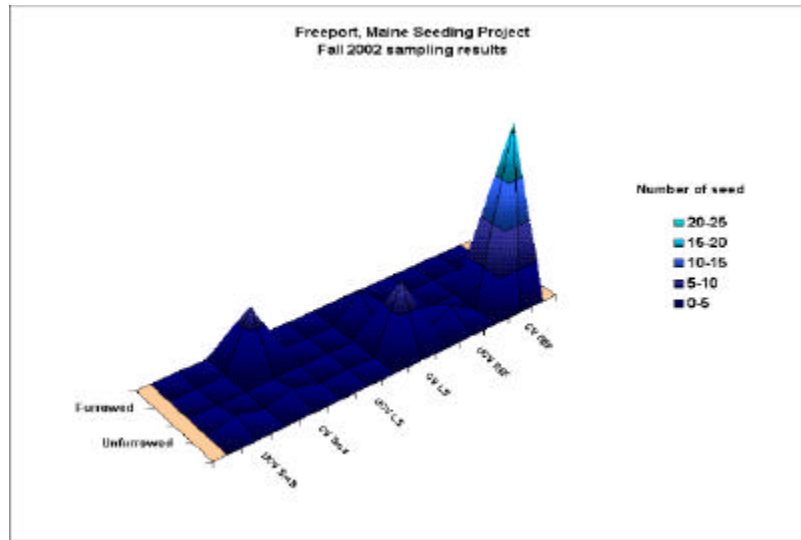
Figure 4.3-13. Number of Seed Recovered (per 3 ft<sup>2</sup>) from Seeding Experiments in Yarmouth, Phippsburg and Freeport

(12.3, 12.0, 15.0, and 7.1) do not match the size range of the LS clams seeded (18-20 mm). Furthermore, as in Yarmouth, similar size, albeit fewer, clams were recovered from the reference

The Fall 2002 results are similarly discouraging with regard to seeded clam survival. In both Freeport and Yarmouth, by Fall 2002 none of the Fall 2001 or Spring 2002 were found, all of the recovered seed being extremely small with mean sizes in the range of 1mm to 4.2 mm and therefore strictly of recent natural settlement. In Phippsburg the rate of survival across all treatments was markedly better than in Freeport and Yarmouth; however, both the number and mean size of clams recovered from the various treatments were either smaller or very similar to the number and mean size of clams recovered from the reference plot, corroborating the early findings of the Spring 2002 sampling.
