# PLEASANT RIVER

## WATERSHED MANAGEMENT PLAN

Cumberland County Soil & Water Conservation District

Prepared by Heather True  
June 2011

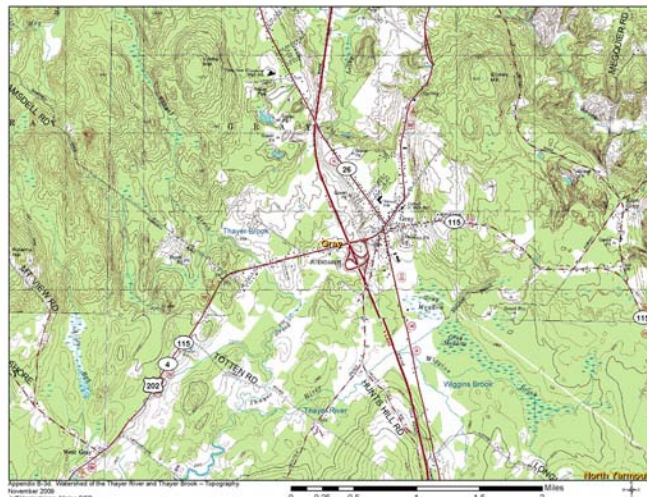
Above map is a topographic map of the headwaters of Pleasant River near downtown Gray. Map from Pleasant River and Tributaries Reconnaissance Study, Maine DEP 2009. (See Appendix A: Topography Maps for larger map).

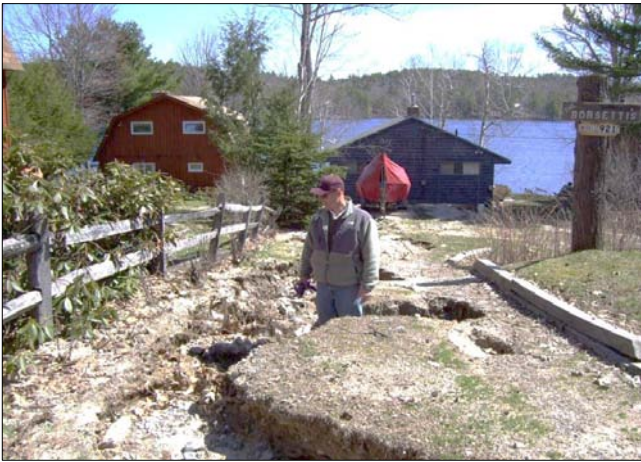
*Sediment from erosion sites such as this one on Little Sebago Lake in Windham is the biggest source of pollution to surface waters in Maine.*

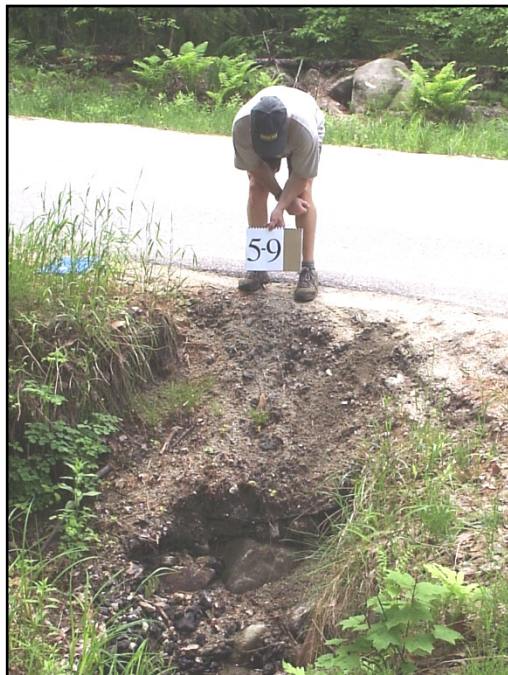
*A Pleasant River Watershed Survey volunteer documents road shoulder erosion above a culvert washing into a tributary of the Pleasant River.*

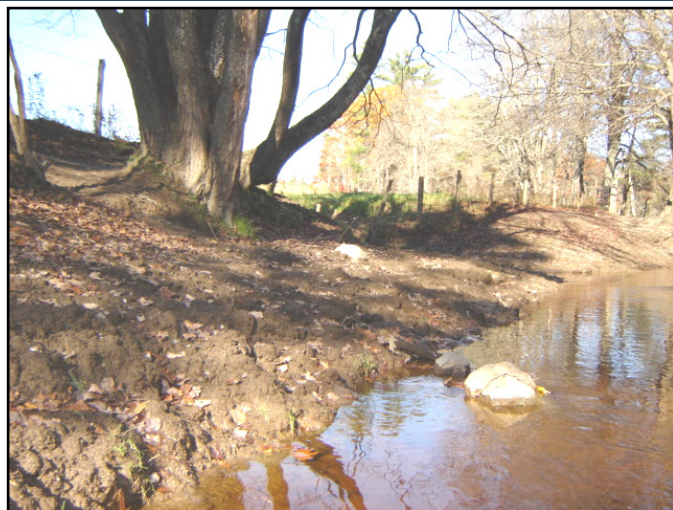
Signs of cattle access to main stem of Pleasant River resulting in stream bank erosion.

A few areas along the Pleasant River were documented in which extreme river widening or bank slumping were occurring. Causes for these observations could include high flow events, geological conditions, sharp bends in the river, human or animal activities, or a combination of these factors.

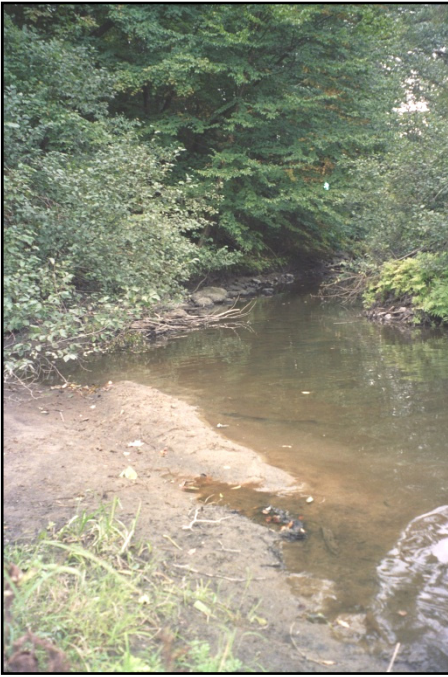
Sediment delta along stretch of Pleasant River in which Brook Floater habitat has been documented. Photo Credit: Maine Dept. IF&W

A follow-up survey by IF&W in the summer of 2010 found only six live brook floaters in two days of surveying. Surveyors noted that turbidity was so high that it was nearly impossible to conduct visual surveys in water more than 1 ½ feet deep throughout most of the upper river. Unfenced cattle and horse access to the stream was noted to damage stream banks. The stream banks appeared to have suffered a tremendous amount of additional damage from recent floods, with some of the turbidity likely related to natural clays, tannins and algal production.

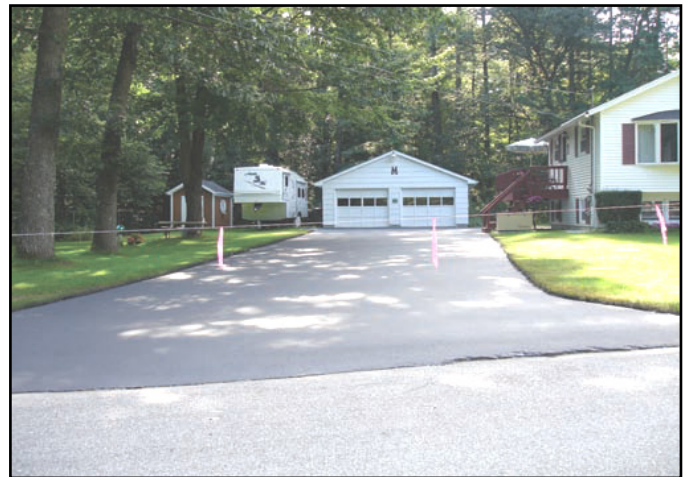
Recently seal-coated driveway in the Pleasant River Watershed; Stormwater picks up harmful polyaromatic hydrocarbons (PAHs) from seal-coating washing them into nearby streams and waterbodies.

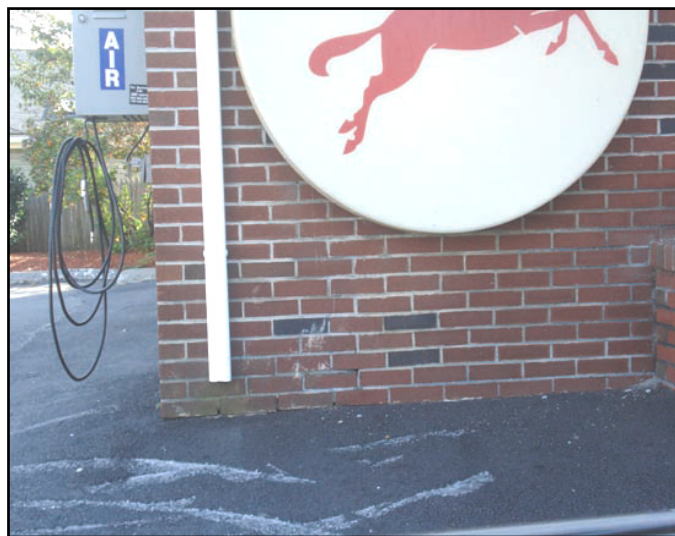
*Downspouts draining onto impervious surfaces rather than being filtered into the ground are considered potential "hotspots" due to the potential pollutants the stormwater can pick up and wash into the Pleasant River.*

- Install crushed stone-filled drip line trench under roof line to capture and infiltrate rainwater (L)
- Install a drywell at gutter downspout to capture and infiltrate stormwater (L)
