Has eelgrass habitat in Casco Bay changed over time?

CBEF Goal: Minimize adverse environmental impacts to ecological communities from the use and development of land and marine resources.

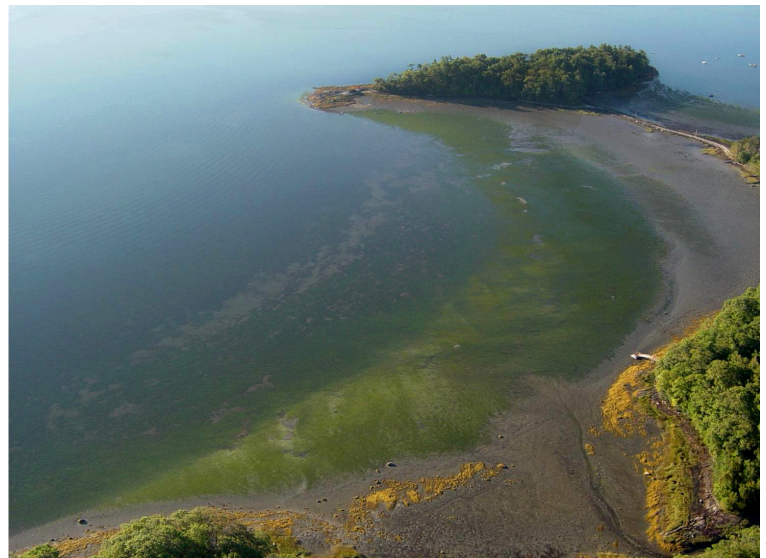
Healthy eelgrass beds like those off Little Flying Point in Maquoit Bay depend on good light penetration through the water column. Excess sediments create turbid water conditions and reduce water clarity, causing stressed eelgrass plants to grow long and thin, stretching toward the surface to reach adequate sunlight.

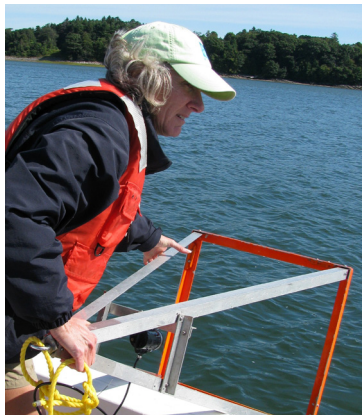
Hillary Neckles, of USGS Patuxent Wildlife Research Center, deploys an underwater video camera to measure eelgrass cover.

In 2009, a collaborative team, comprising Friends of Casco Bay, the Casco Bay Estuary Partnership, the US Geological Survey, and Bates College, began to develop a baseline of boat-based rapid assessment eelgrass data at randomly selected monitoring stations within Maquoit Bay and off Mackworth Island. Initial analysis of the 2009 data provided valuable information to help guide future eelgrass surveys in Casco Bay, and generally suggested that eelgrass is present and healthy where expected, based on previous macro-scale assessments and habitat modeling. Additional boat-based data collection should expand understanding of eelgrass conditions within Casco Bay.
