Mill Brook

Stream Habitat Walk

Cumberland County, Maine
May 31, 2003

Report Date: September 18, 2003
Prepared by the Maine Stream Team Program

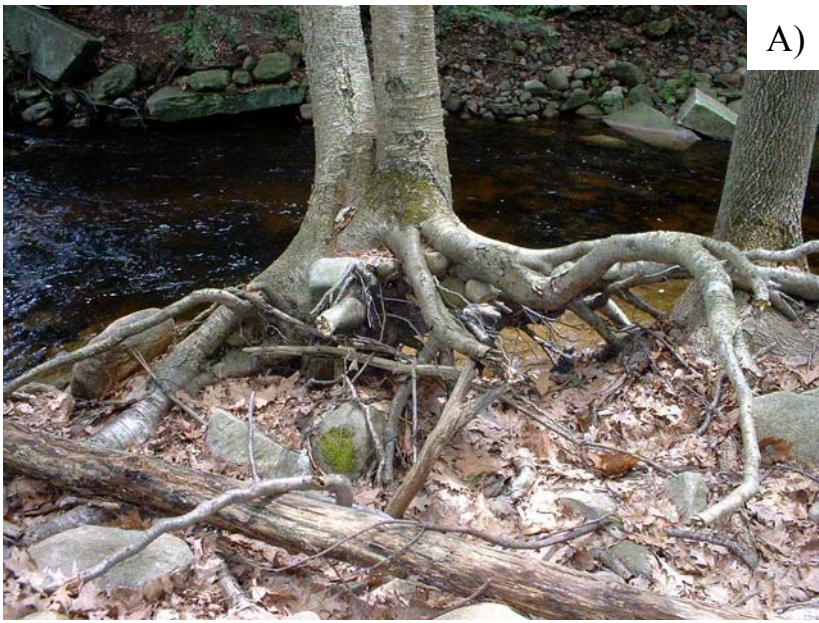
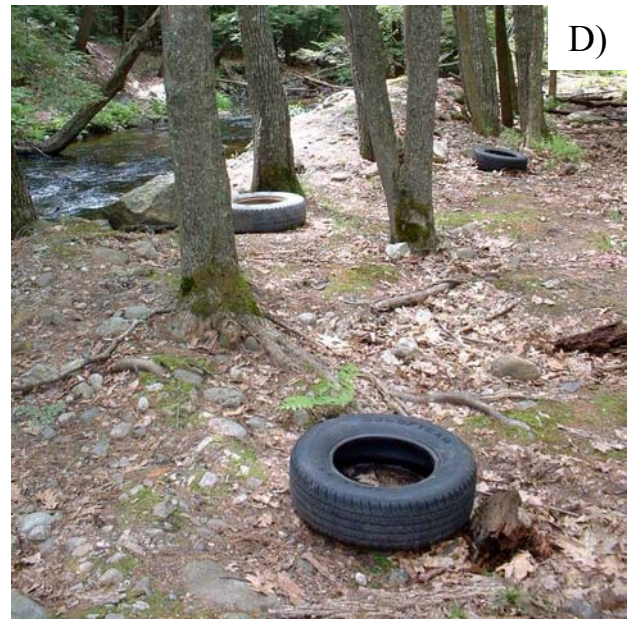
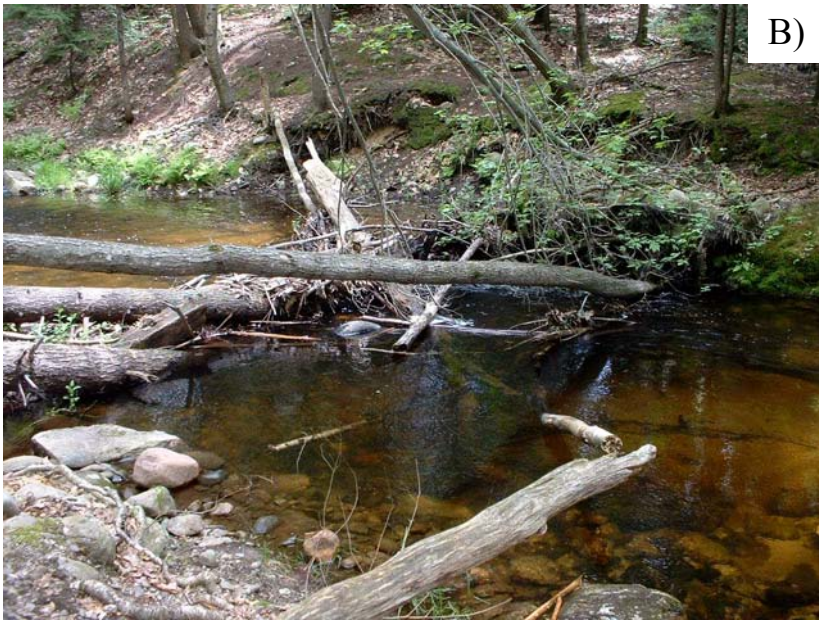
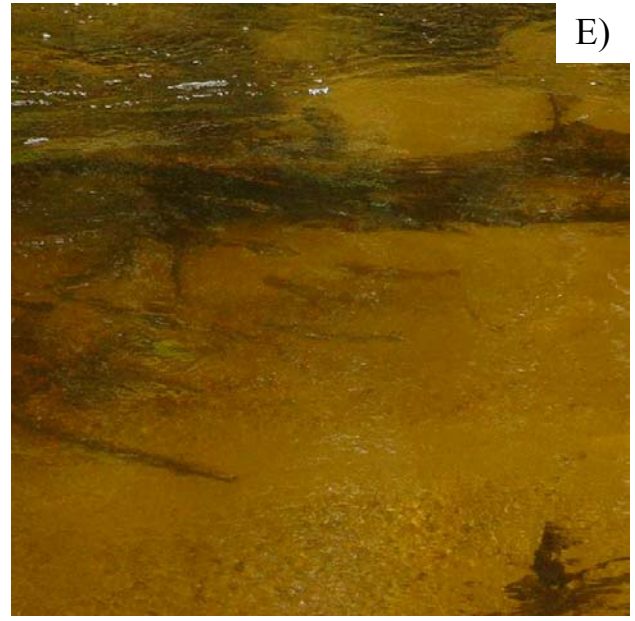
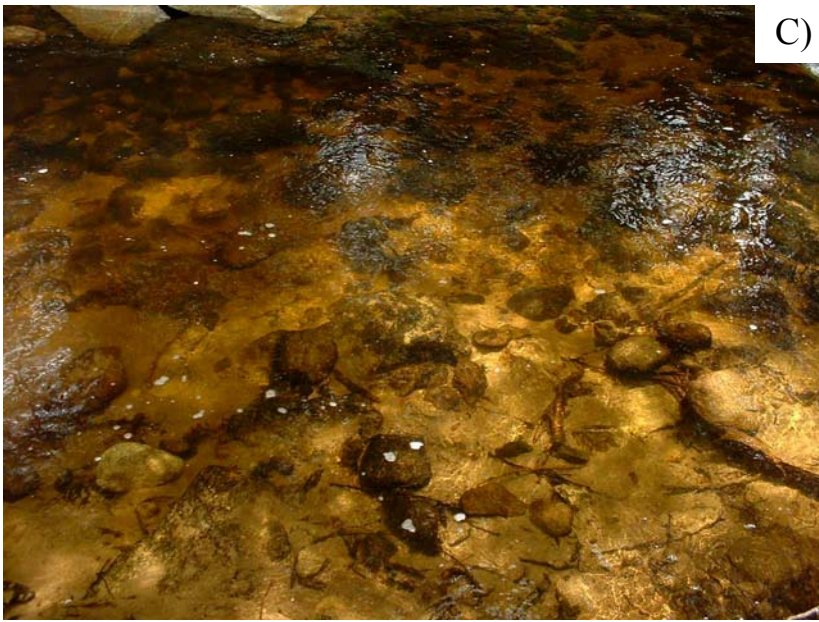
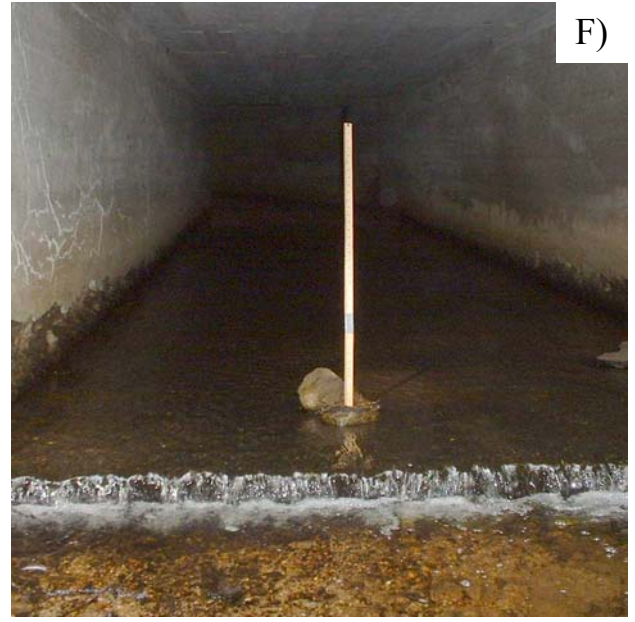
Site 1 photographs: A) scoured tree roots downstream of the Route 302 bridge/culvert; B) a woody debris dam and pool; C) a representative photograph of substrate in a run; D) trash on the streambank; E) alewives; and F) water level in the culvert (approx. 1 inch) (photo F taken on 7/14/03).

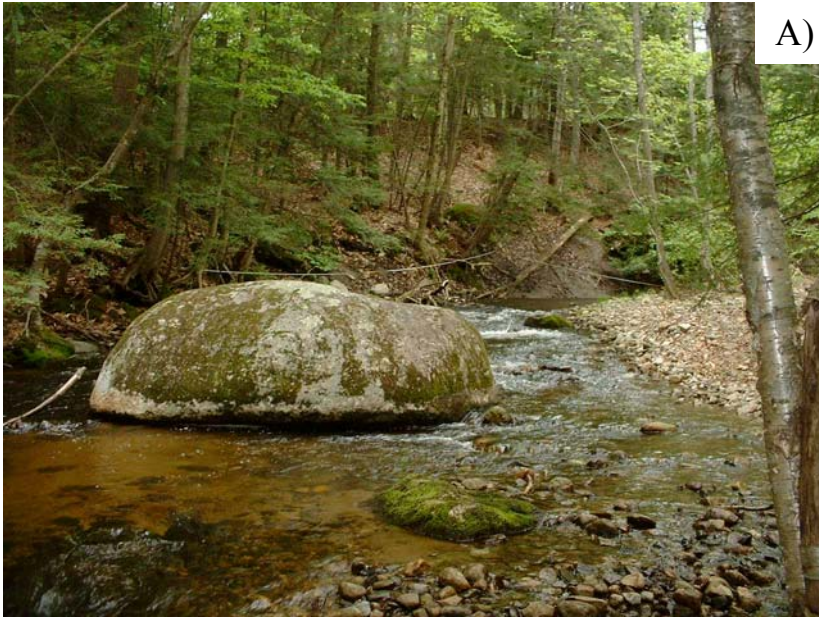
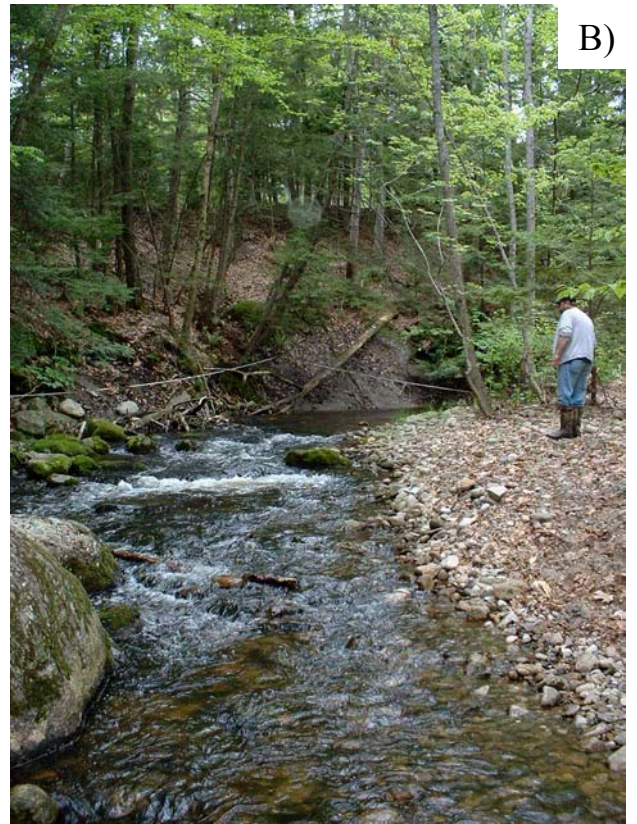
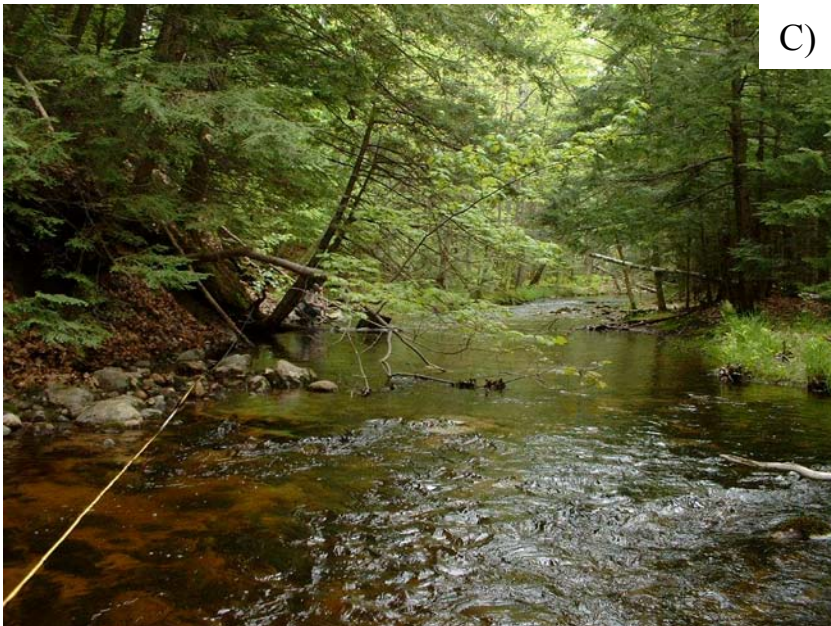
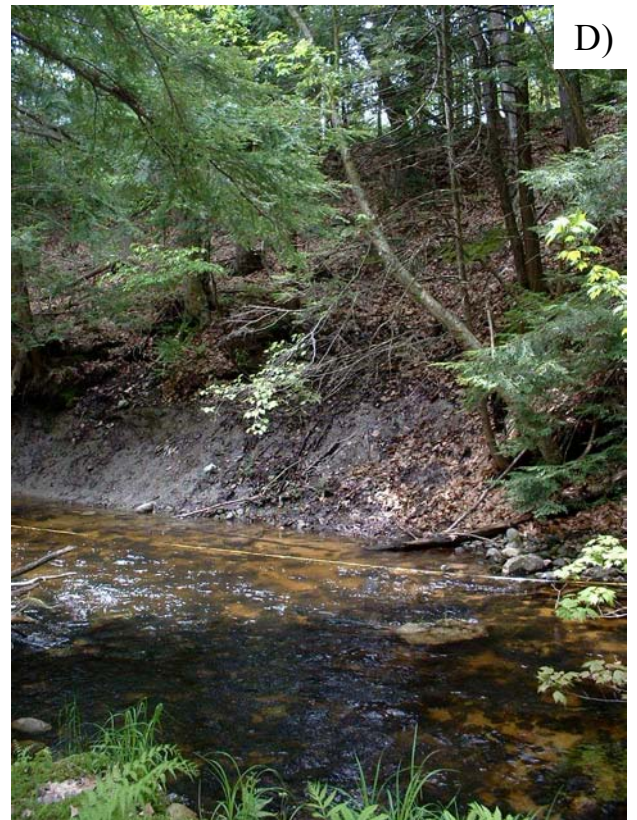
Site 2 photographs: A) a riffle, boulder, and pool sequence; B) a riffle; C) run habitat; and D) groundwater seepage out of a bank along with some apparent scour and/or bank sloughing.

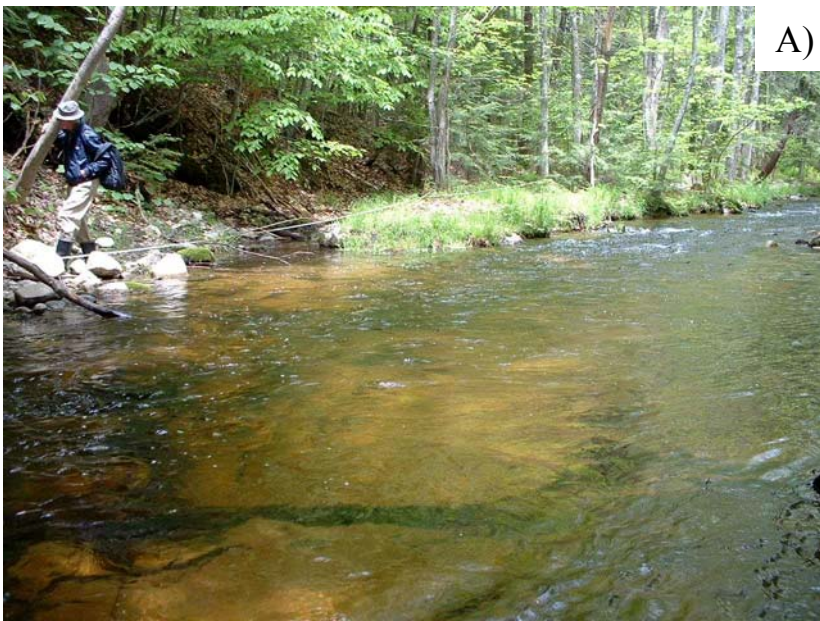
A)

Site 2 photographs: A-B) signs of sediment inputs via a tributary containing some road runoff; C) sediment accumulation on the bank of Mill Creek opposite from the tributary input; D) a close-up photo of the tributary (notice the frog on the rock in the middle); and E) some “J-shaped” tree trunks on a nearby, steep bank, indicating relatively slow hillside erosion rates in the local area.

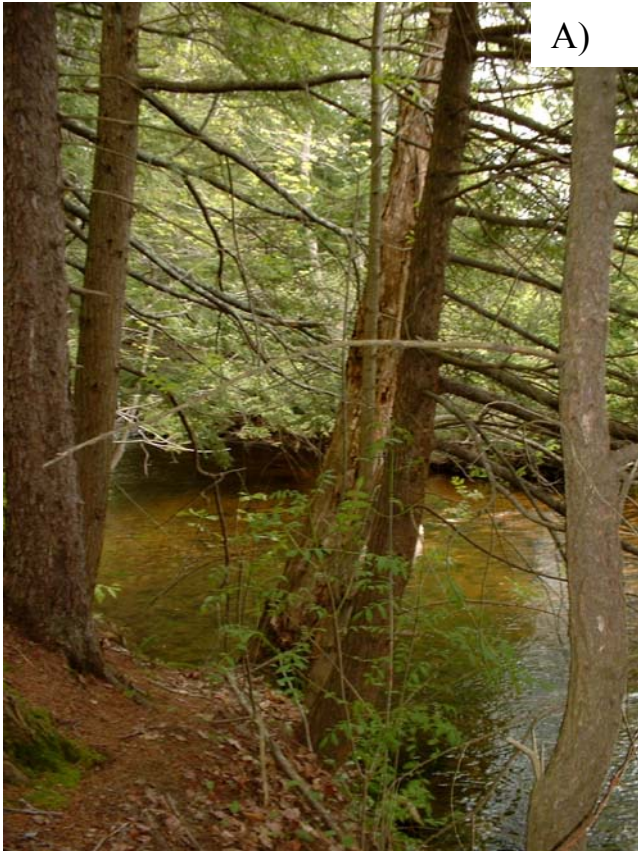
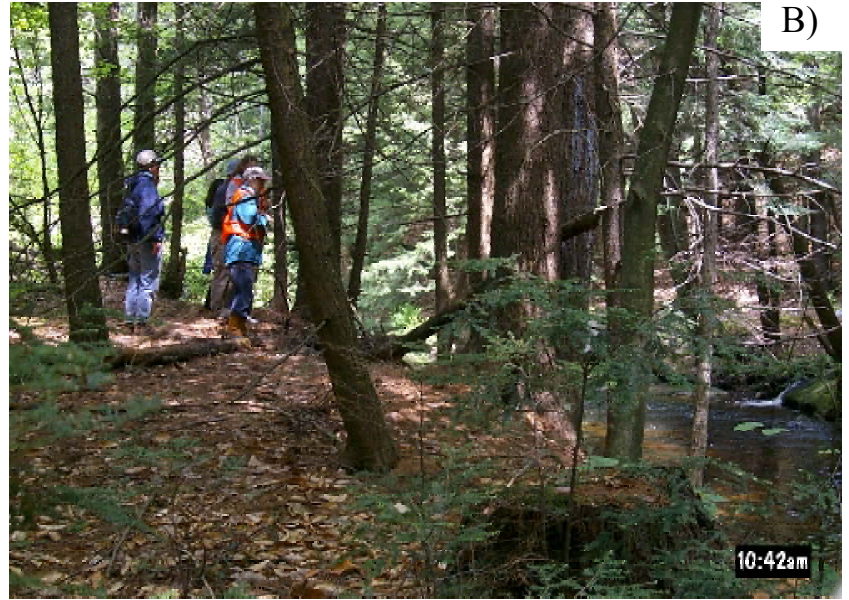
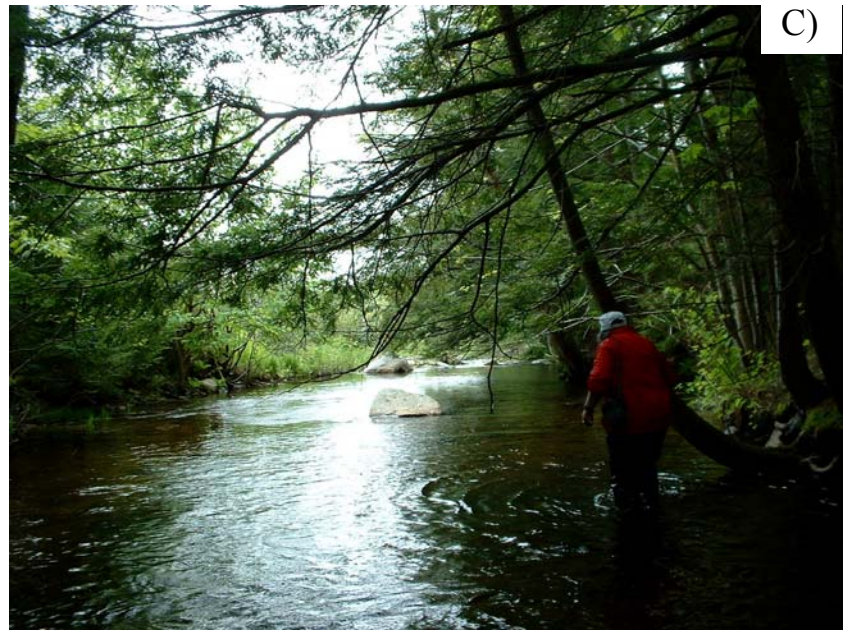
Site 3 photographs: A-B) view of stream through forested banks (note the J-shaped trees - they suggest that bank erosion rates may be relatively slow in the local area; C) a shaded pool.; and D) a riffle.

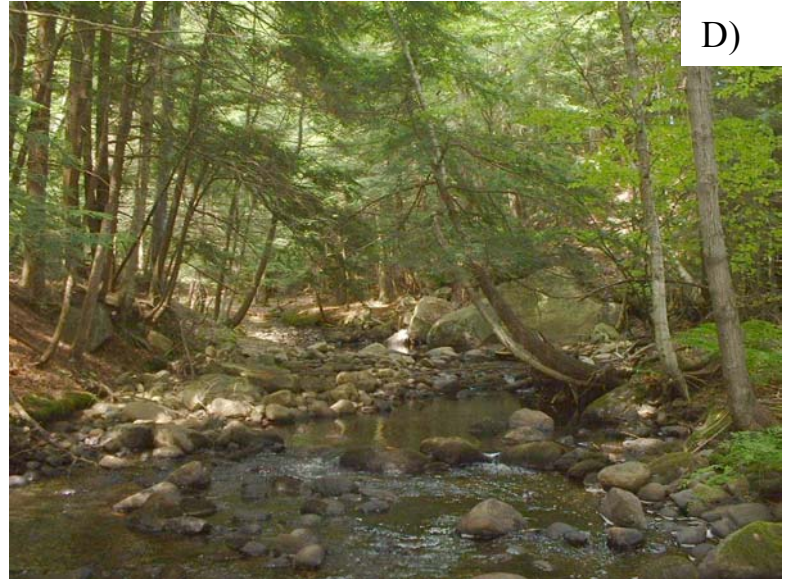
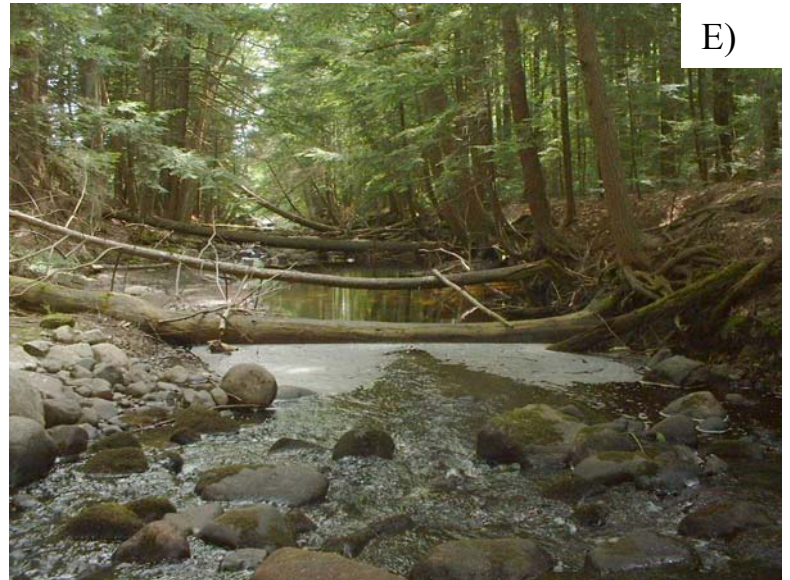
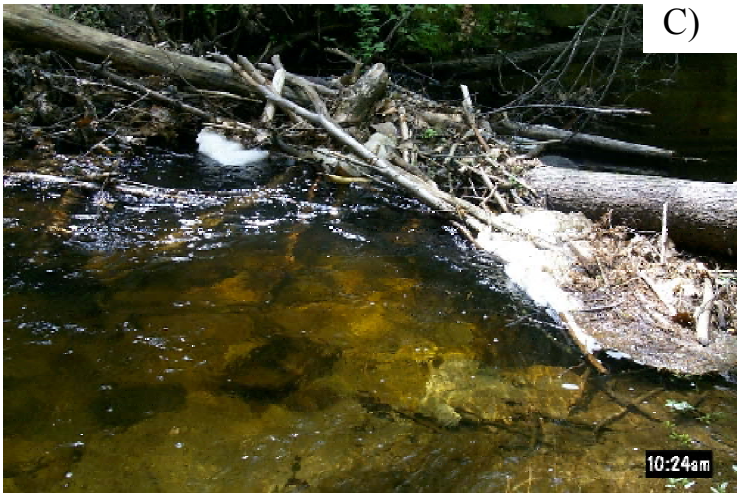
Site 3 photographs: woody debris dams (photos A, B, D, and E were taken on 7/14/03). Fallen large woody debris is important for creating stream habitat diversity and for trapping / retaining food resources for aquatic organisms. However, large numbers of fallen trees may sometimes indicate that the channel is trying to widen, in response to human impacts to the stream. More investigation may be needed to determine the types and stability of processes occurring in Mill Brook.

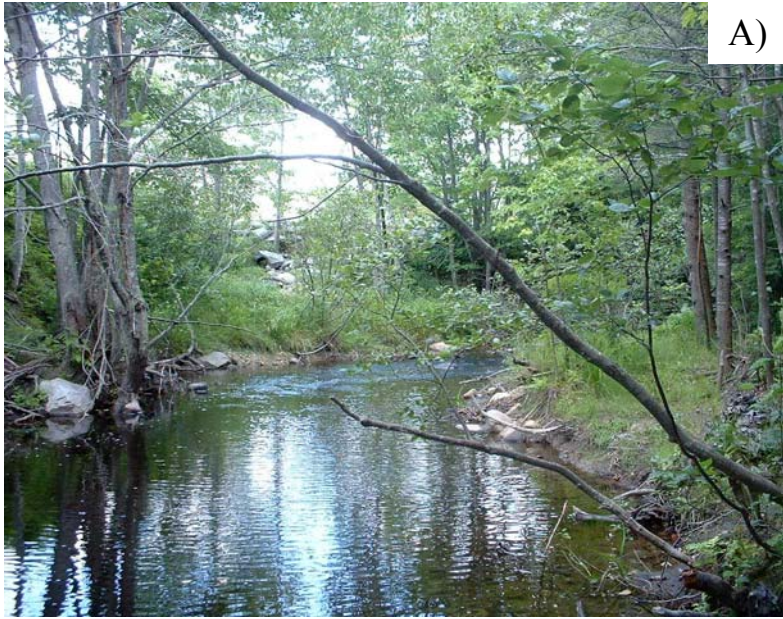
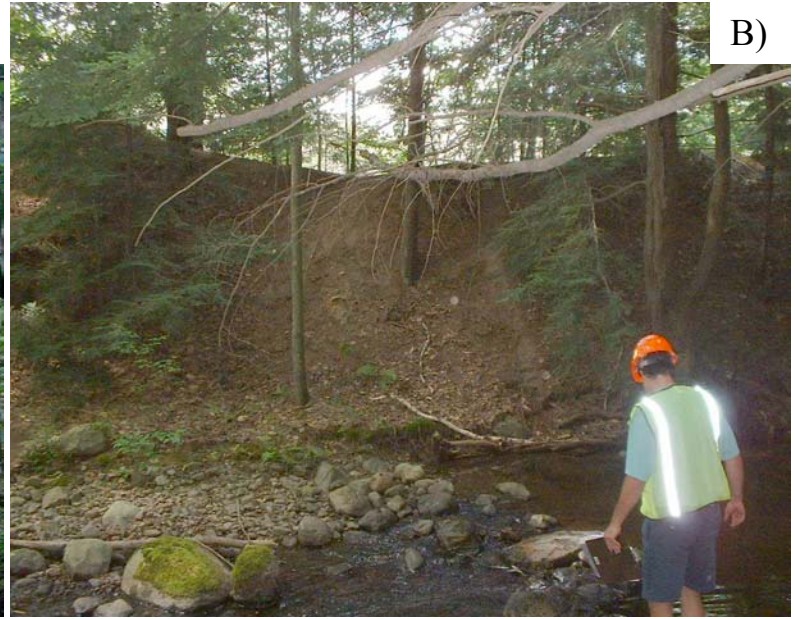
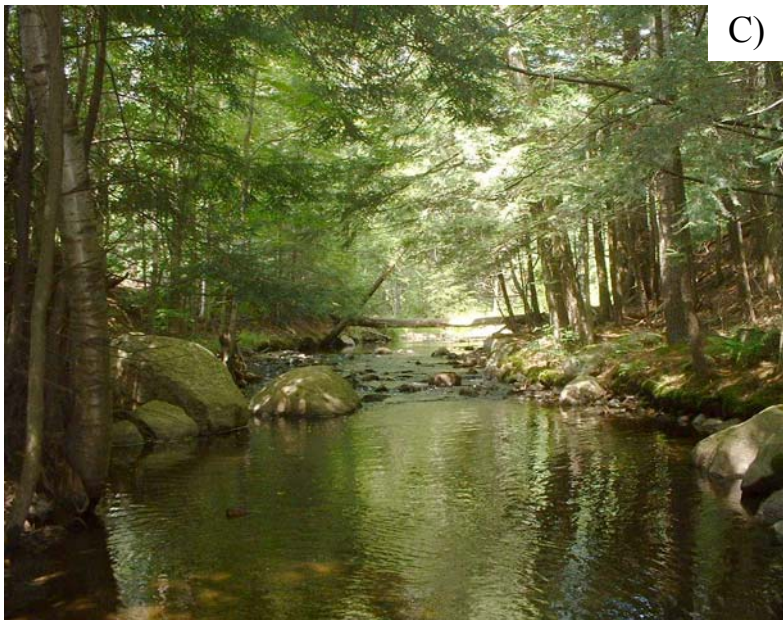
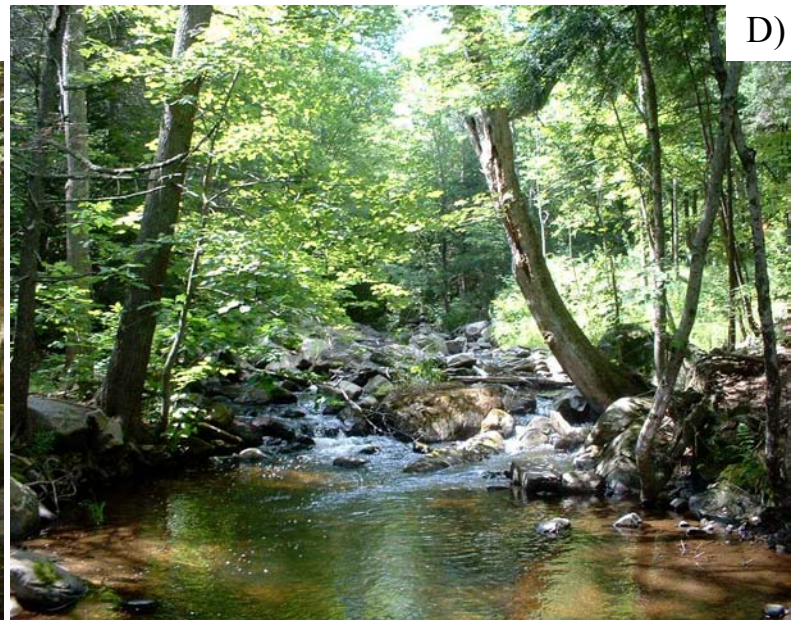
Site 4-B* photographs: A-B) Mill Brook and streamside areas in the vicinity of a gravel mining operation (note the berm wall on one side of the stream - it currently is serving as a barrier between a stormwater detention pond and the stream) and C-D) pools, riffles, and streamside forest. *These photos were taken on July 25, 2003, on a reconnaissance walk of this area, which is located downstream of Site 4 (see the map on page 2).

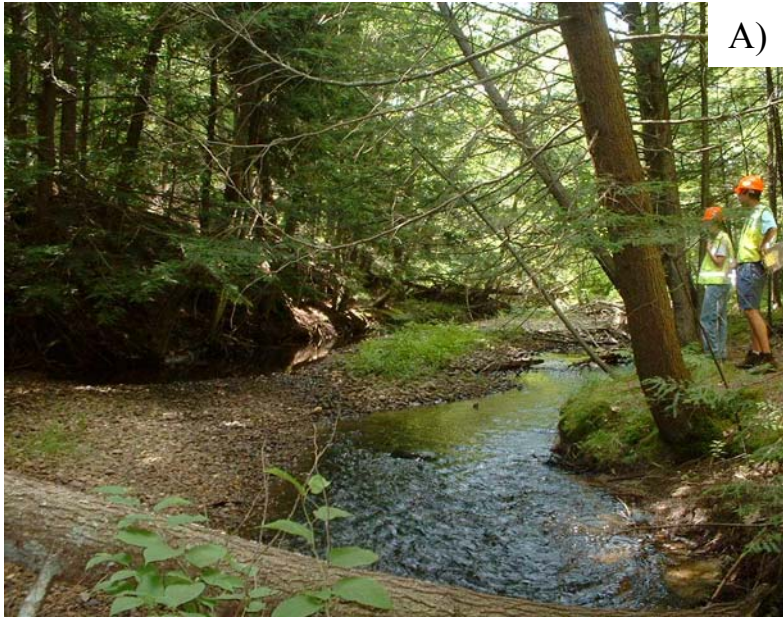
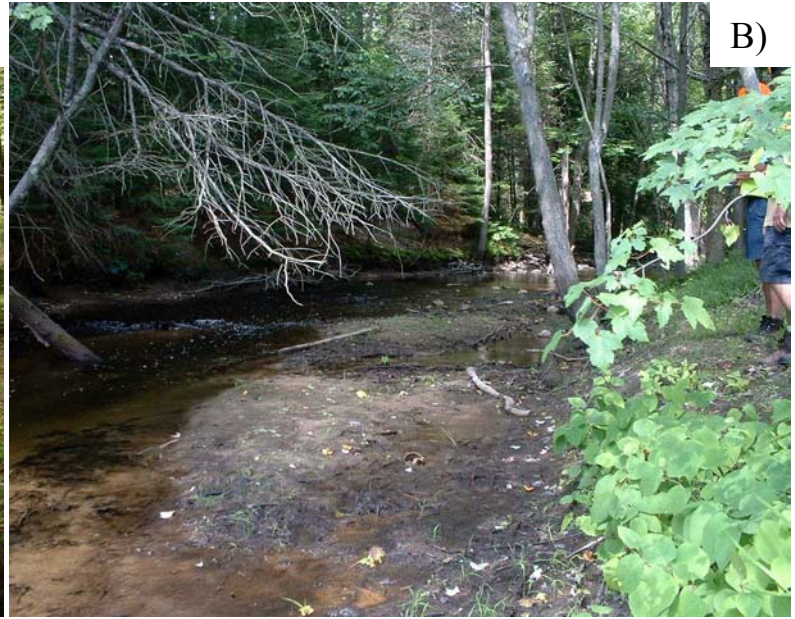
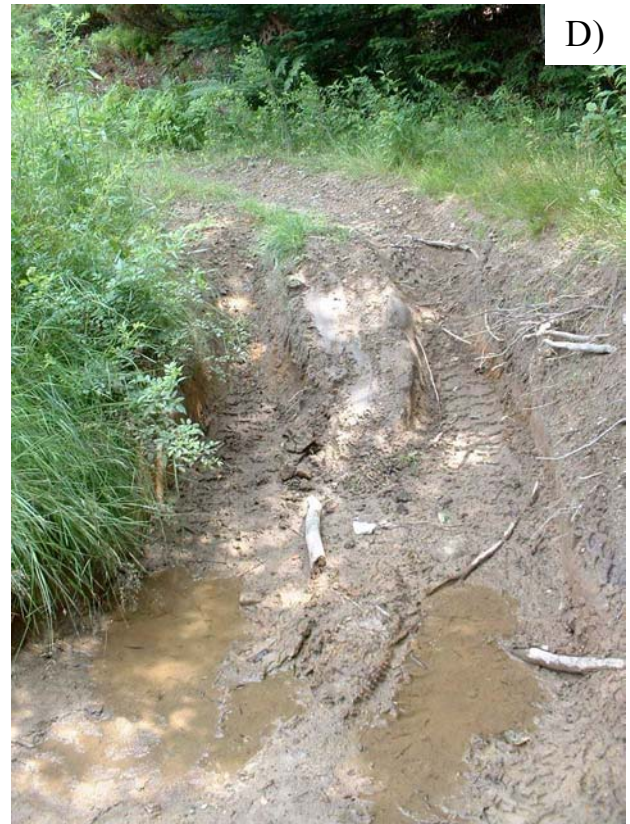
Site 4-B* photographs: A-B) signs of aggradation (that is, sediment accumulation or bar formation) in the middle of Mill Brook's channel and C-D) local ATV trail impacts. *These photos were taken on July 25, 2003, on a reconnaissance walk of this area.

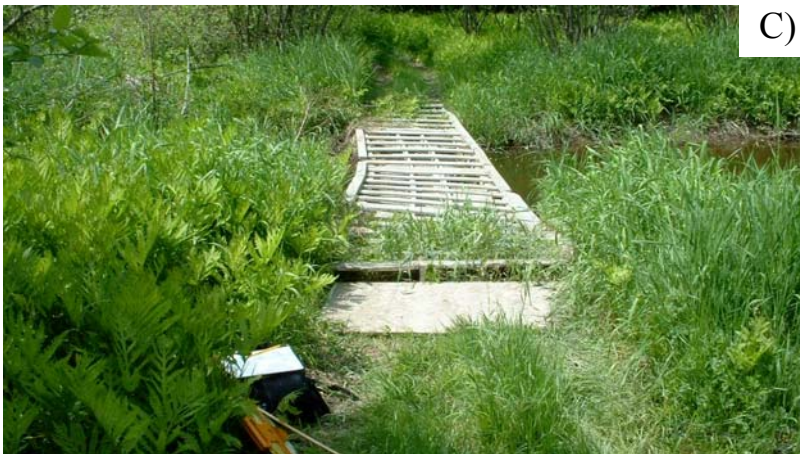
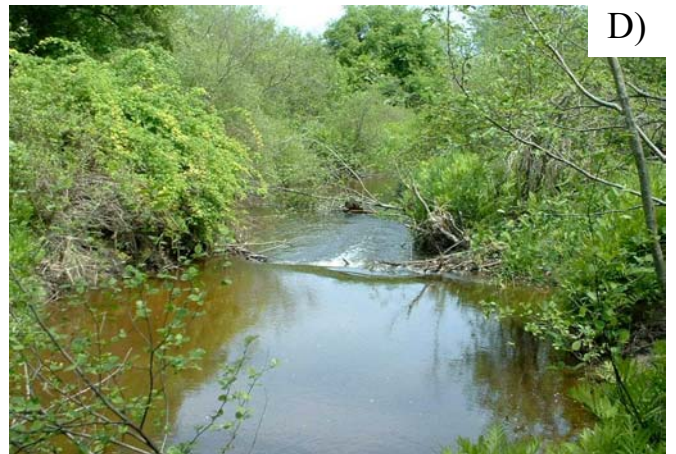
Site 5 photographs: A-B) Looking upstream and downstream from the ATV bridge shown in photo C; C) ATV bridge; and D) a small debris dam perhaps created by beaver.

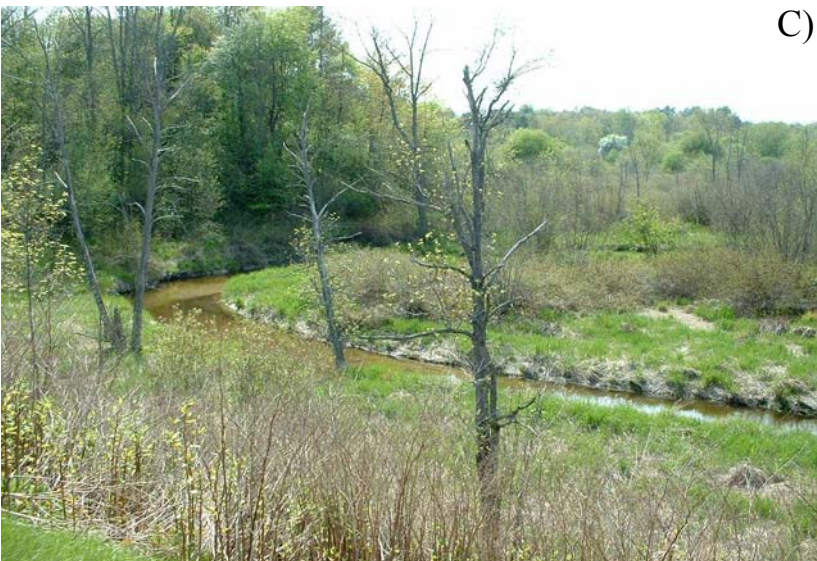
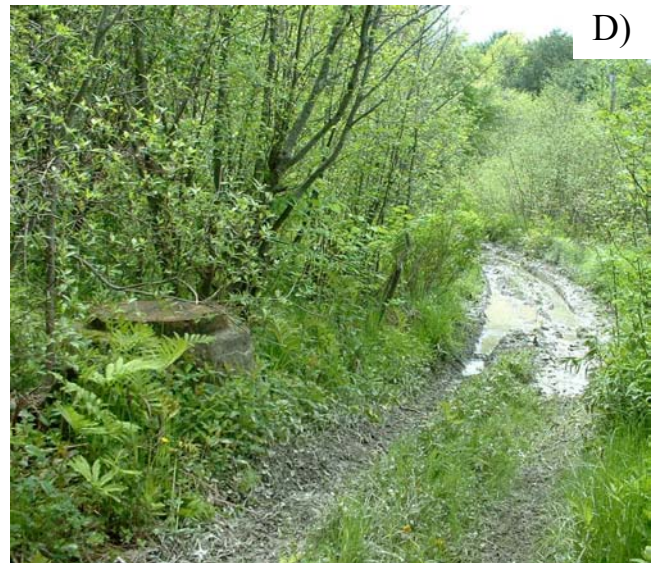
Site 6 photographs: A-C) meandering, low gradient, silty-sandy-bottomed stream; and D) a manhole above a sewer line and an ATV trail near Mill Brook. Photo C was taken on 5/20/03 and it is situated just upstream of Bridge Street.

Sites 5 & 6) Major concerns: Sediment pollution from badly eroding ATV trails, thermal stress from a general lack of many mature, tall trees in the riparian zone, and potential sewer line leaks.

³ A sewer line was close to the stream in these areas, which possibly could contribute nutrients, bacteria, and viruses if leaks were to occur.

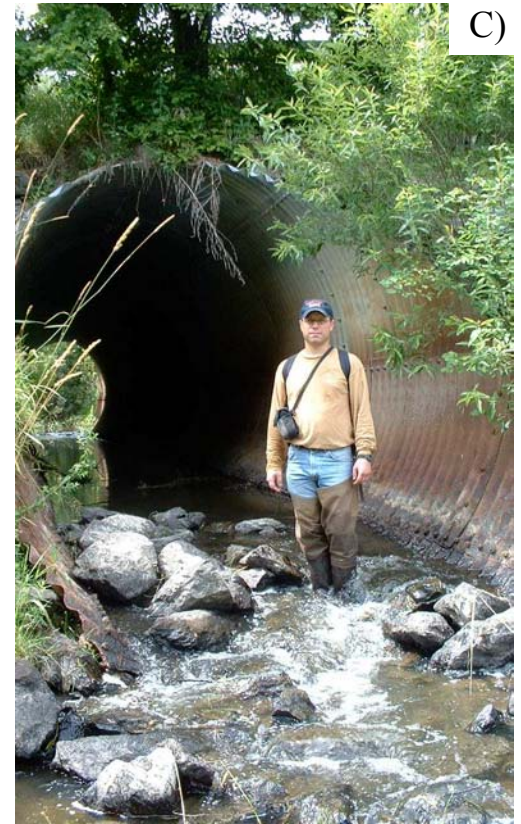
Photographs of the culverts underneath Bridge Street: A) taken on May 20, 2003; and B-C) taken on July 14, 2003.

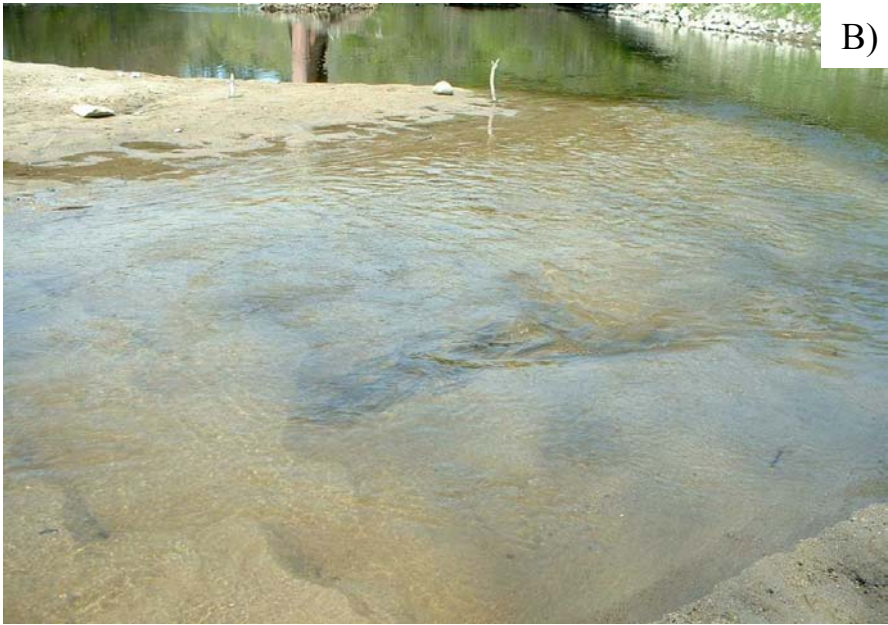
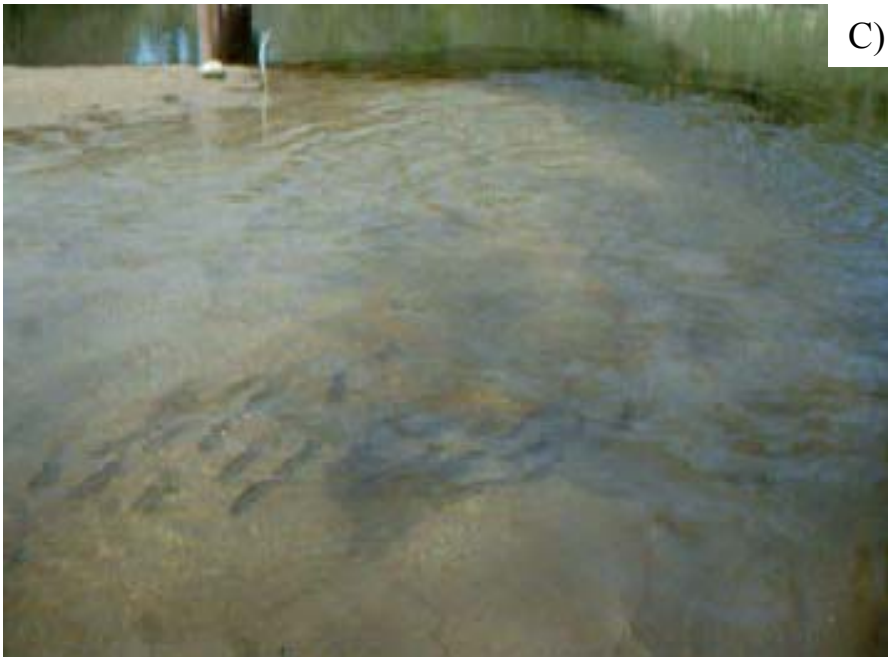
Photographs taken near where Mill Brook drains into the Presumpscot River: A) sandy banks; and B-C) alewives entering Mill Brook.

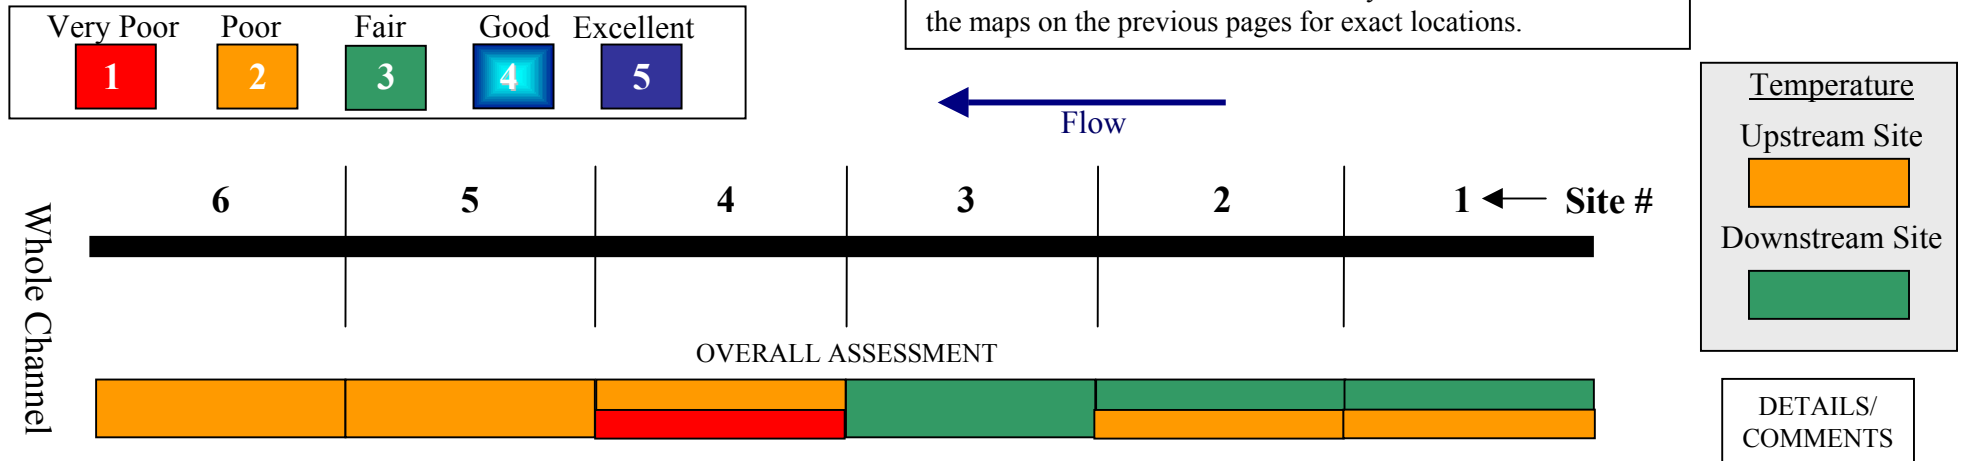
Figure 1. Overall Assessment.

> A number of land-uses in close proximity to Mill Brook's channel and riparian (streamside) zone area appear to threaten the stream's water quality and in-stream habitat conditions. Some of these land-uses include ATV (all-terrain vehicle) trails, powerlines (and their associated clearings of most vegetation except grasses), roads, a sewer line, and a gravel quarry. Other land-uses known to occur in the area, but that were not detailed in this survey, include a dam and Highland Lake, a dump, a horse farm, and suburban development. For the sites that were included in this survey, ATV trails, roads (sources of polluted runoff), and water warming via powerline clearings and the existence of an upstream lake/dam appeared to be the land-uses most threatening to the brook and its communities.

> On average, the in-stream and near-stream habitats, from a trout and salmon habitat perspective (except for water temperature), generally were "fair" in areas relatively removed from human activities and "poor" to "very poor" in areas near human encroachment. This was concluded, in part, due to the fairly high embeddedness of the much of the larger channel bottom materials (e.g., cobbles and gravels). In other words, potential spawning habitat areas appeared to have lots of sands and silts in the cracks and crevices of the large rocky materials on much of the channel bottom, including the faster riffle areas. This may be due in part to sediment pollution from road runoff, ATV trail erosion, and riparian (streamside) areas. However, it is important to note that this may, in part, be a natural occurrence due to the fact that much of local surficial geology has a large presence of sands and clays (see surficial geology map for more information). From adult trout/salmon and macroinvertebrate (e.g., aquatic insects, crustaceans, etc.) perspectives, habitat was slightly better near sites 1, 2, 3, and 4-B due to their relatively rockier channel bottom, water re-aeration (due to turbulence), and shading conditions. Except for shading, these conditions were partly a result of these sites naturally having a greater slope (gradient) than most of the downstream sites.

> Temperature data from continuously-recording data loggers suggested that water temperatures generally are sub-optimal, at best, for trout and salmon. The relatively healthy riparian zone in much of the stream does appear to help cool the waters as it moves from upstream to downstream locations. Highland Lake, its dam, and the relatively open and shallow area downstream of the dam, which are at the upstream end of the stream, likely are the features primarily responsible for warmer waters in the upper reaches of the stream.

Site 1) Major concerns: Sediment and other associated pollutants from nearby roadways. Also, trash was a problem here. The stream in this area appears as though it may have been straightened (channelized) historically, and the right bank appears as though it may have had fill added to it to turn it into a berm.

Site 2) Major concerns: Input of sediment and other associated pollutants from nearby roadways and drainage as well as some steep banks.

Site 3) As the stream approaches the powerline area, the landform shapes suggest that this particular stretch of stream may have been straightened or channelized in the past. This might explain why this section of stream appears to be quite wide and shallow, and also why so many trees appear to be falling into the stream.

Site 4) This area has been heavily disturbed by powerline-area clearing and associated ATV trail use. There is a high potential for erosion and sedimentation, as well as stream shading/temperature, problems here.

Site 4-B) This site only was only subjected to a reconnaissance walk. However, this rapid survey discovered that sedimentation appears to be a problem, which is likely due to ATV trail use, upstream sources of erosion, as well as possibly a nearby gravel pit (although sediment settling basins are present here).

- > Further investigation regarding the riparian zone is recommended - especially at the powerline areas (near sites 4 and 4-B) and the lower brook sites (near sites 5 and 6). It would be worth knowing whether these areas, especially at the lower, apparently minimally-disturbed sites, would the vegetation type naturally be just a mix of shrubs, grasses, and smaller riparian trees (e.g., alder) as a result of what might be locally moist, hydric soils, or should there also be larger conifer and deciduous trees in the area? There may have historically been a large-scale tree harvest, perhaps about the time the sewer line was put in place. Another question might be: “Could anything be done to enhance the riparian vegetation conditions?”. In other words, are the conditions right for doing riparian vegetation restoration projects at the lower brook sites or powerline areas (assuming the landowners would permit it)?

- > Further investigation into why so much of Mill Brook’s channel bottom is embedded is also recommended. This includes investigation into the influence of local geologic conditions versus the contribution of sediment pollution from roads and erosion.

- > Conduct a fluvial geomorphological investigation of the watershed. This investigation would lend insight into the current degree of stability of the stream as well as the potential impact of erosion and sediment inputs into the stream and riparian zone alterations as well as the influence of water and in-stream-sediment regulation (by the dam) and the local geologic setting on the stability and quality of in-stream and streamside habitats.

- > Keep the existing, intact riparian (streamside) forest areas protected in order to insure provision of shading, bank stability, and small / large organic matter to the stream. Small and large organic matter, such as leaves, twigs, and logs, is a source of habitat diversity as well as both food and protective cover to aquatic organisms in streams and rivers.

- > Investigate potential fish passage issues at all the culverts on the stream.
- > Conduct more stream walks on sites not included in this survey, including small tributaries to Mill Brook which might provide cold water to certain areas of the brook that can provide cold-water refugia to fish such as salmonids during warm periods of the year.

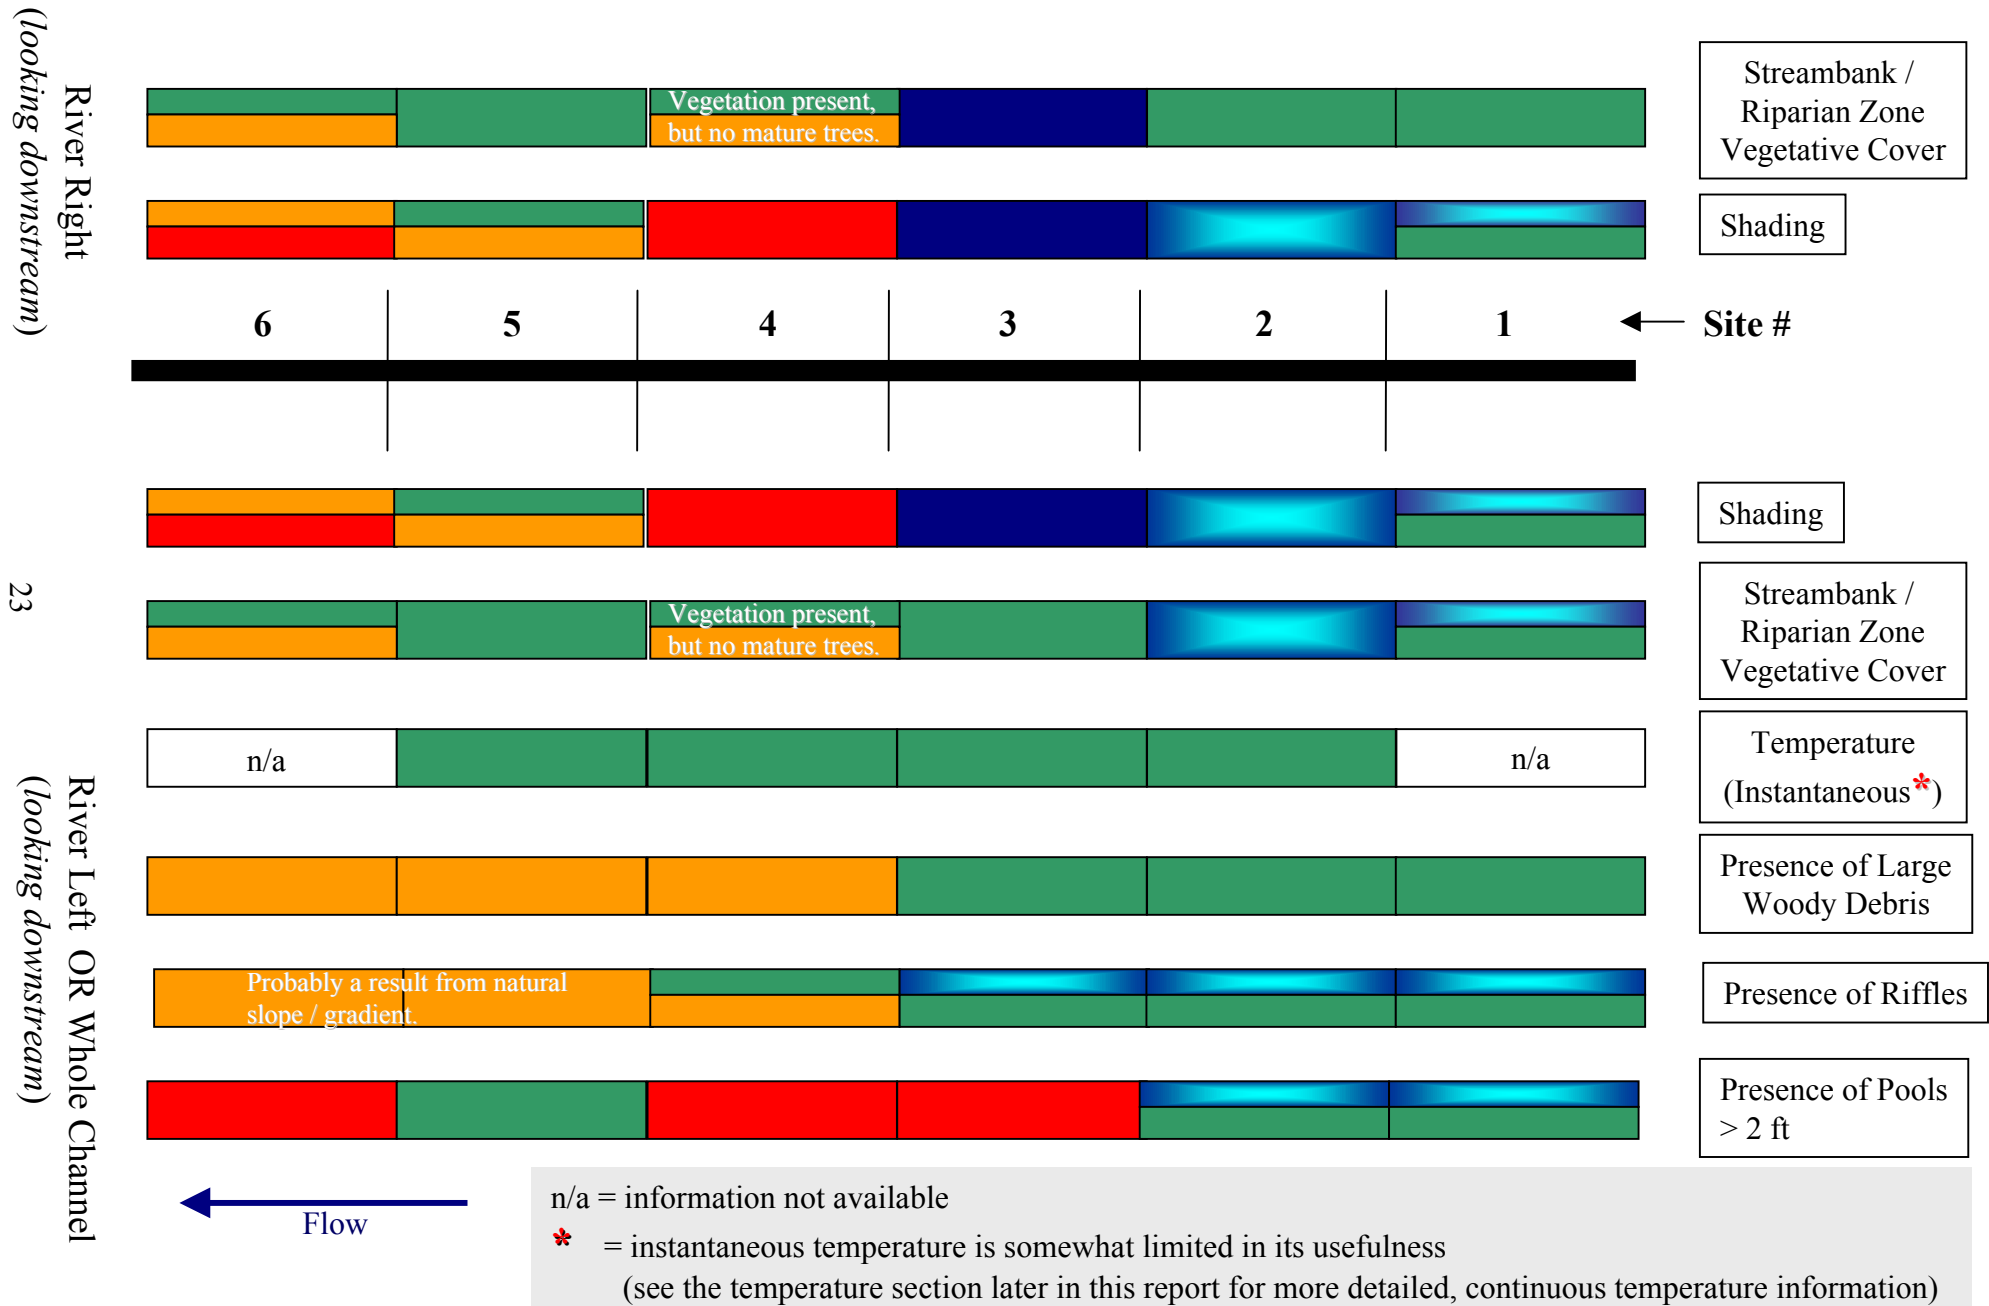
Figure 2. Habitat measures.

¹ Embeddedness is high in many places, although the fact that the local surficial has a lot of sands and clays in it may be a large influence.

² The substrate at these sites was almost entirely sands and silts. This may be due to natural factors such as local surficial geology, gentle slope, beaver activity in addition to erosion from ATV trails and poorly vegetated areas.

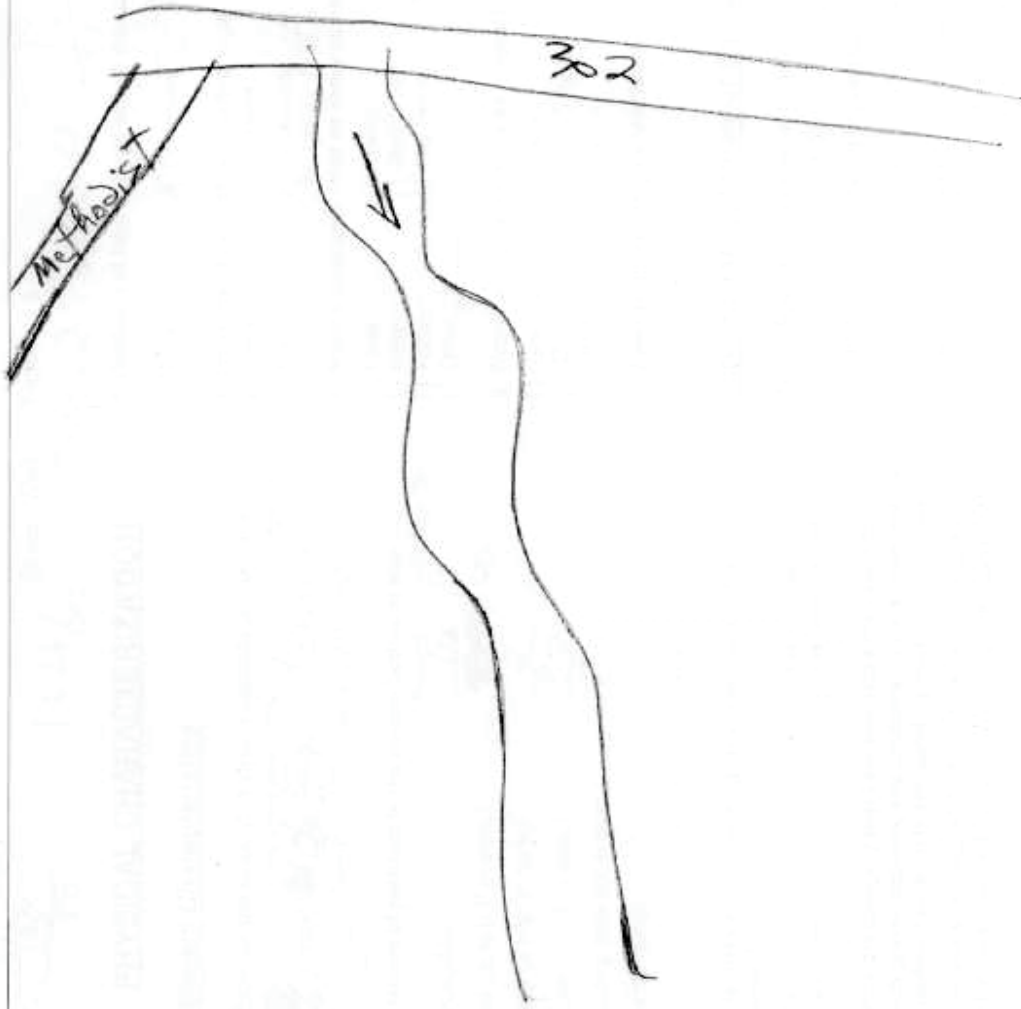
Dead fox; reportedly moose, deer, squirrel, etc. Old bridge remnants protected banks during 1996 flood. Large pool below bridge.
