Mill Brook

Stream Habitat Walk

Cumberland County, Maine
May 31, 2003

Report Date: September 18, 2003
Prepared by the Maine Stream Team Program

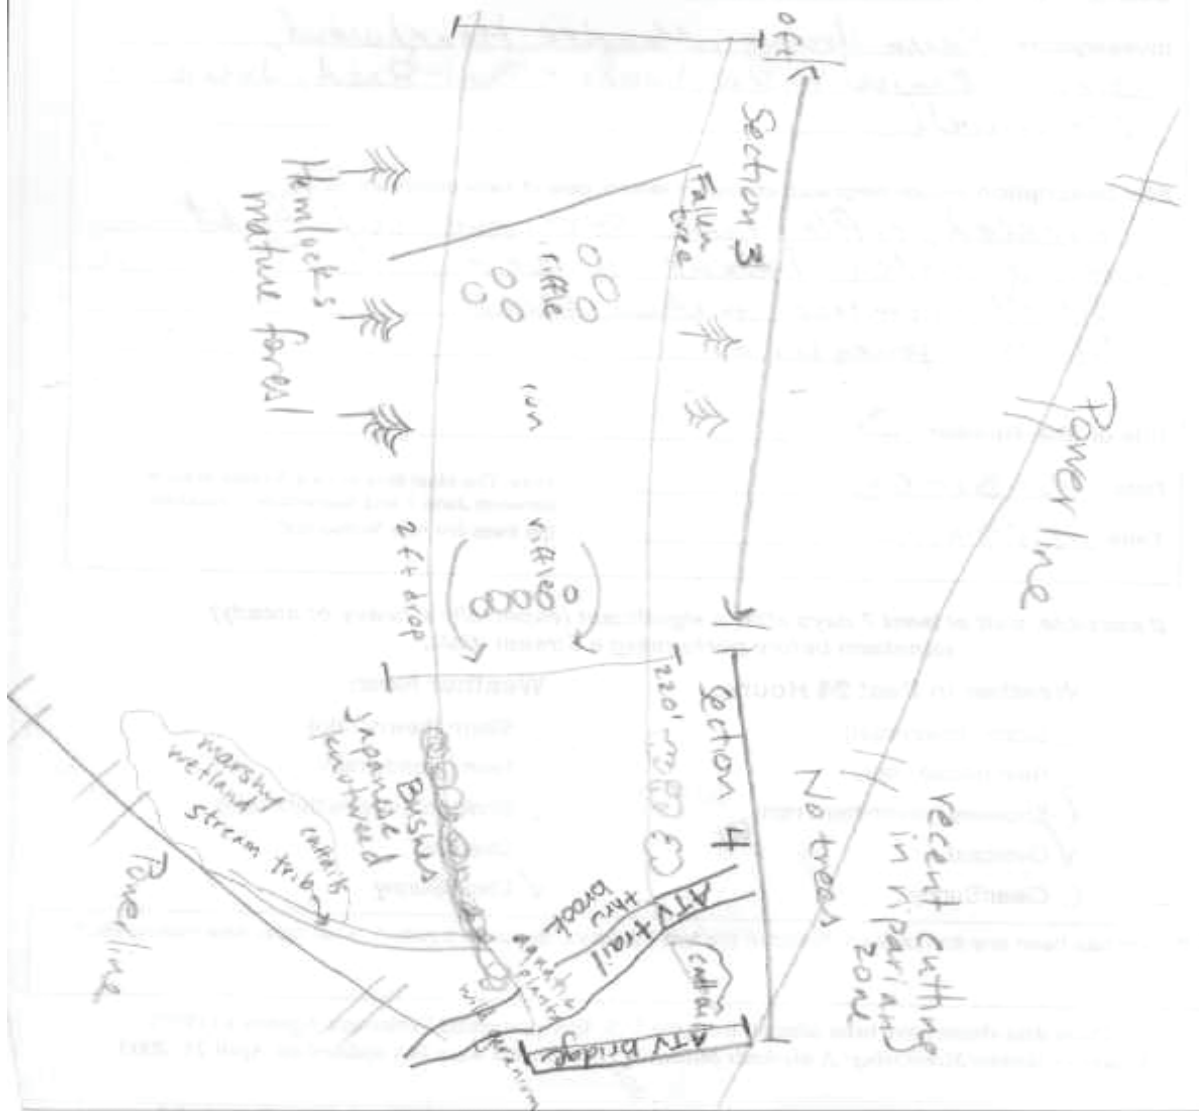
Powerline crossing. Recent cutting in the riparian zone. Mostly bushes, fast water movement and a riffle/run system.

East side of study area "hilly" powerline property. All vegetated but no trees. Bushes no higher than 10'. ATV use in Powerline trails. Trail crosses in stream but a bridge is available. Crayfish found on second visit. Many fish seen.

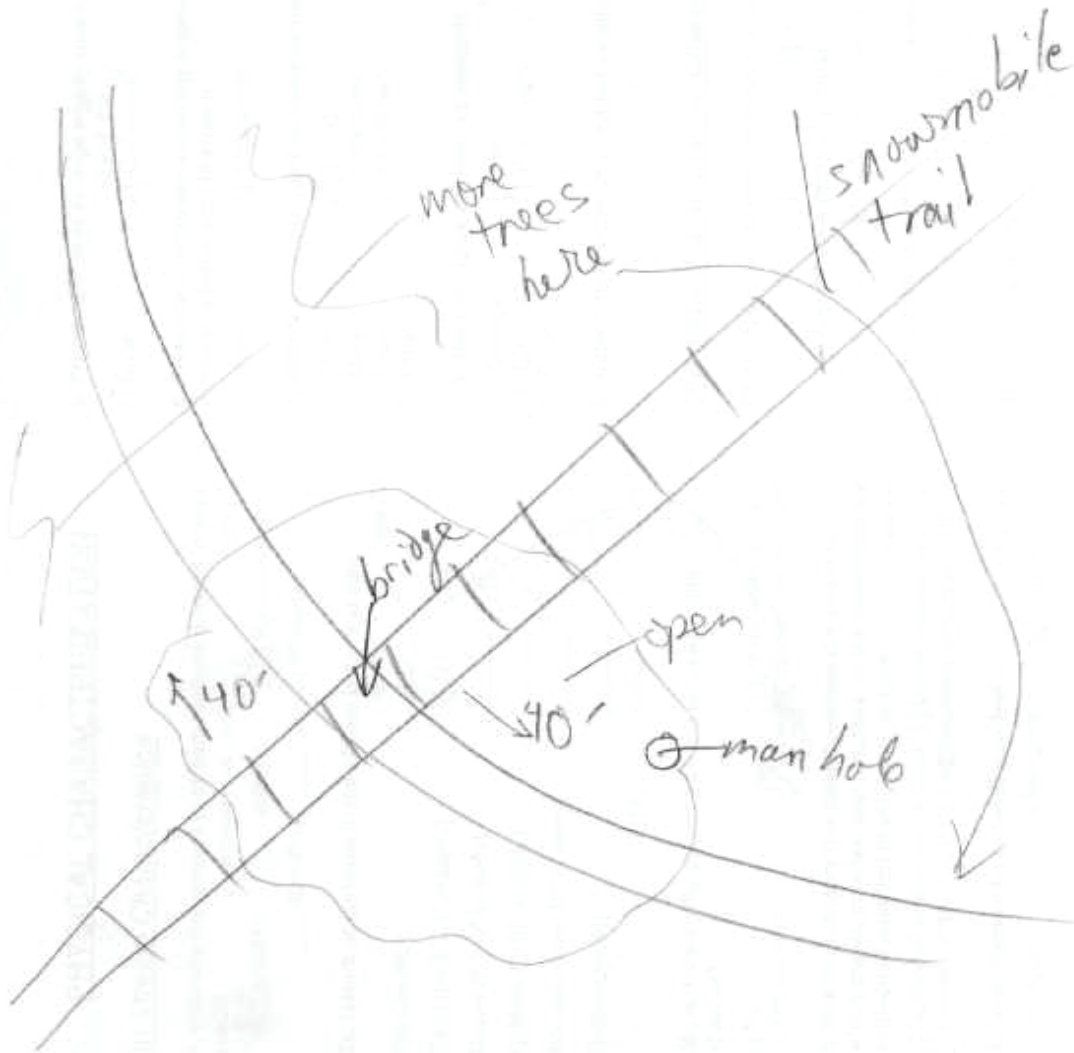
Low gradient, meandering, lots of snowmobile and ATV trails along stream

ATVs come close to stream destroying riparian areas. Leaky-sewer line. Smell evident in wet, screwed up ATV areas.

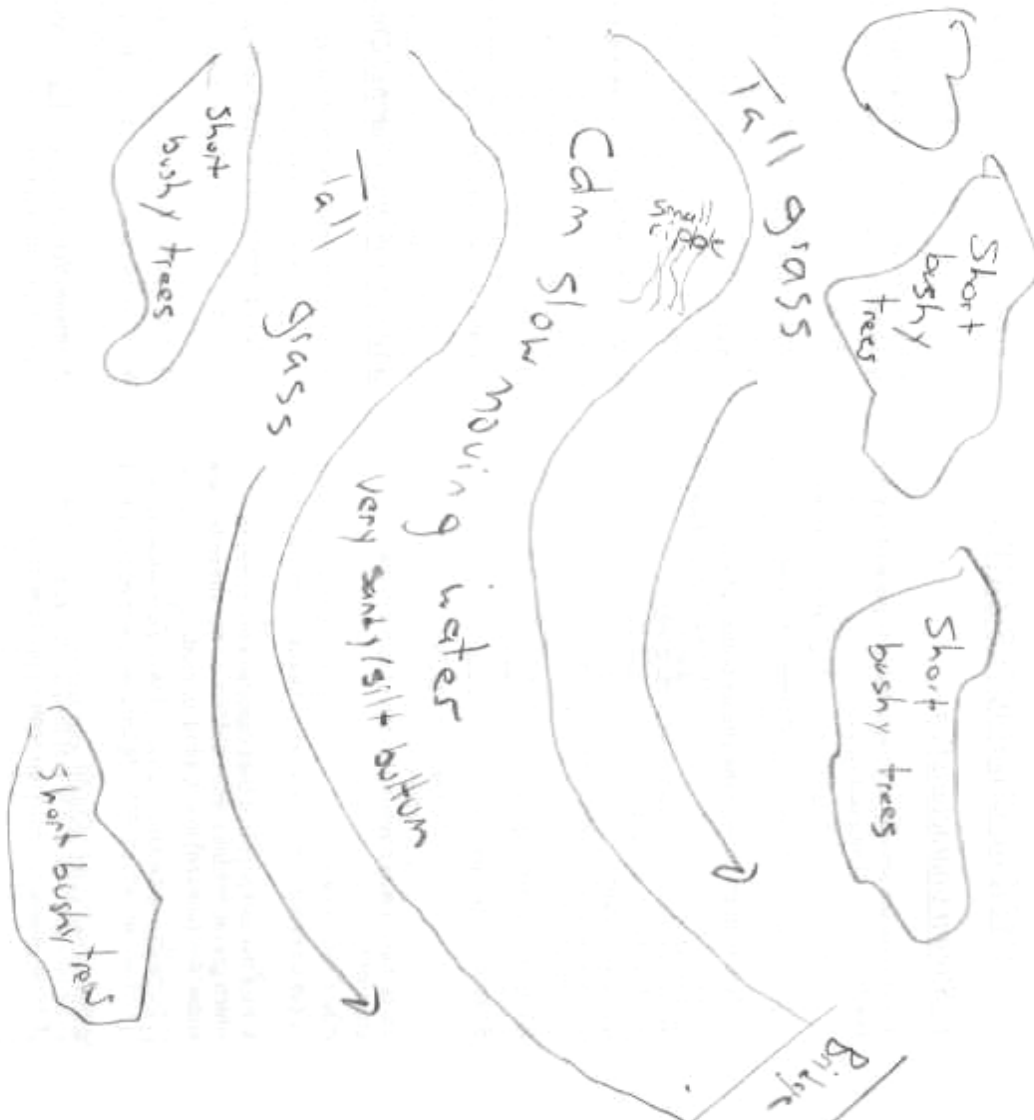
Sketch of Site

Low gradient, meandering, lots of snowmobile and ATV trails along stream
