Stormwater Management in Cold Climates – A Historical Perspective

Written by Daniel Holzman

CASE HISTORY

Cote d'Or Subdivision

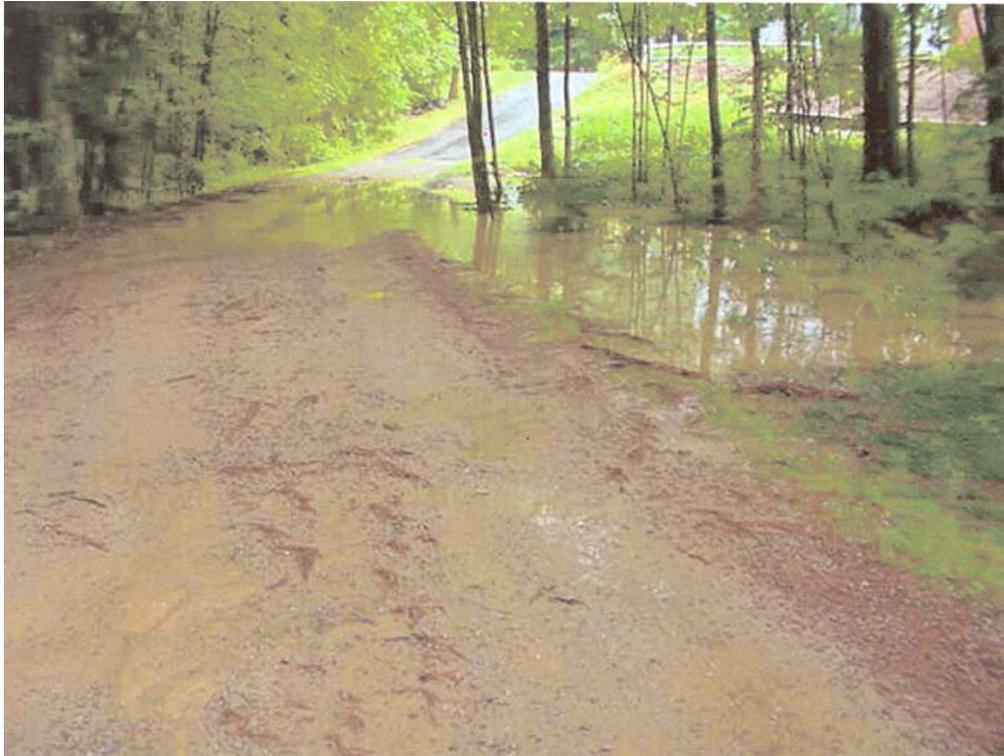
Figure 3: Flooding across Whippoorwill Lane August 2003

The summer of 2003 was significantly wetter than usual, including two short but intense storms in August. The storm of August 4, 2003 created flooding conditions at Whippoorwill Lane, including deposition of significant amounts of silt on the main subdivision road. Damage to septic systems, wells, basements, the fire pond, and the road itself resulted (see Figure 3). Flooding of this sort has apparently not been experienced in the close to 50 year history of Whippoorwill Lane, and occurred as a result of a storm estimated to have been less than 2 inches of rain in one hour.

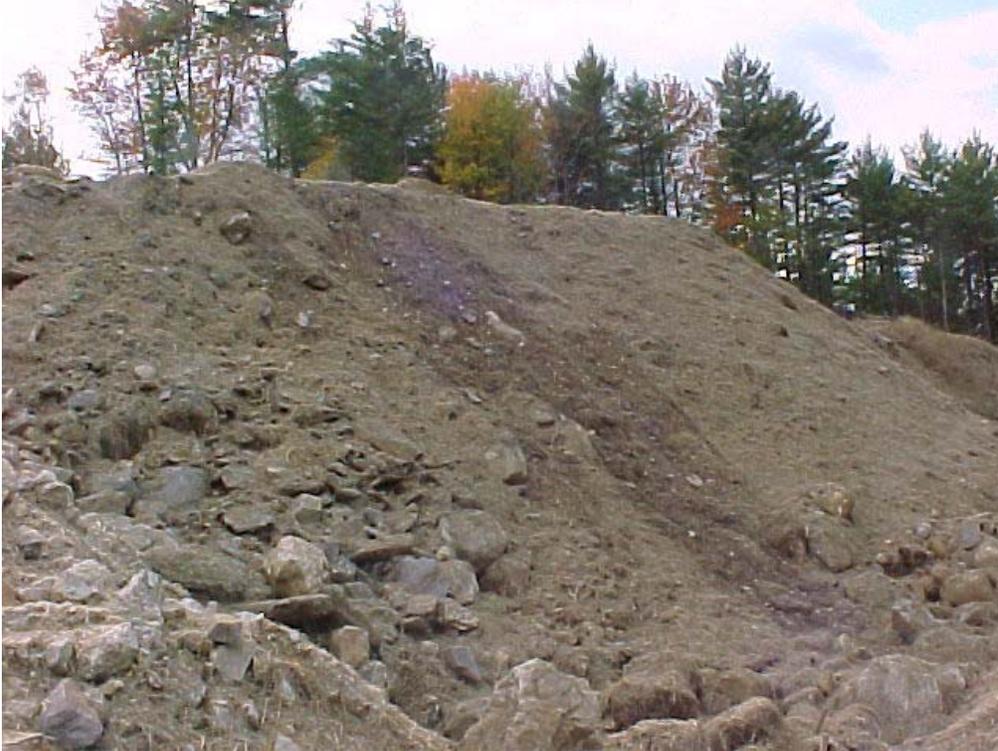
1. The lots immediately uphill of Whippoorwill Lane had been severely disturbed, with minimal installation of silt fencing and haybales to retard flood flow and soil erosion (see Figure 4). The result was migration of large amounts of silt from the top of the hill to the bottom, directly onto Whippoorwill Lane.

Figure 4: Disturbed soil off Burgundy Terrace. This photo was take after hydroseeding

The Town of Bedford has no special regulations covering temporary erosion control during construction, and generally relies upon State and Federal regulation to minimize problems. Due to limited resources, there was little or no federal or state oversight on this project, and common erosion control techniques such as installation of haybales and silt fencing, excavation of temporary detention ponds, and use of erosion control fabric were not effectively utilized. Ultimately, the Town issued a cease and desist order on several lots preventing further construction, and arranged for hydroseeding of bare slopes along Burgundy Terrace prior to the end of the growing season (early October).

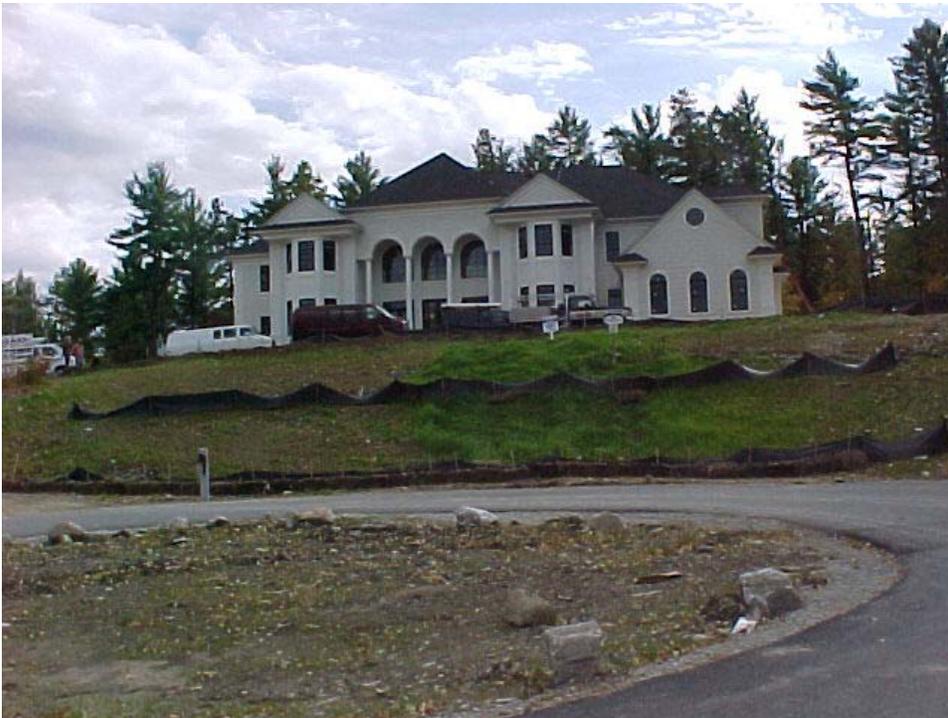
2. The estimate of 4,000 square feet of impervious surface per lot significantly underestimated the actual development. The effect was to underestimate the average runoff curve number, leading to an underestimate of storm flows.

4. The subdivision proved to be very popular, and multiple contractors have been building large houses simultaneously (see Figure 5). The result has been extensive soil disturbance occurring over as many as 15 lots simultaneously, leading to exposure of more acres of soil than anticipated in the erosion control plan. Erosion control measures have generally been ineffective and weakly enforced.

Figure 5: House with 8000 square feet impervious area on Burgundy Terrace

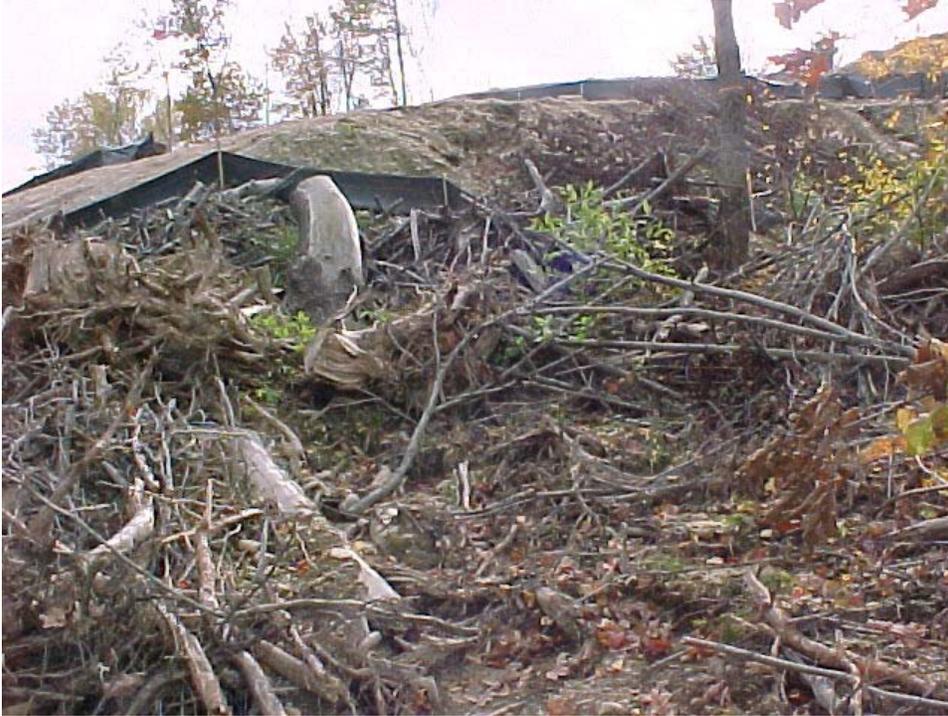
Poor erosion control practices during construction were a significant issue for this project. Temporary erosion control is often seen as an unnecessary expense by site contractors, who may hope that dry weather eliminates the need for extensive protective measures. Unfortunately, the wet summer of 2003 included a series of intense storms that carried silt and debris downhill to Whippoorwill Lane, leading to resident complaints (see Figure 6).

Figure 6: Erosion gully in poorly stabilized soil
